St. Johns County State Route A1A

Historic Resources Survey Report St. Johns County, Florida

GAI Project Number: R210889.00

July 2022

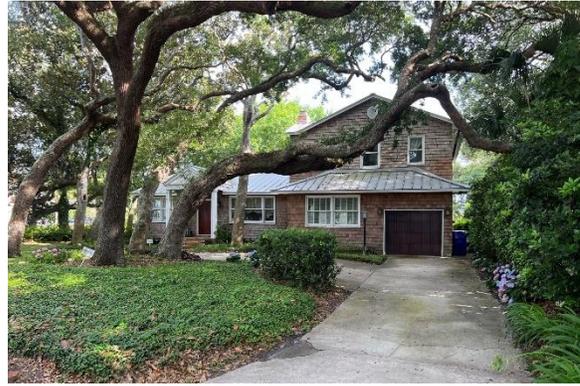
Photograph 19. SJ03766, 40 Ponte Vedra Circle.

The resource is a two-story, 1941 Colonial Revival dwelling (Photograph 19). The foundation material is not visible from the public right of way. The dwelling is clad in wood shingle siding, and capped by a front-gable roof covered in standing-seam metal. An interior, brick chimney interrupts the roof surface. A one-story, three-bay addition, capped by a side-gable roof, is appended to the east elevation. An enclosed former porch is located on the north elevation. An obscured, gable roof addition is appended to the rear elevation. The primary single entrance, atop a one-bay porch and sheltered beneath a gable roof supported by wood posts, is located on the north elevation. Fenestration includes one-over-one and four-over-four, double-hung, wood-sash and an octagon window.

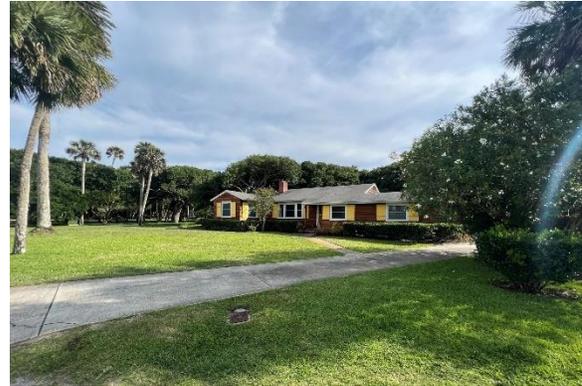
Photograph 21. SJ03769, 1 Ponte Vedra Circle.

The resource is a one-story, 1942 frame vernacular dwelling (Photograph 21). The dwelling rests on a concrete foundation, is clad in horizontal wood board, and capped by a side-gable roof covered in asphalt shingle. An interior, brick chimney interrupts the roof surface. Two one-bay additions, capped by a gable roof, are located on the north and west elevation. The primary single entrance, atop a one bay porch and sheltered beneath an extended roof supported by a wood post, is located on the north elevation. Fenestration includes one-over-one, double-hung, vinyl-sash windows.

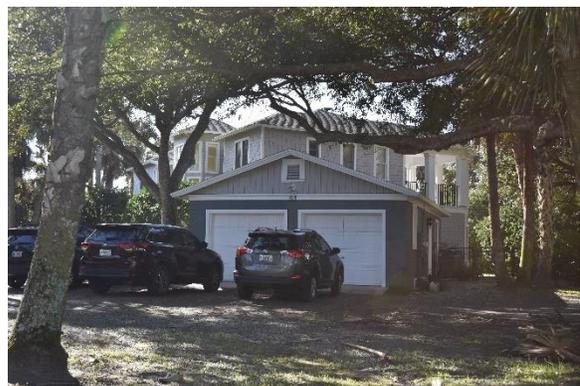
Photograph 25. SJ03774, 51 San Juan Drive.

The resource is a two-story, 1947 frame dwelling with a sprawling, irregular plan and a single-story, front-gabled two-bay attached garage (Photograph 25). The foundation material is not visible from the public right of way. The dwelling is largely clad in cement-mineral fiber shingles, with painted brick exterior walls used throughout the garage, which has board and batten siding in the gable end. An irregular, hipped roof covered in asphalt shingles caps the two-story portion of the resource, which includes an octagonal turret on the north side of the east elevation, adjacent to the primary entrance. A shed-roofed porch on large wooden pillars with square-cut trim shelters the entry door, and a second-story covered porch with identical pillars and a metal balustrade is located on the west elevation. A single interior chimney punctuates the roof, and fenestration consists of vinyl one-over-one double-hung windows throughout.

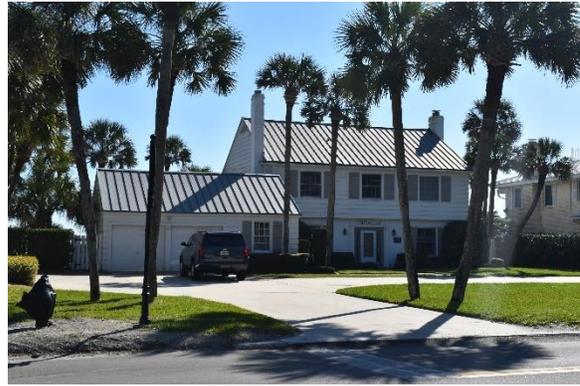
Photograph 28. SJ03794, 301 Ponte Vedra Boulevard.

The resource consists of a two-story, 1940, Georgian Revival dwelling standing three bays wide with a three-bay wide, single-story addition (Photograph 28). The dwelling has a concrete foundation, is clad with aluminum siding, and capped by a side-gable roof covered with standing seam metal. An external chimney is located at the north and south gable ends. The single-story addition is appended to the north corner of the west elevation and includes a two-car garage. The primary entrance is located on the west elevation with sidelights and pilasters. Fenestration includes eight-over-eight and six-over-six, double-hung, wood-sash windows.

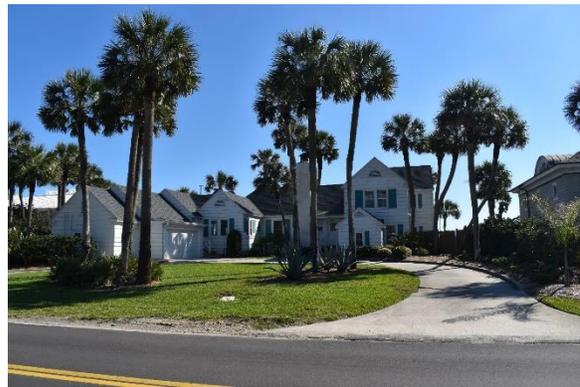
Photograph 29. SJ03795, 305 Ponte Vedra Boulevard.

The resource consists of a one-and-a-half-story, 1938, Frame Vernacular dwelling standing seven bays wide (Photograph 29). The dwelling has a concrete foundation, is clad with wood shingle siding, and capped with a cross-gable roof covered with asphalt shingles. An exterior, brick chimney is located on the west elevation. A two-car garage is appended to the west elevation. The primary entrance is located on the west elevation sheltered beneath a shed-roof hood. Fenestration includes simulated, four-over-four and six-over-six, double-hung, vinyl-sash windows. A semicircular driveway is located in front of the dwelling.

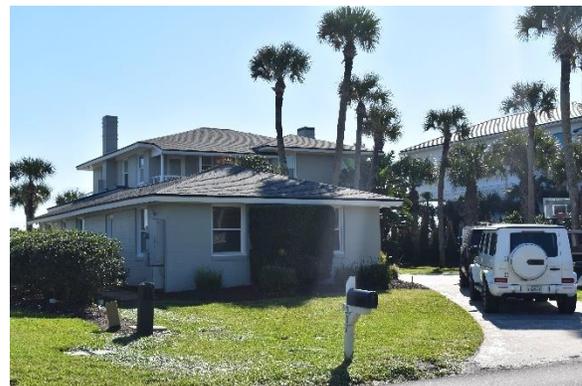
Photograph 32. SJ03798, 311 Ponte Vedra Boulevard.

The resource consists of a 1940, two-story Masonry Vernacular dwelling (Photograph 32). The foundation material is not visible from the public right of way. The dwelling is clad with brick and capped with hipped roof covered in asphalt shingles. An external brick chimney is located on the north elevation. The eaves have a wide overhang. The primary entrance is recessed within the west elevation. A balcony is located above the entrance, recessed beneath the roofline. Fenestration includes one-over-one, double-hung, vinyl-sash windows, and horizontal-sliding windows. A one-story apartment is located adjacent to the west elevation.

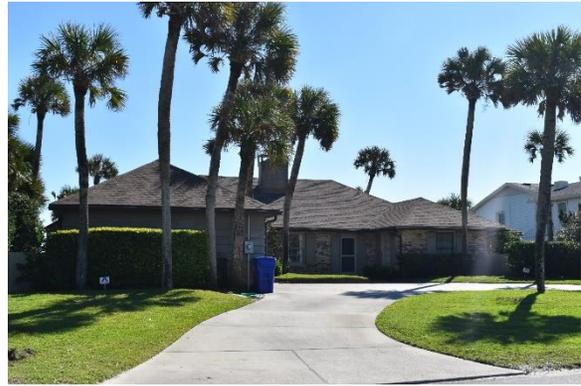
Photograph 47. SJ03827, 419 Ponte Vedra Boulevard.

The resource is a one-story, 1935 masonry vernacular dwelling (Photograph 47). The dwelling rests on a concrete foundation, is clad in brick and aluminum siding and capped with a hipped roof covered in asphalt shingle. An obscured one-story addition, capped by a hipped roof is appended to the west elevation. An intersecting hipped roof addition with two single-car garages, is appended to the west elevation. An interior concrete chimney interrupts the roof surface. The primary single entrance is located on the west elevation. A secondary single entrance is located on the south elevation of the garage addition. Fenestration includes six-over-six, double-hung, wood-sash windows.

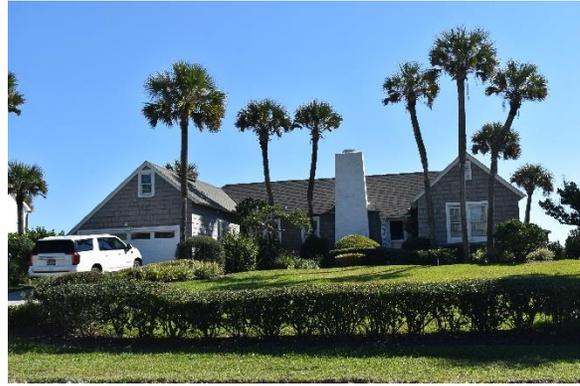
Photograph 50. SJ03837, 511 Ponte Vedra Boulevard.

The resource consists of a one-story, 1942 frame dwelling with Craftsman style elements (Photograph 50). The foundation material is not visible from the public right of way. The dwelling is clad with wood shingle siding, and capped with a cross gable roof covered with asphalt shingles. A large exterior brick chimney is located on the west elevation. A front-gable, one-and-a-half-story, two-car garage addition is appended to the north end of the west elevation. The primary entrance is located on the west elevation, beneath a shed roof hood supported by a decorative metal column. Fenestration includes six-over-six, eight-over-eight, and four-over-four, double-hung, vinyl-sash windows.

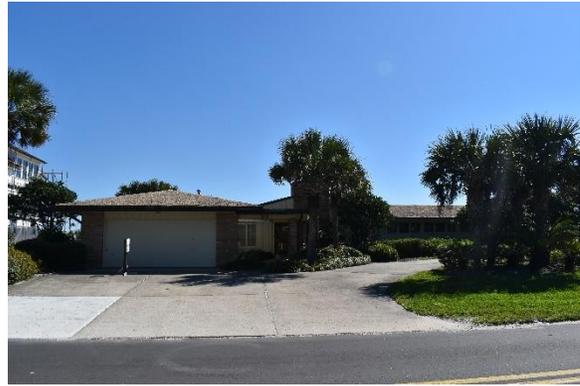
Photograph 55. SJ03851, 545 Ponte Vedra Boulevard.

The resource consists of a 1953, one-story, Ranch dwelling standing ten bays wide (Photograph 55). While the foundation material is not visible from the right of way, exterior walls are clad with a combination of wood board and batten siding and stacked stone veneer. The low-sloped, hipped roof, which has wide, overhanging eaves, is covered in built-up gravel roofing. The resource has an L-shaped footprint with a built-in, two-car garage located within the northernmost wing adjacent to a flat-roofed covered walkway supported by masonry piers clad in stone veneer. A prominent external chimney clad in stone veneer is situated on the primary elevation adjacent to the primary entrance door. Fenestration includes six- and four-light vinyl-sash casement windows and eight- and four-light vinyl-sash awning windows.

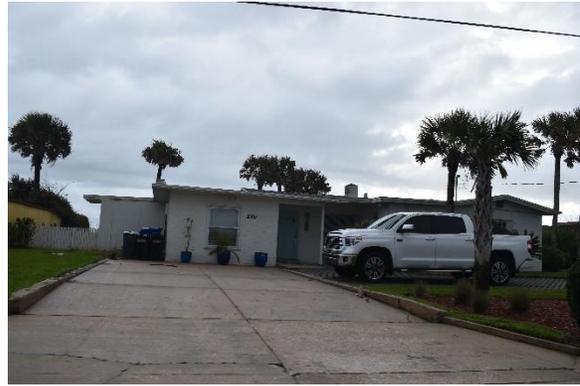
Photograph 63. SJ03888, 2503 Ponte Vedra Boulevard.

The resource is a one-story, 1949 Ranch dwelling (Photograph 63). The concrete block dwelling rests atop a concrete foundation and capped with a side-gable roof covered in asphalt shingle. A one-bay addition, capped by a gable roof, is appended to the west elevation. A wraparound addition, capped by a flat roof, is located on the west, north, and east elevations. An interior brick chimney interrupts the roof surface. The primary single entrance is located on the west elevation, atop a two-bay porch and sheltered beneath an extended roof supported by a wood post. Fenestration includes one-over-one, double-hung, vinyl-sash and six-over-six, double-hung, wood-sash windows.

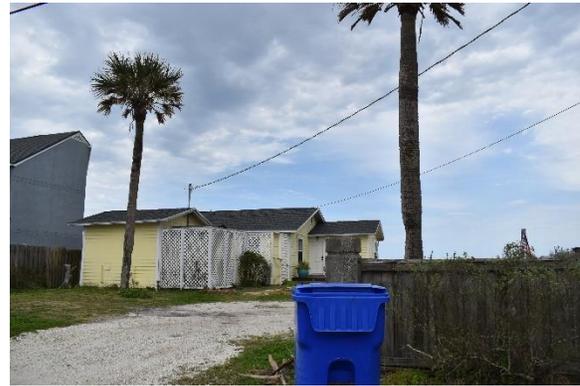
Photograph 65. SJ03891, 2871 Ponte Vedra Boulevard.

The resource is a one-story, 1947 frame vernacular dwelling (Photograph 65). The foundation material is not visible from the public right of way. The dwelling is clad in weatherboard siding and capped with a side-gable roof covered in asphalt shingle. A gable roof addition is appended to the west elevation, connected to the dwelling by a gable walkway. A gable roof addition is appended to the south elevation. The primary entrance is located on the south elevation addition, atop a one-bay porch and sheltered beneath the eaves. Fenestration includes three-over-one, double-hung, wood-sash windows. A wood latticework fence partially obscures the dwelling.

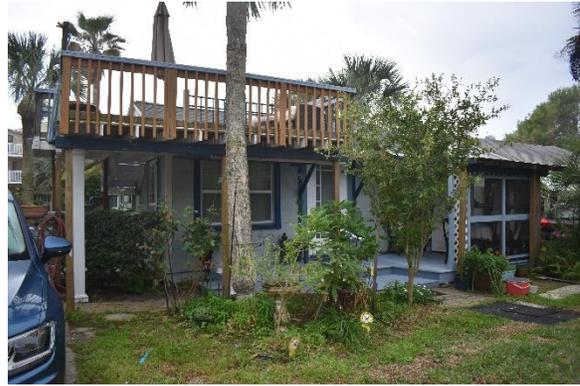
Photograph 83. SJ03917, 2854 #6 Coastal Highway.

The resource consists of a one-story, 1970 side-gabled frame vernacular residence with a shed-roofed, partially-screened entry porch and a second-story uncovered deck (Photograph 83). The primary entrance door is centered on the north elevation. Exterior walls are clad in horizontal asbestos siding with corner boards, while the roof is sheathed in asphalt shingles. Fenestration consists of vinyl four-over-one double-hung windows.

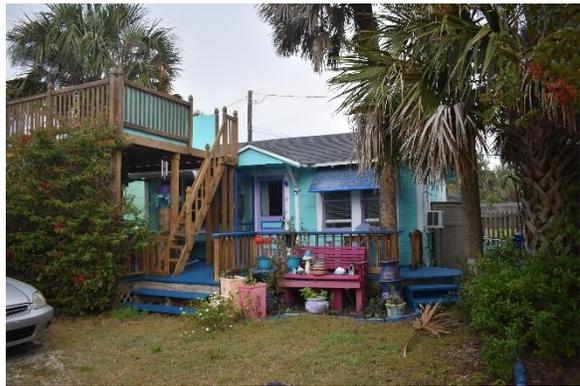
Photograph 84. SJ03918, 2854 #2 Coastal Highway.

The resource consists of a one-story, 1970 side-gabled frame vernacular residence with an uncovered, full-width entry porch situated beneath a second-story uncovered deck (Photograph 84). The primary entrance door is centered on the south elevation and situated beneath a front-gabled bracketed overhang. Exterior walls are clad in horizontal asbestos siding with corner boards, while the roof is sheathed in asphalt shingles. Fenestration consists of wood one-over-one double-hung windows, some of which appear beneath bracketed awnings.

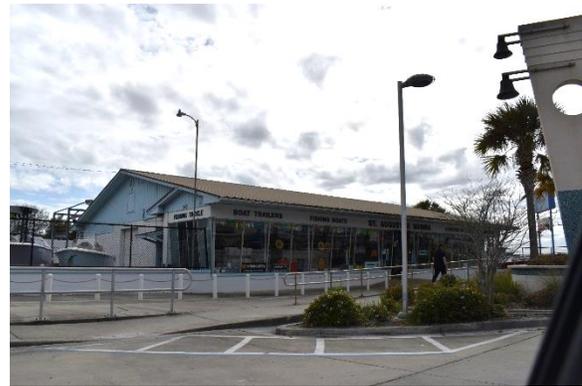
Photograph 127. SJ08067, 245 Vilano Road.

The resource consists of a one-story, 1966 side-gabled concrete block commercial building with canted aluminum storefront display windows spanning the north elevation (Photograph 127). The canted storefront wraps both the northwest and northeast corners, topped with secondary inset gables. The primary roof has wide, overhanging eaves and is sheathed in standing seam metal. Side-gabled and shed-roofed additions are appended to the southern side of the original building. The primary single-leaf glazed aluminum entrance door is centered on the north elevation. Exterior concrete block walls are painted, while gable ends are clad in vertical siding. Fenestration consists of aluminum fixed and vinyl one-over-one double-hung windows. A side-gabled concrete block garage building with eight bays is situated east of the primary Marina building, and a secondary storage building with a combination side-gabled and flat roof is located to the south.
