April 23, 2025

Building Evaluation and Feasibility Report – Magic Beach Hotel, Vilano Beach, Florida

This report has been prepared to review the current conditions of the Magic Beach Hotel buildings and associated improvements on the property. We have examined the original building as well as the various additions that have been added to the building in the past.

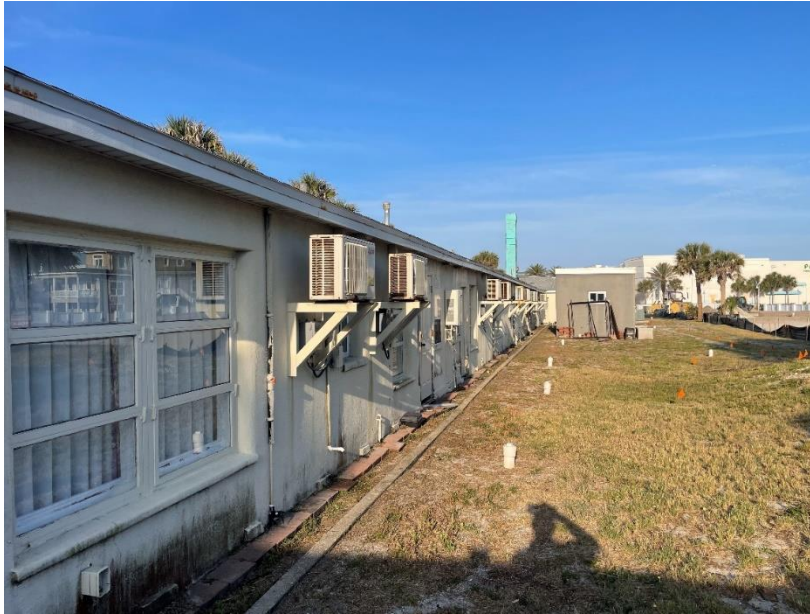
The current hotel, originally constructed in the early 1950's is located 8" below the current grade of all the adjacent properties. Note the retaining wall along the rear building edge where the slab is located below grade. Note the mold deteriorating the siding adjacent to the lower elevation.

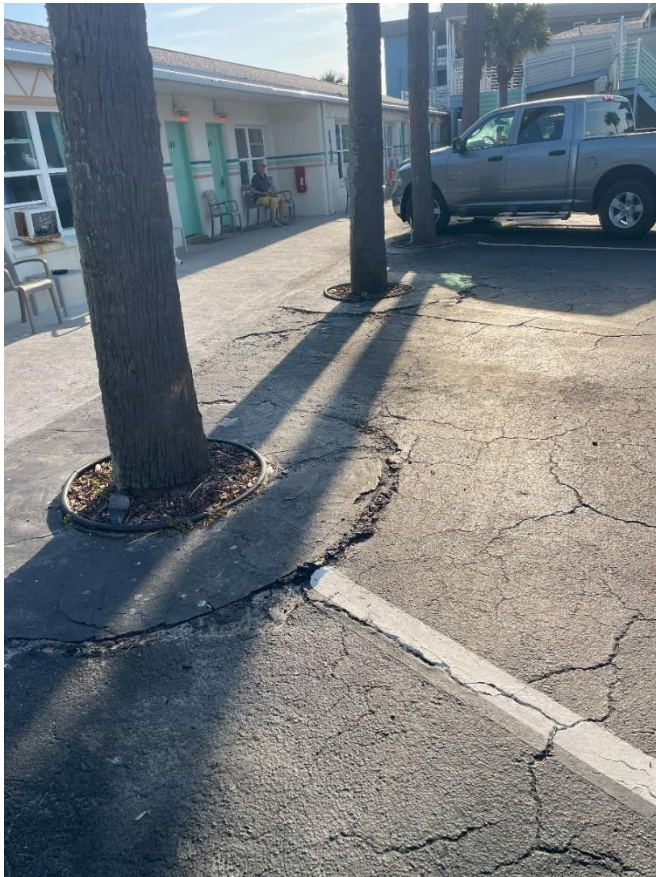
The grade at the front of the building is aligned with the parking lot and adjacent roadway. No raised ramp, sidewalk or step up is seen. Note even the palm tree planters are on the same grade with the building.

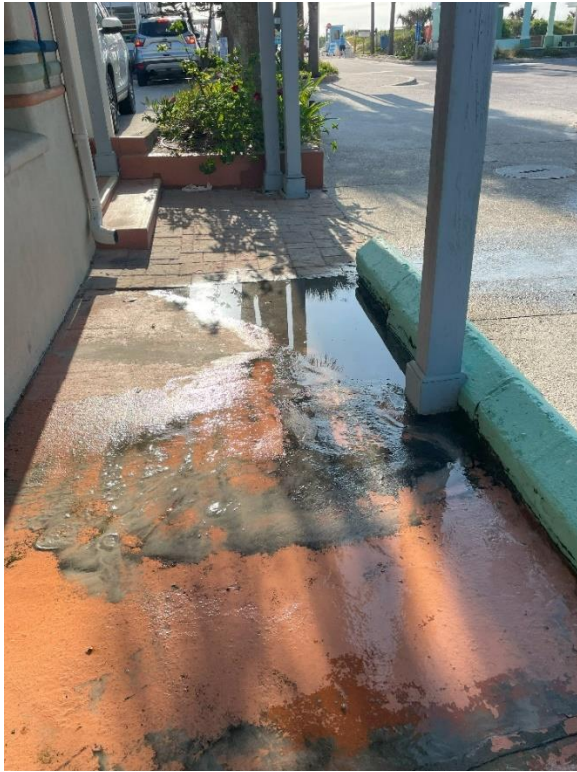
A retaining wall is located on the front property line adjacent to the public sidewalk. Note the puddling water and internal drain channel that collect water from the right of way. The building is below the grade of the sidewalk.

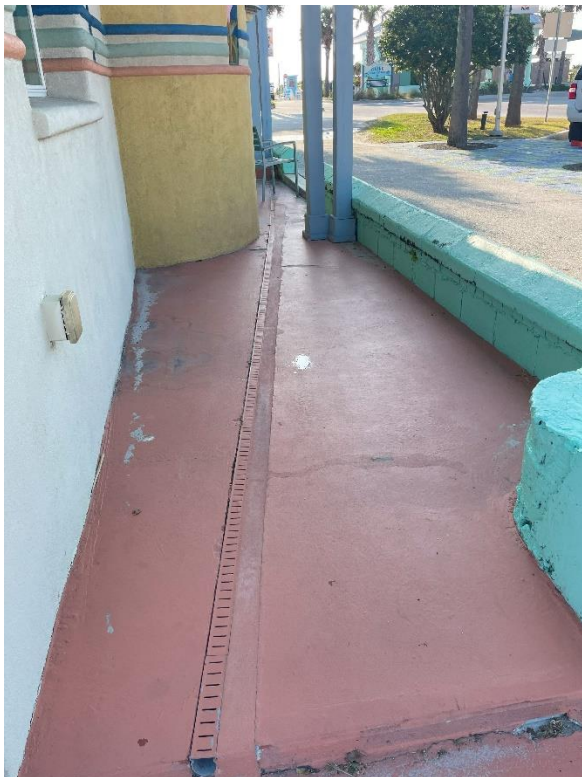
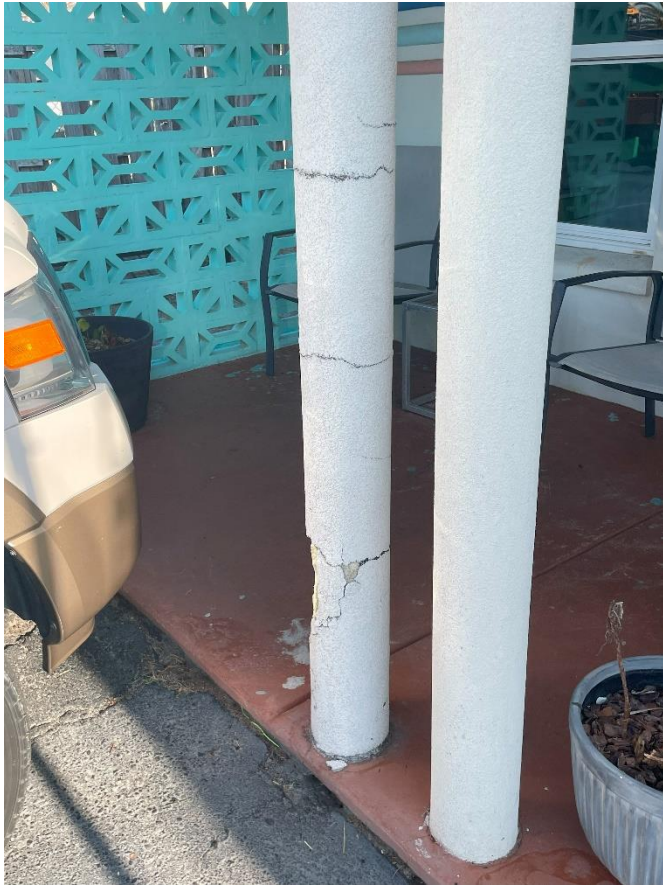
No curb line to restrict vehicles from colliding with structural columns supporting the building. Note column has been hit by a vehicle.

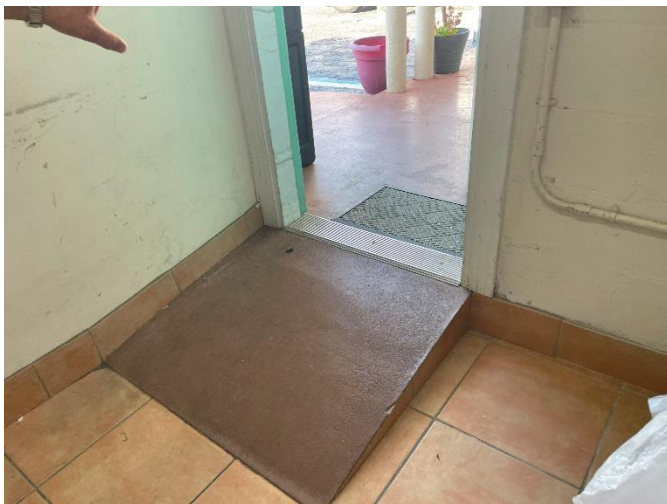
The finished floor of portions of the hotel are below the exterior grade.

- Raising the first floor of the building to a FEMA elevation (+ 5 feet higher). This means using pile type construction to raise the finished floor of the building.

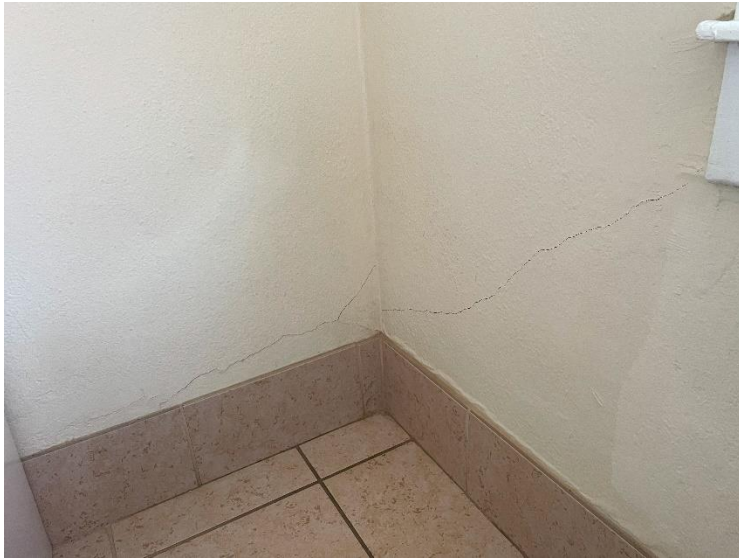
Multiple cracking observed in plaster walls at grade locations. Foundation has settled.

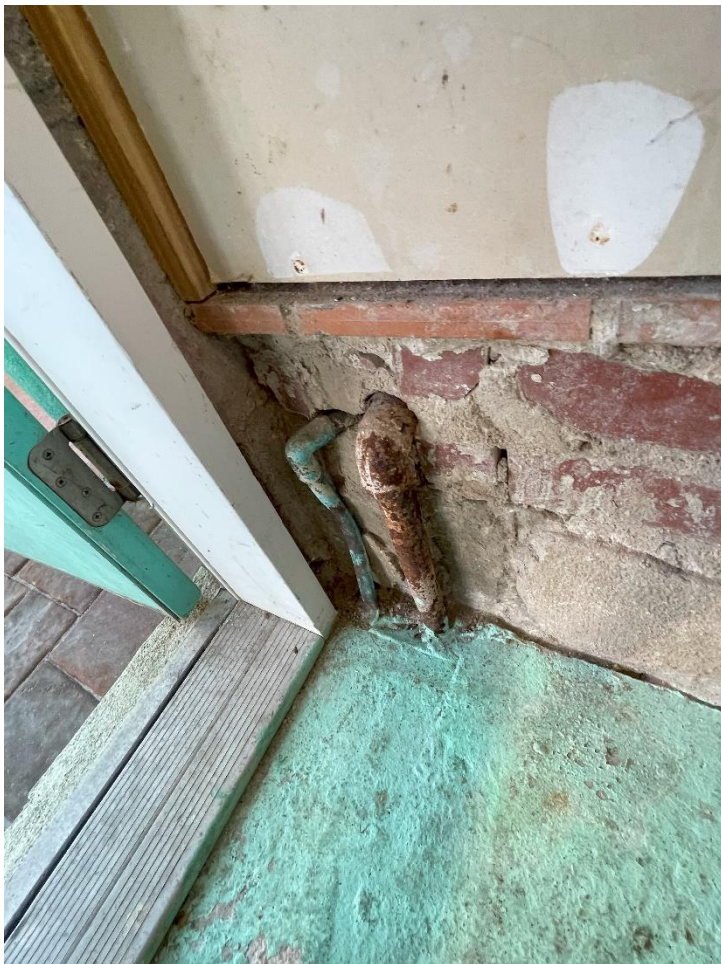
Poor original construction. Note the rough quality of brickwork, steel piping exposed and rusted, copper pipe all unprotected. No expansion joint between the slab and the wall.

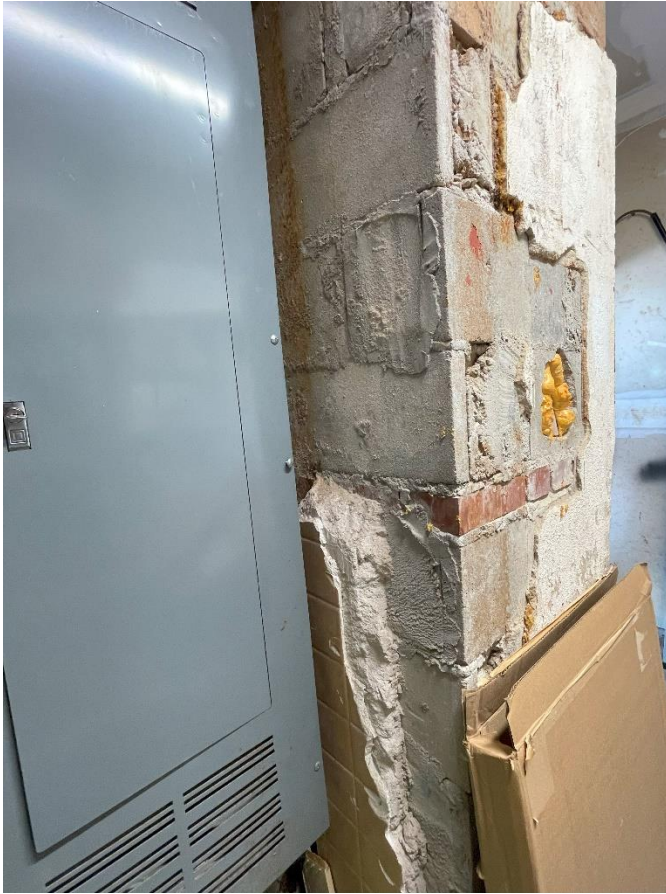
Poor original construction. Note: The chimney construction a mix of CMU and brick with terrible workmanship.

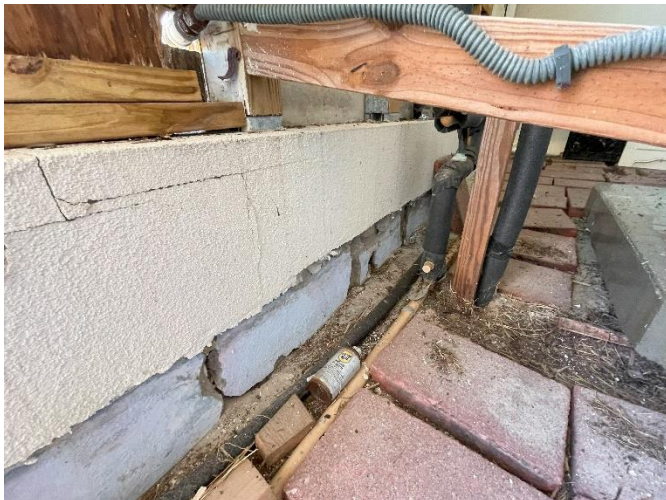
Extremely poor construction conditions. This wall condition is concerning. Observed open gaps in the CMU wall system, no concrete slab (pavers), standard wood verse pressure treated at the masonry.

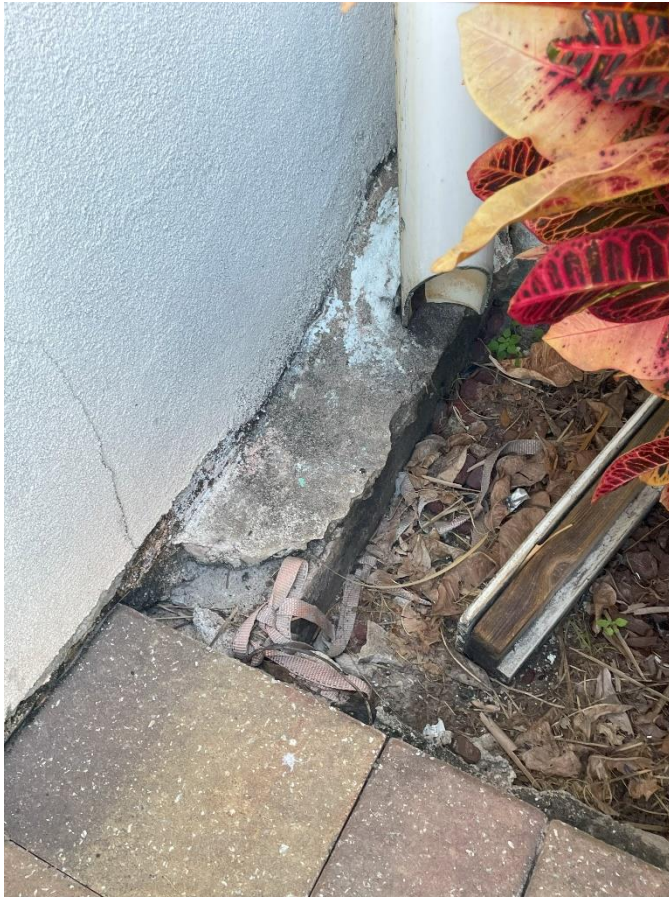
Existing foundation is exposed. Note the narrow substandard width. Looks to be 16" wide in total with 4" projecting from the 8" CMU. Note cracking at the wall EFIS stucco and the down spout that dumps its water on top of the foundation.

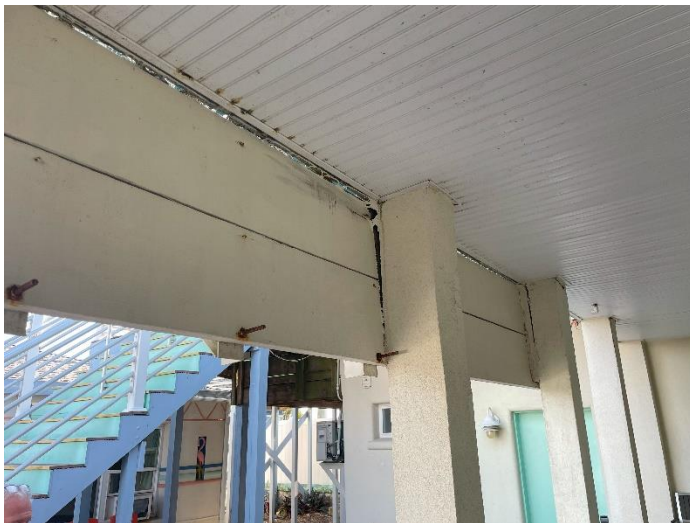
Retrofitted wood beams pulling away from the structure. All fasteners are rusted. No use of stainless steel for fasteners. Any steel fasteners will have a life span of less than 10 years.

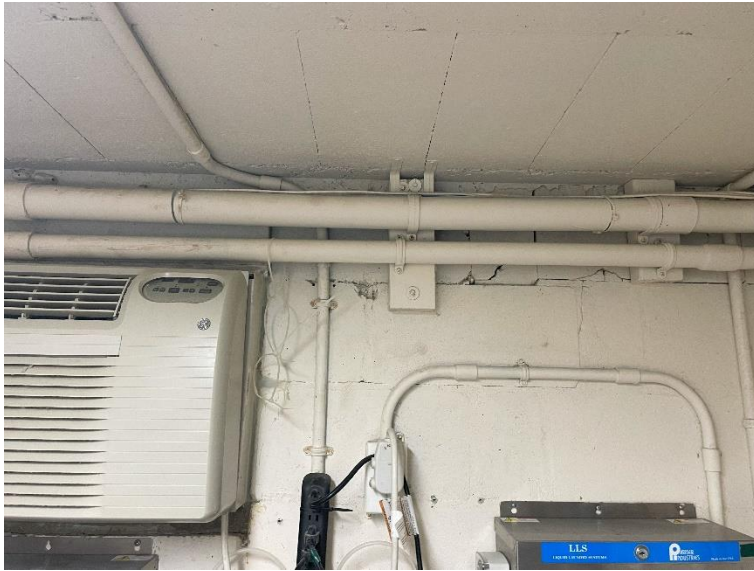
CMU walls cracking with little or no rebar supporting verticals or beams. Electrical distribution system is in substandard condition.

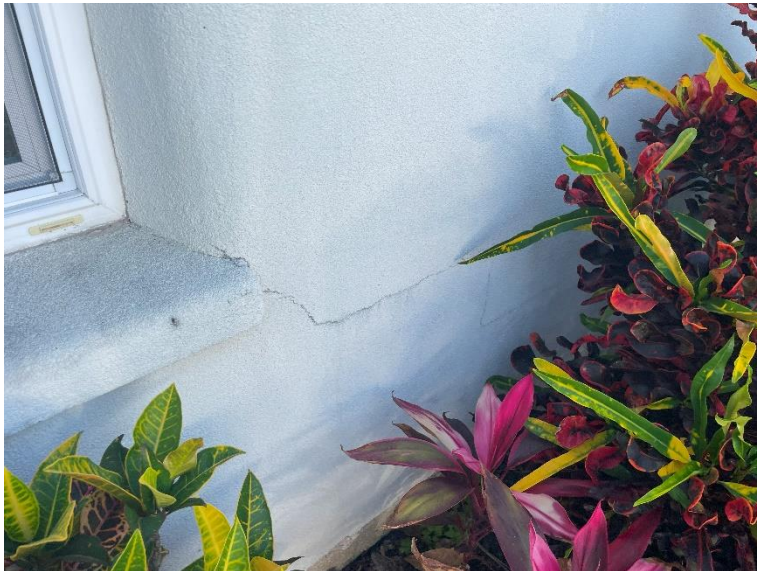
The building has been wrapped in EFIS (a newer material) and yet CMU cracking is still visible. Foundations have settled to cause the cracking seen in the walls.

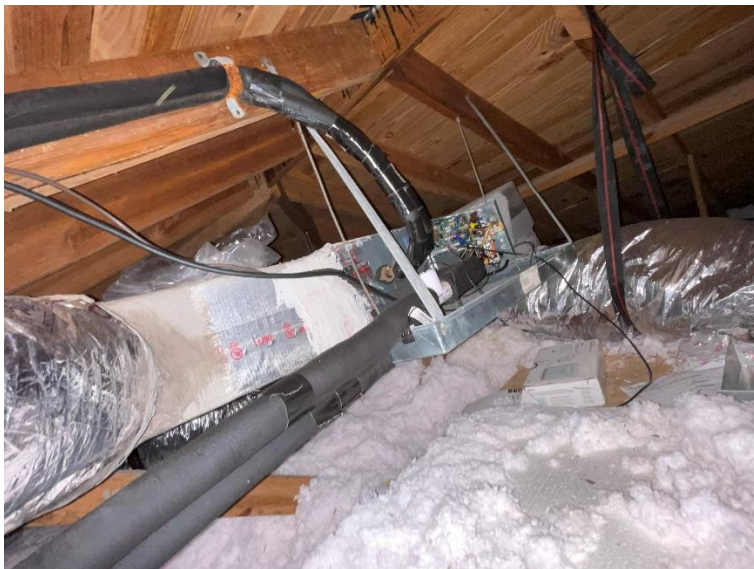
Poor original construction conditions. The air conditioning has been retrofitted post original building and located in an unconditioned attic not meeting code. Note that no rafters or beams have any type of hurricane clip or metal strapping.

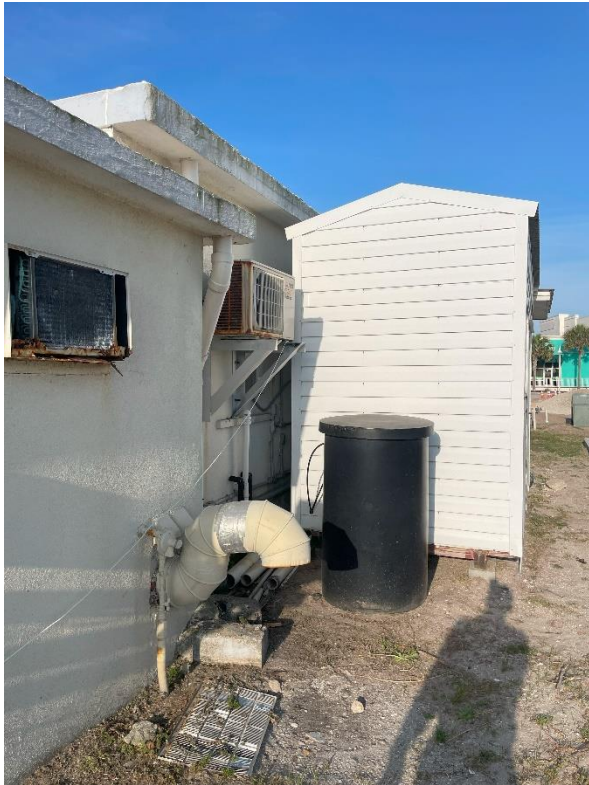
Original building has seen multiple additions over the years. Some may align with the original structure, and some do not, as seen in this case. Note the retrofitted A/C units along the front and rear sides of the building. New services were just added over the years with no central plan on how to incorporate them into the existing building fabric.

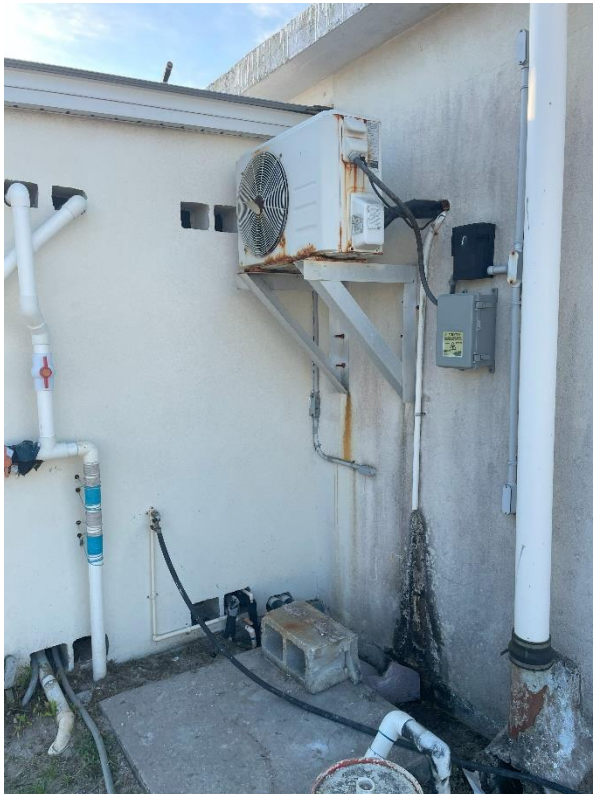
More of the same hap-hazard services added to the building.

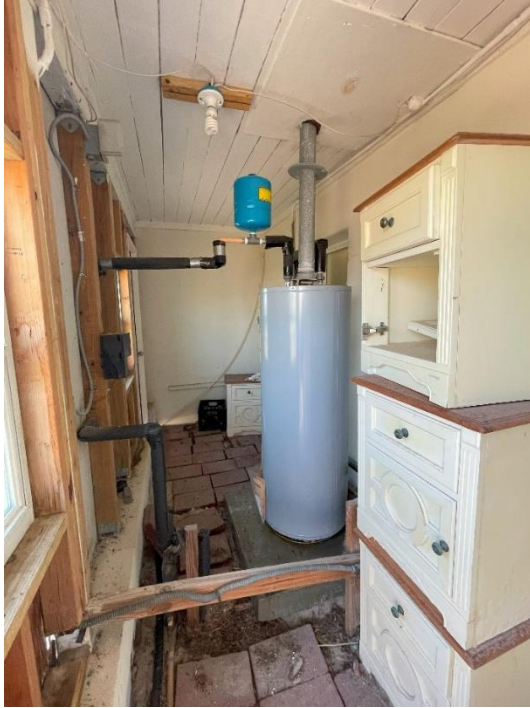
Retrofitted water heater condition in the roughest portion of the hotel. This occurs at 2-3 locations on the property. Multiple problems are evident in this photo.

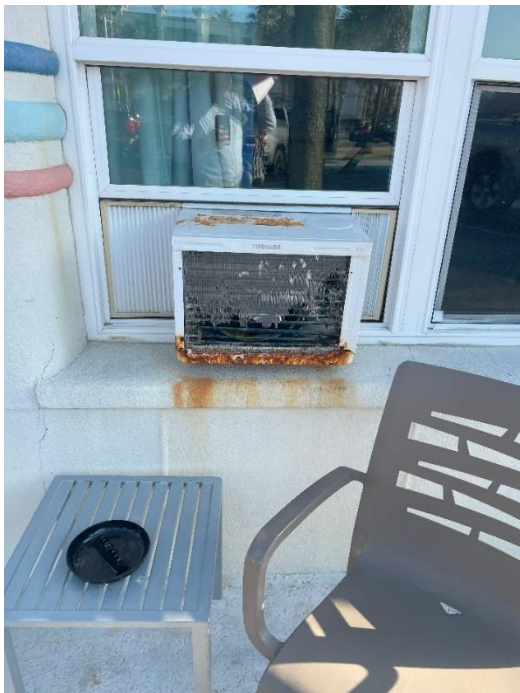
Air conditioning solution is to install window mounted units. Note the poor condition, and cracks in the EFIS stucco.

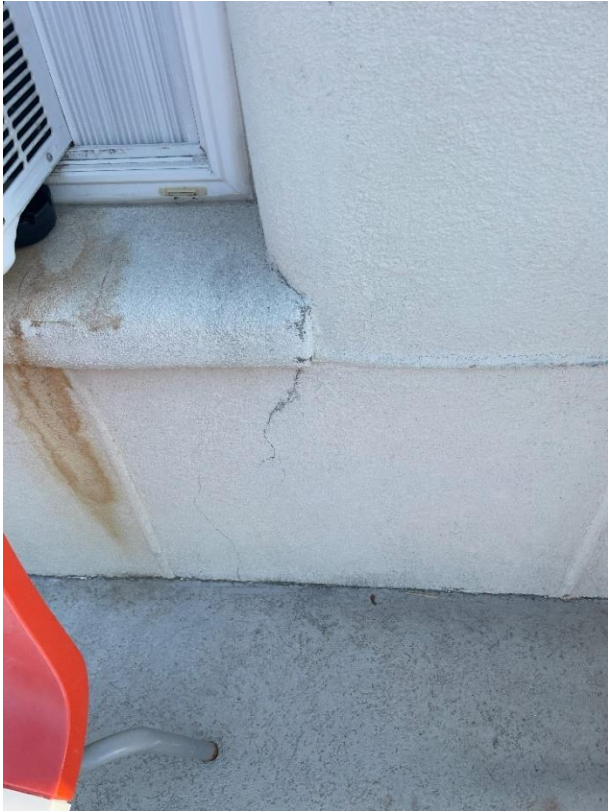
The original building has been wrapped with an EFIS system. system. Note the foam insulation below the broken section. EFIS spans building cracks and yet more cracking is shown through. The original building façade has been hidden behind the EFIS system.

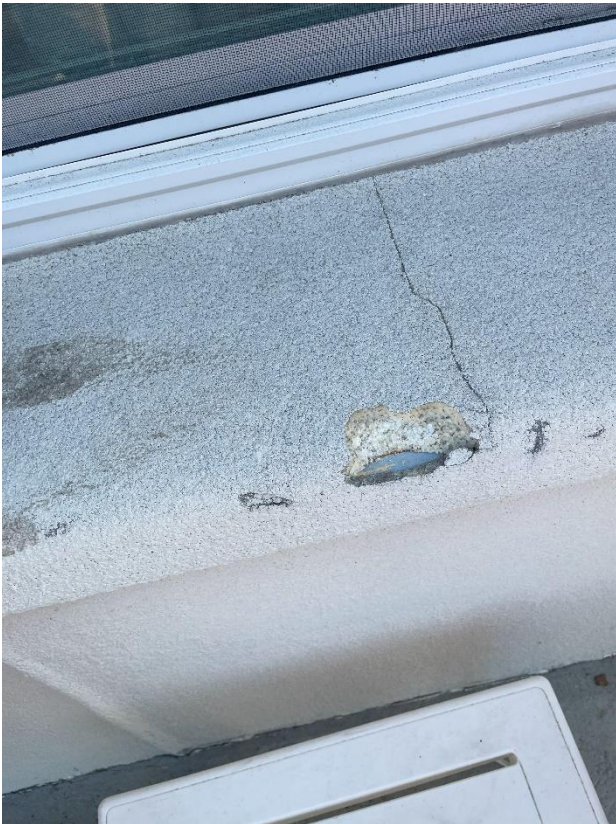
Building settlement cracking showing through the EFIS. This often occurs at the exterior walls.

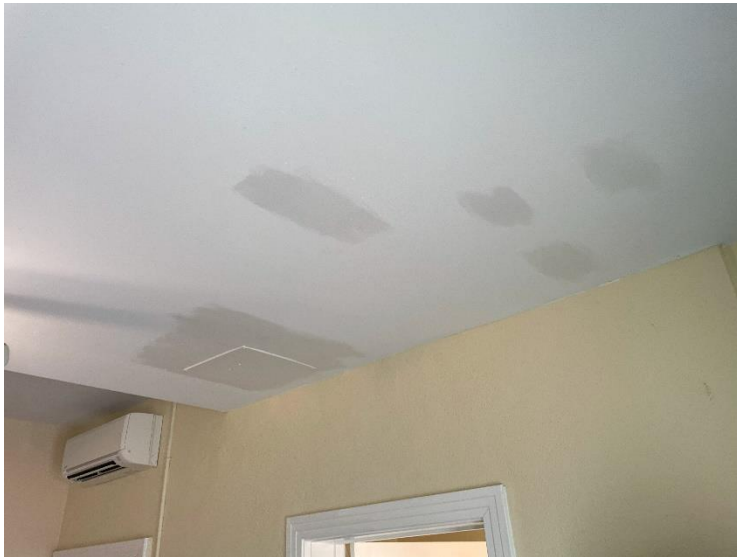
Evidence of multiple roof leaks. Portions of the roof are in poor condition and the front façade of the eastern most addition is missing through wall flashing causing further leaks.

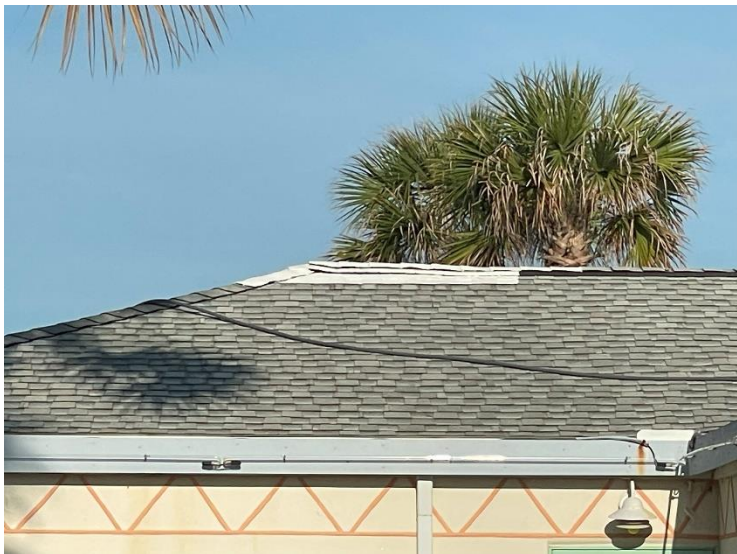
Existing roof has a leak point and has been “repaired” with a painted roof coating. Note unsupported electrical wiring laying on the roof surface.

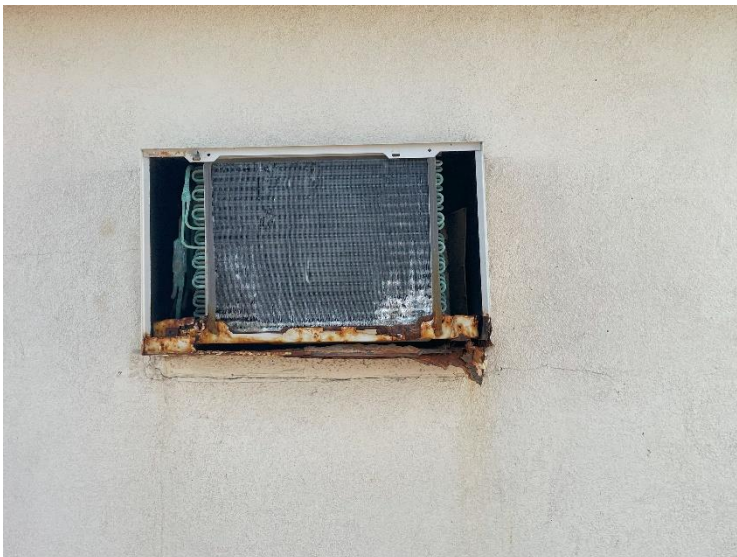
Wall condition at A/C unit allows for rainwater to enter the building envelope.

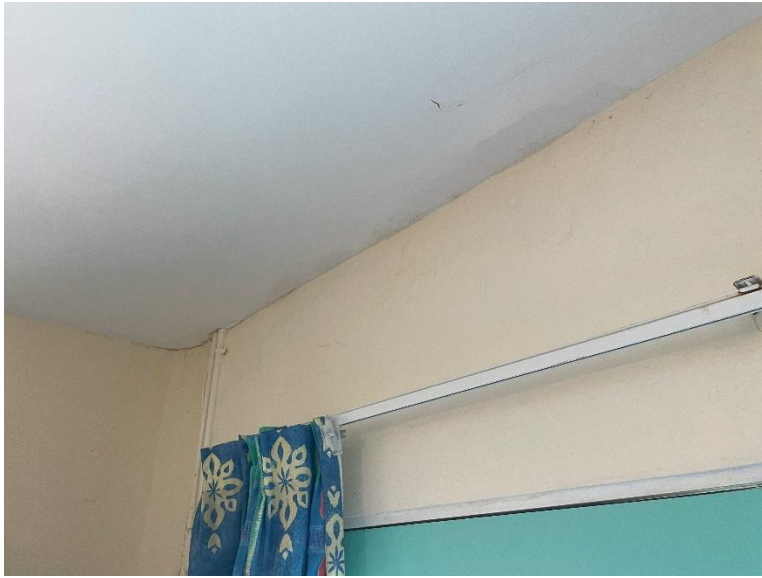
Evidence of roof leakage in another guest room.

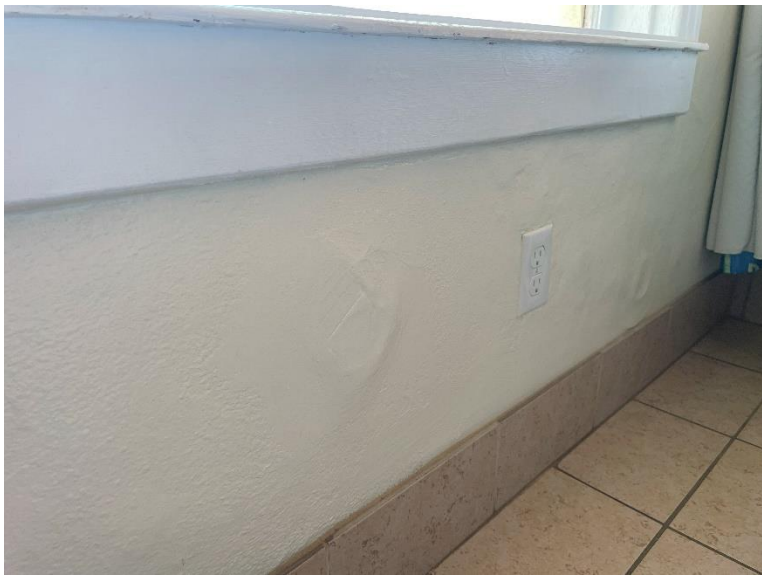
Evidence of water leakage in the wall and window system is prevalent in most guest rooms.

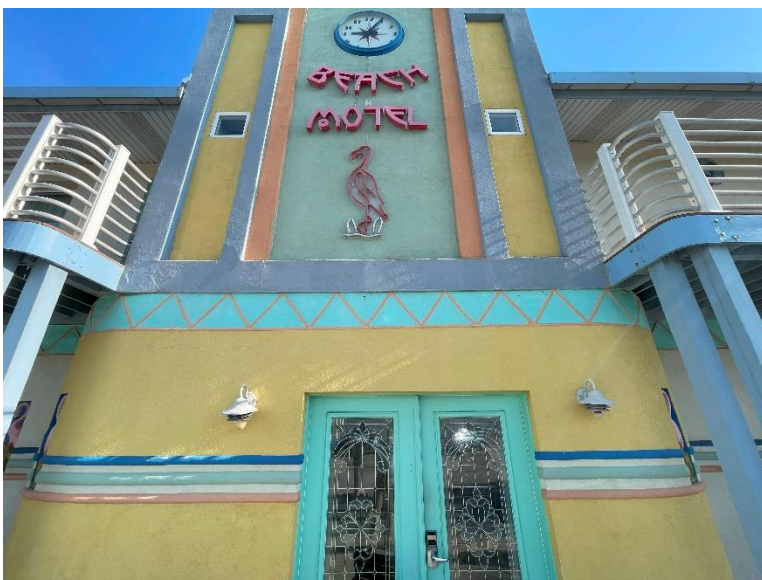
This is the most successful Art Deco example on the building. This is an addition from 20+/- years ago. The wall flashing is not installed and the wall leaks into the first-floor room below.

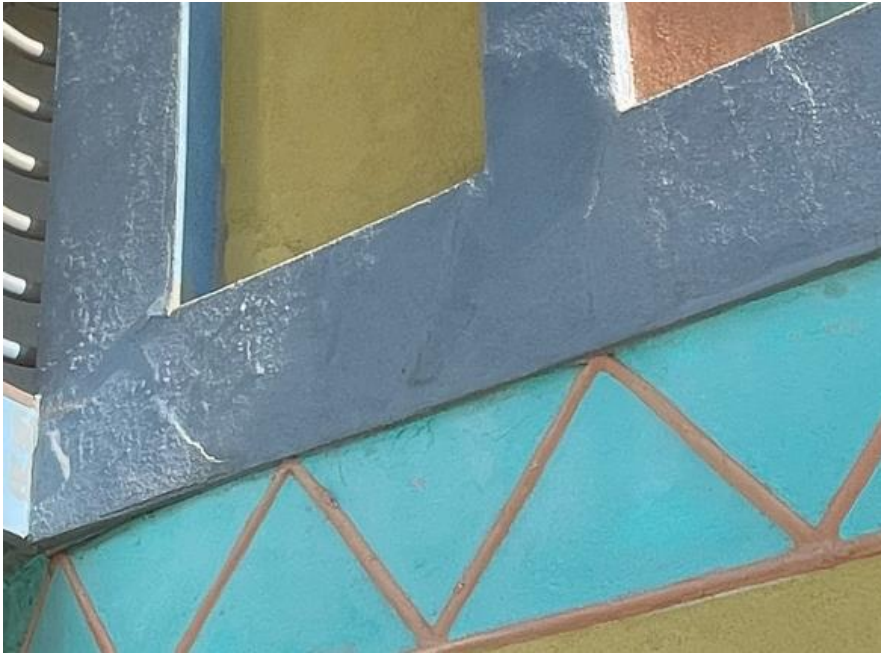
Note several "patch" jobs to the exterior EFIS stucco system.

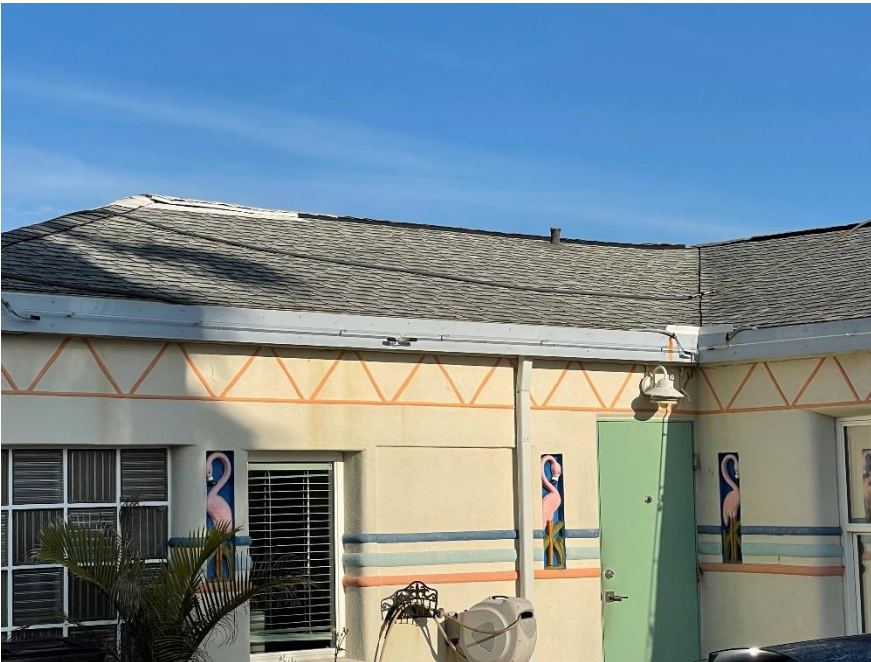
Electrical service is substandard. Note an electrical cable is unsupported and laying on the roof. When this building was improved for the TV show "Magic Beach" the neon lighting along the building was installed. The large sign was also installed, and power looks to have been installed in a temporary fashion.

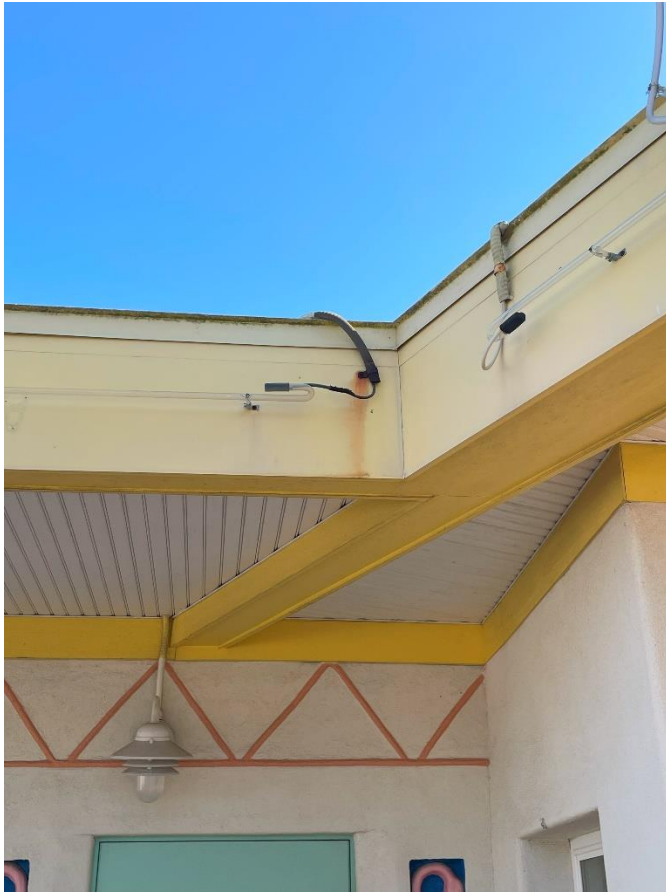
Newer neon lighting installed on the building fascia. Note the power is improperly terminated and the cables simply laid on the roof or in the gutters.

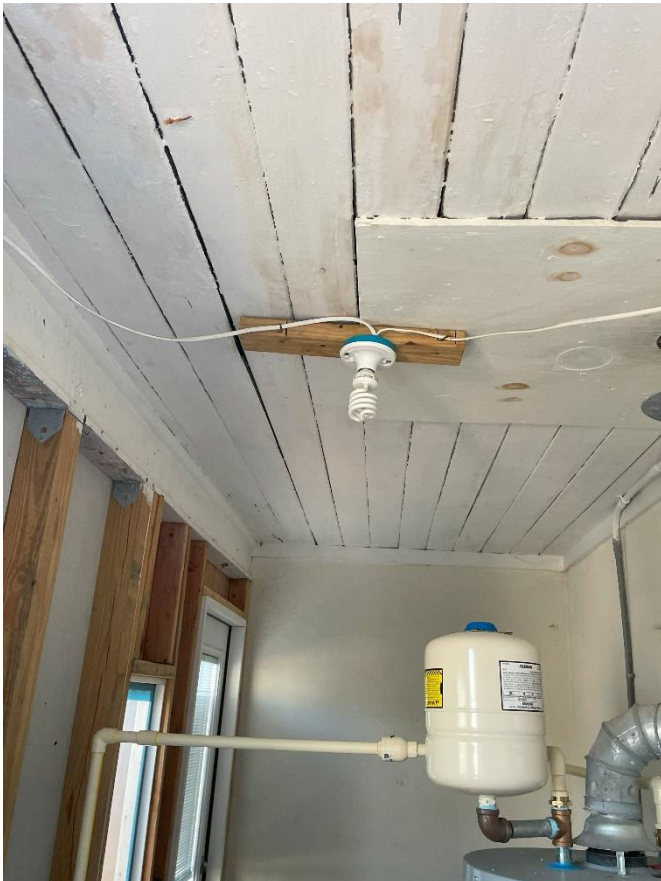
Utility room with improper electrical wiring. This occurs frequently around the building.

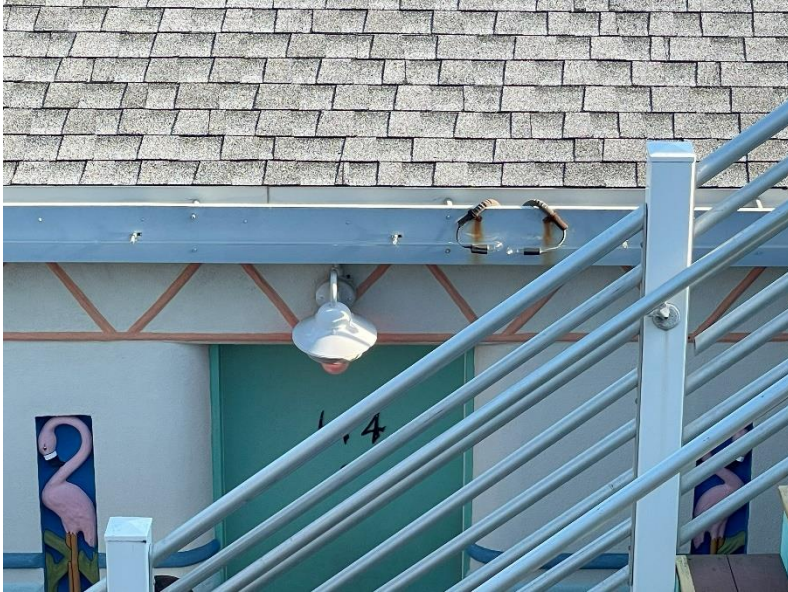
Newer neon lighting has shorted out and caused a small fire. See evidence. Wiring is run in the gutters.

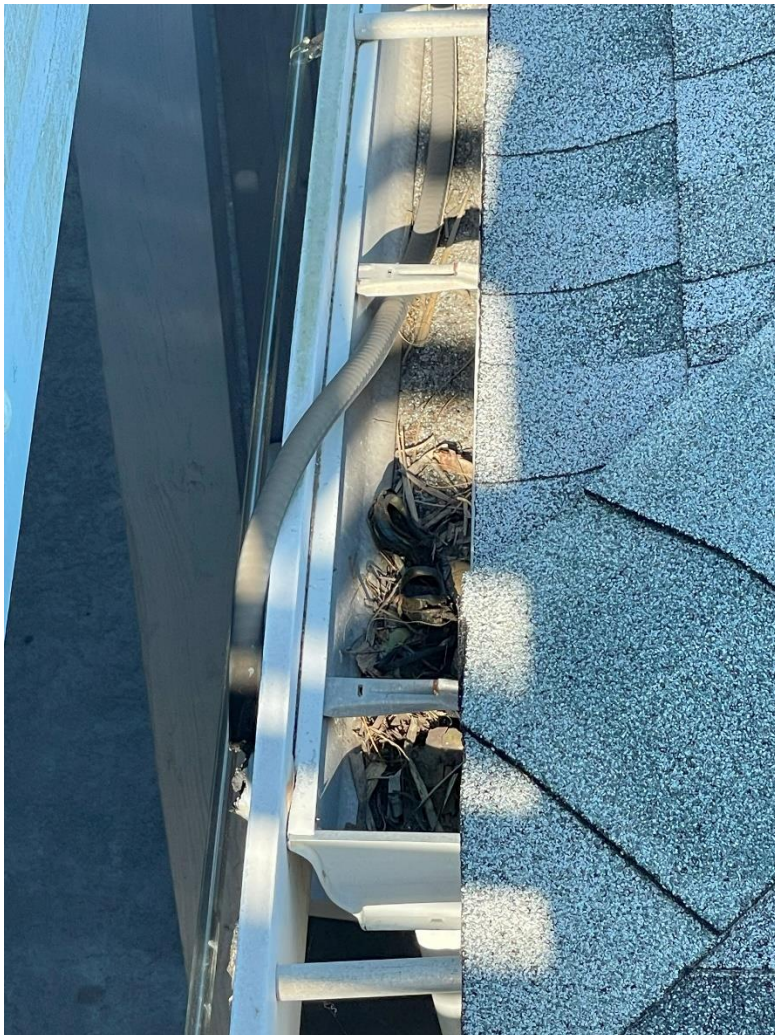
Electrical wiring run in the gutters.

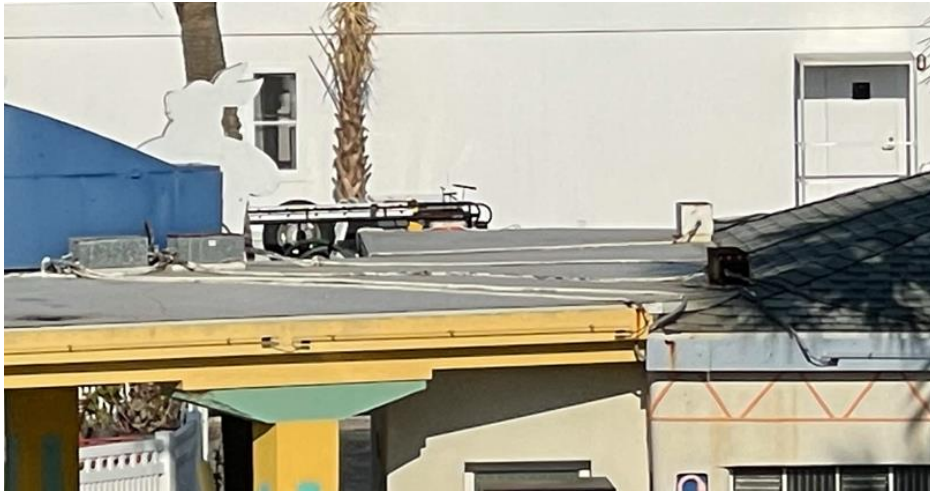
The roof is home to multiple transformers and switches for the neon lighting that was added by the TV show. Wiring is improperly laid on the roof.

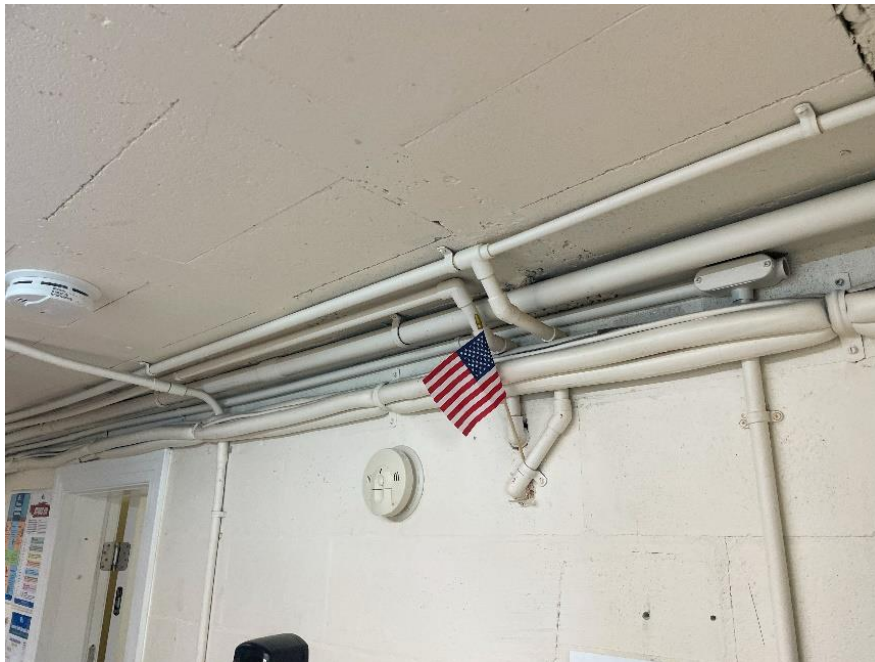
A mix of electrical conduit and water piping run in a hap-hazard way.

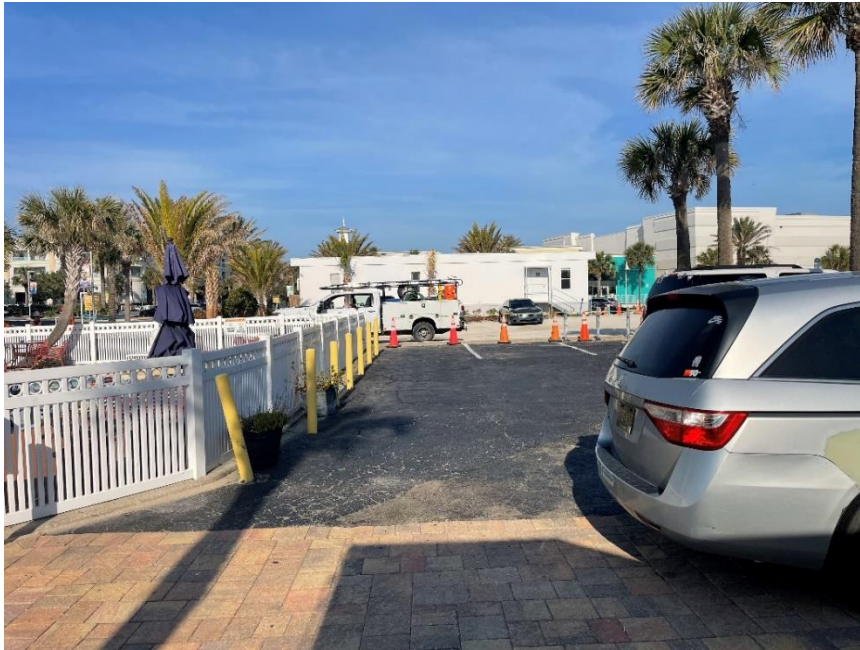
The parking lot does not follow any logical code. Parking spaces are irregular and access to them is dangerous. Beyond the minivan are 5 parking spaces. Note the large SUV parked behind the minivan.

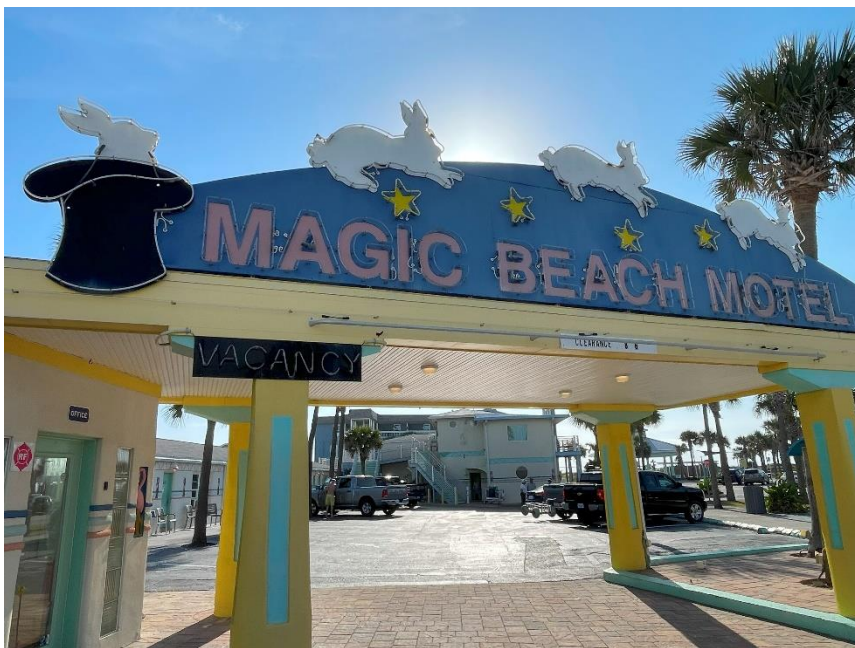
The new Magic Beach sign violates the fire department vehicular access to the building. The fire department requires 13'-6" clearance for any porte cochere.

- Tear down the porte cochere and install a new one that meets the Fire Marshal height requirements.
- Redesign the parking lot which would significantly reduce the parking count. This would reduce the room count to what the parking lot would allow. I estimate 1 parking space per unit would be necessary plus several spaces for the staff.

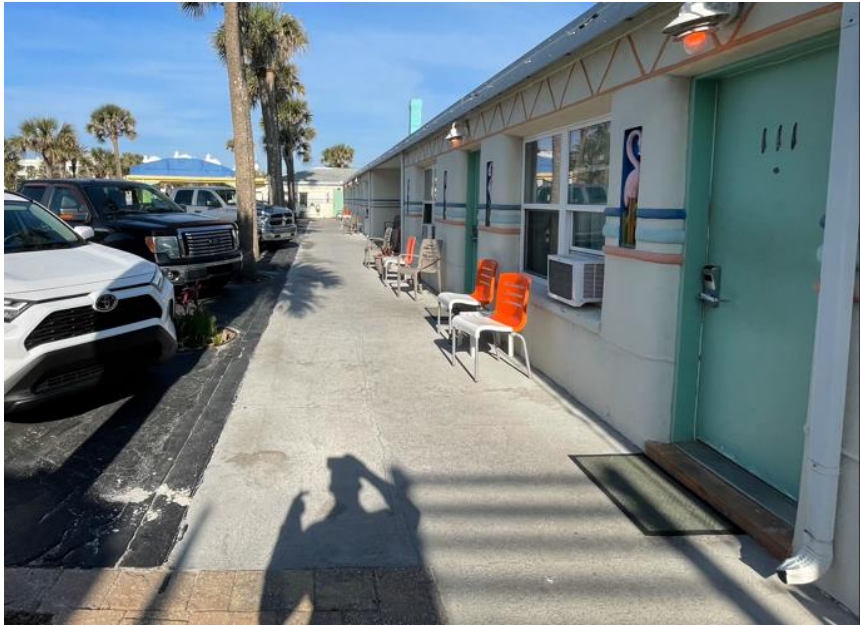
ADA access is not evident. Even with the parking on the same elevation as the sidewalk there is still a 3" step into each hotel room unit. Note the lack of wheel stops preventing the vehicles from running into the building.

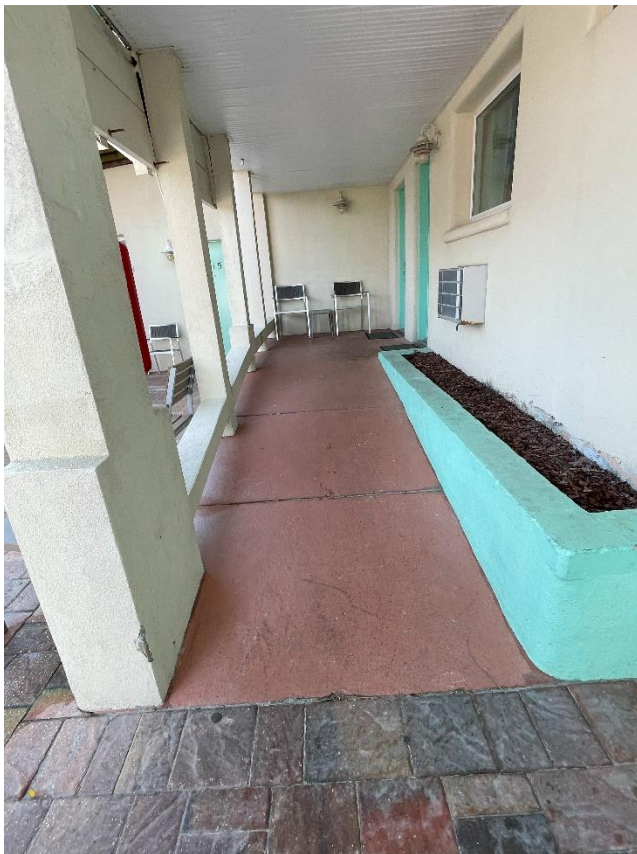
Ramp to guest rooms is not ADA compliant. The slope is too great and there are no handrails present.

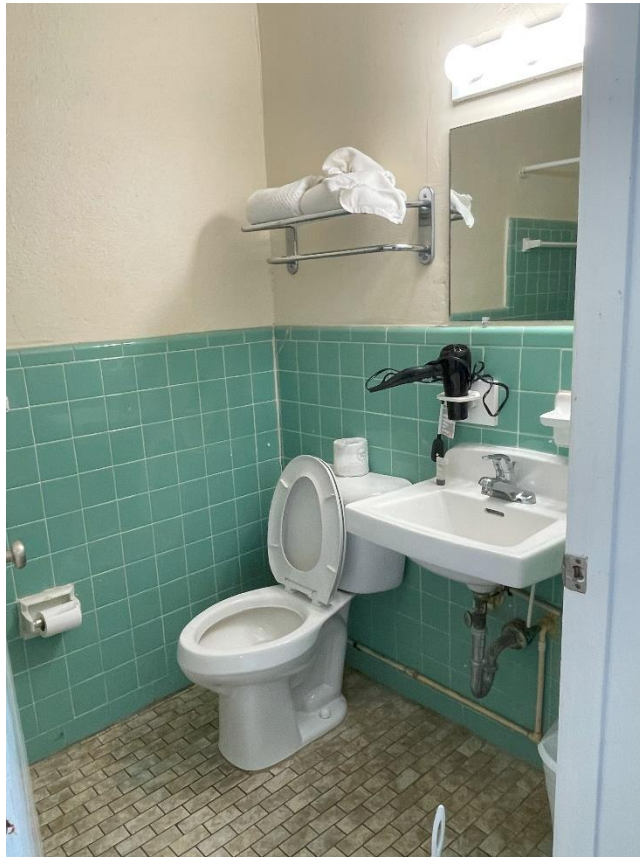
No ADA guest rooms with adequate bathroom sizes.

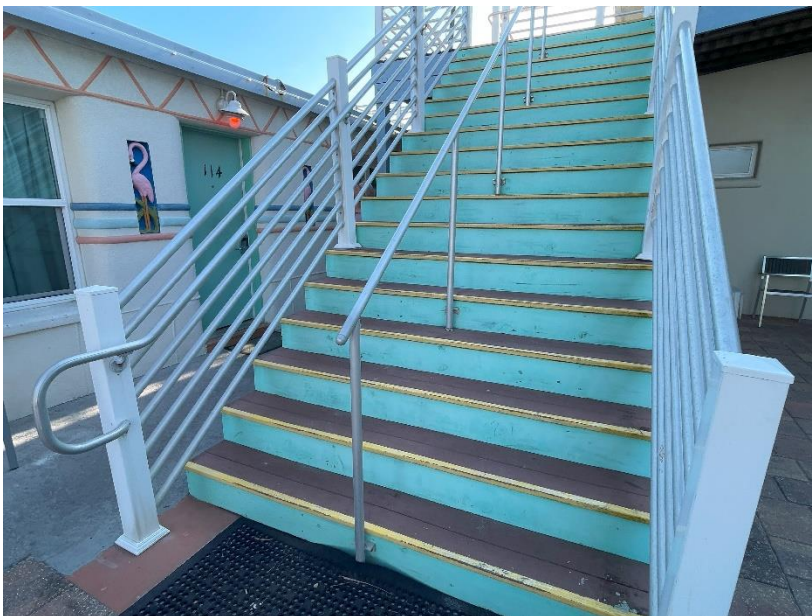
The second floor is not ADA accessible. This is the only exit for all five of the second-floor rooms.
