St. Johns County Andy King Reef

2022 Reef Observations and Report Authored by: Joe Kistel, Kistel Media LLC 6-27-22 Submitted to: 500 San Sebastian View St. Augustine, FL 32084 Contract #: 22-GAS-KIS-16164 U. S. Army Corps of Engineers permit: SAJ-2009-00237 (SP-BAL) [Bridge of Lions]

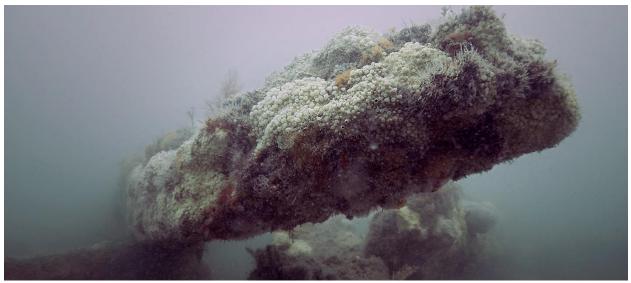
Figure 1 - Underwater Image Captured by Joe Kistel at Andy King Reef on 5-16-22

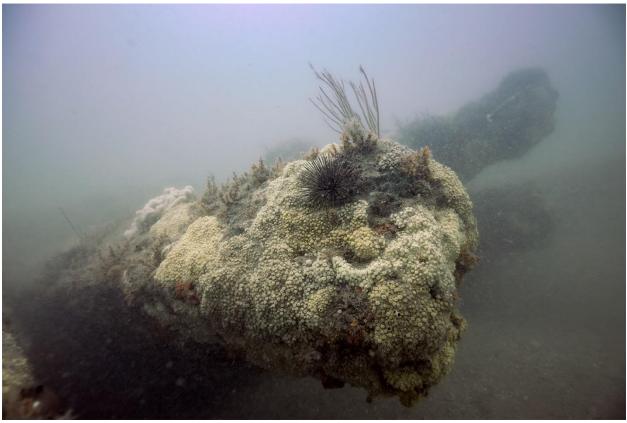
Figure 5 Underwater View of Encrusted Concrete Pilings Observed During the Dive Investigation

A variety of fish species were present and the sunken concrete pilings were completely grown over with marine life. Every inch of concrete surface was hidden under coral, sponge, algae and other encrusting life forms that would not exist in the absence of a solid foundation.

Structurally, it appears the concrete pilings are fixed in a stable orientation. Concrete pilings are stacked in piles in some areas and lying directly on the ground in less crowded areas. There did not seem to be

obvious signs of any major settling/sinking into the sand. The sea floor seemed relatively firm and stable.

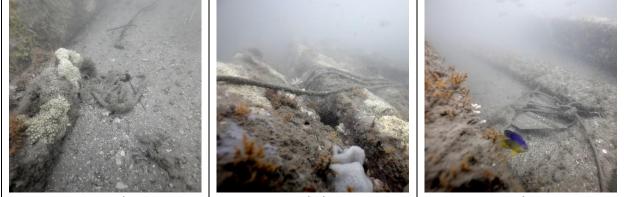
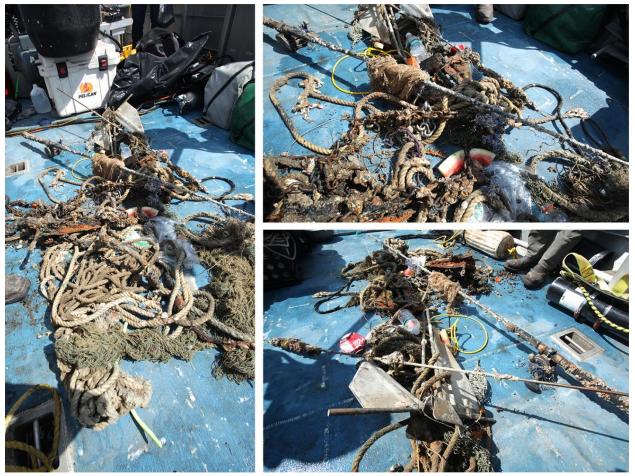
The Andy King Reef is located relatively close to the St. Augustine Inlet and has likely received consistent fishing use since its deployment in 2010. This was evident by items encountered down below. Fishing line was observed over several of the concrete pilings as well as in clustered clumps. Some of the monofilament line had attached fishing tackle including lead weights, hooks, and lures. Several long sections of rope were found and recovered. Two fishing poles and multiple anchors were retrieved, some with chain. A few types of netting were also recovered, some possibly being part of shrimp net or even derelict netting that drifted into and lodged into the reef structure.

Figure 6. Debris and Entanglement Hazards Removed from the Andy King Reef
