St. Johns County Capo Reef (North and South)

2022 Reef Observations and Report

Authored by: Joe Kistel, Kistel Media LLC

8-4-2022

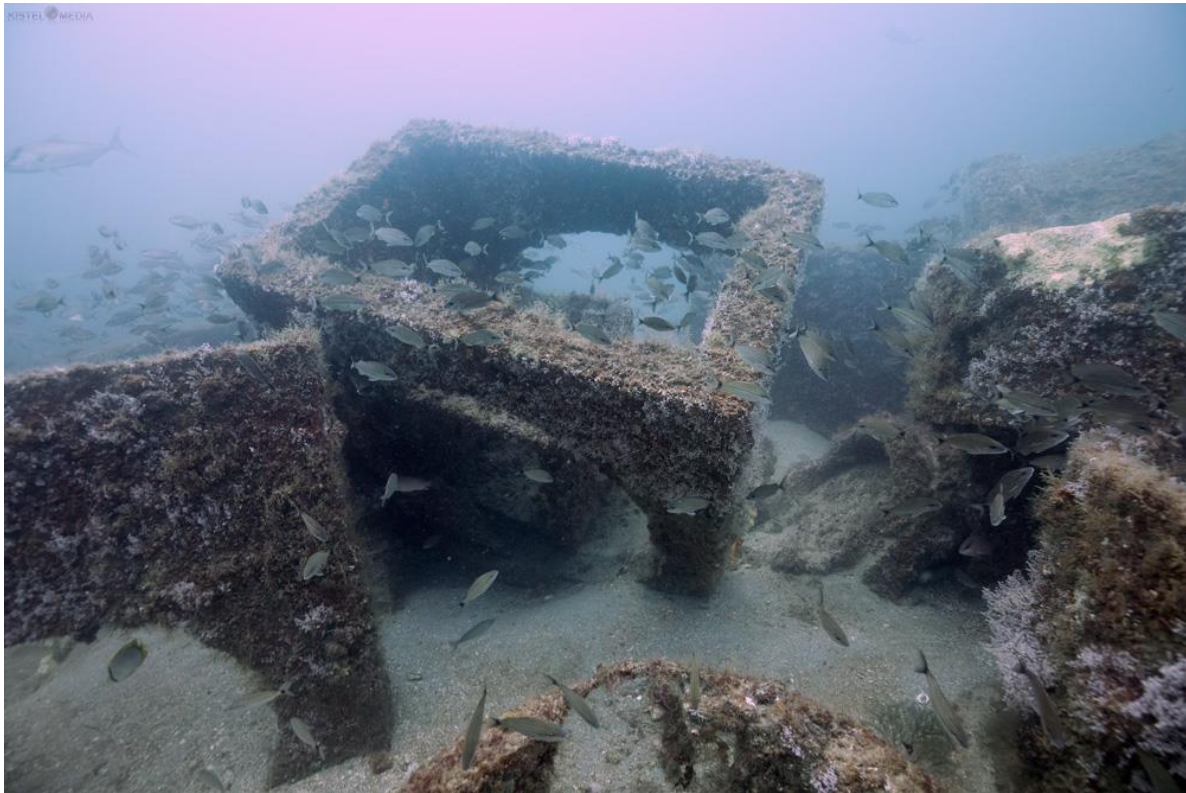
Figure 4 Underwater View of Encrusted Concrete Structures at Capo North During the Dive Investigation 6-1-22

A variety of fish species were present and the sunken concrete structures were completely grown over with marine life. Every inch of concrete surface was hidden under coral, sponge, algae and other encrusting life forms that would not exist in the absence of a solid foundation.

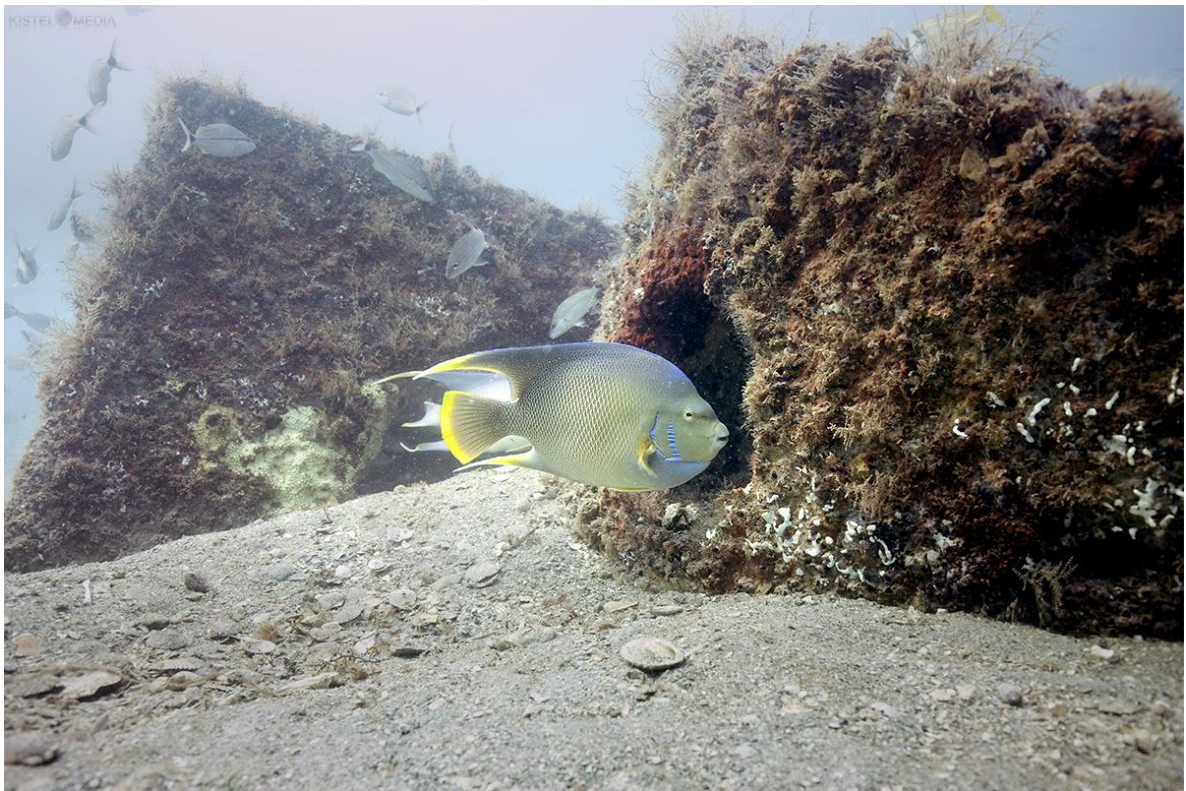
Figure 5 Blue Angel Fish and Concrete Reef Structures at Capo South 6-22-22

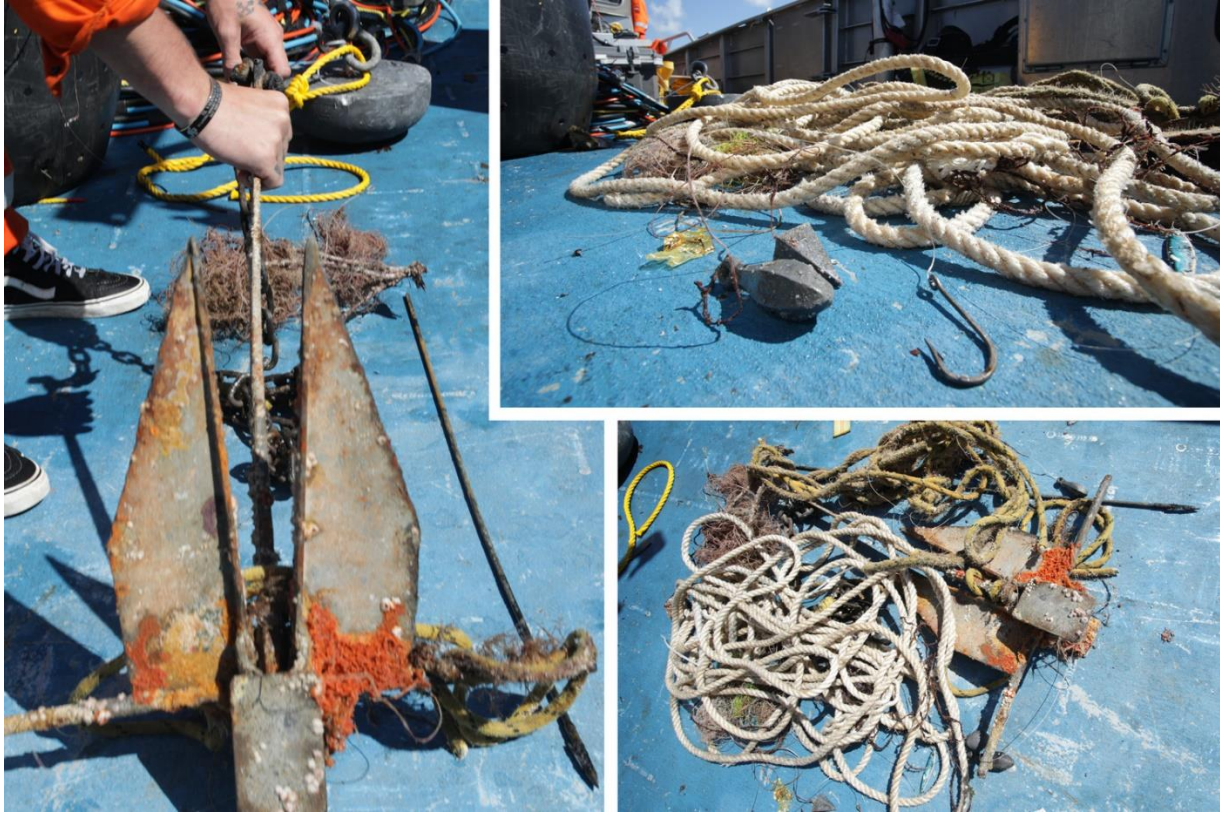
The Capo Reefs are located a further distance from the St. Augustine Inlet than the other reefs monitored during this project. Even so they have likely received moderate fishing use since the deployments in the year 2000. This was evident by items encountered down below. Fishing line was observed and some of the monofilament had attached fishing tackle including lead weights and hooks. Several sections of rope were found and recovered. A lost fishing pole and what is assumed to be a discarded military canister was retrieved.

Figure 6. Debris and Entanglement hazards Removed from Capo Reef North 6-1-22

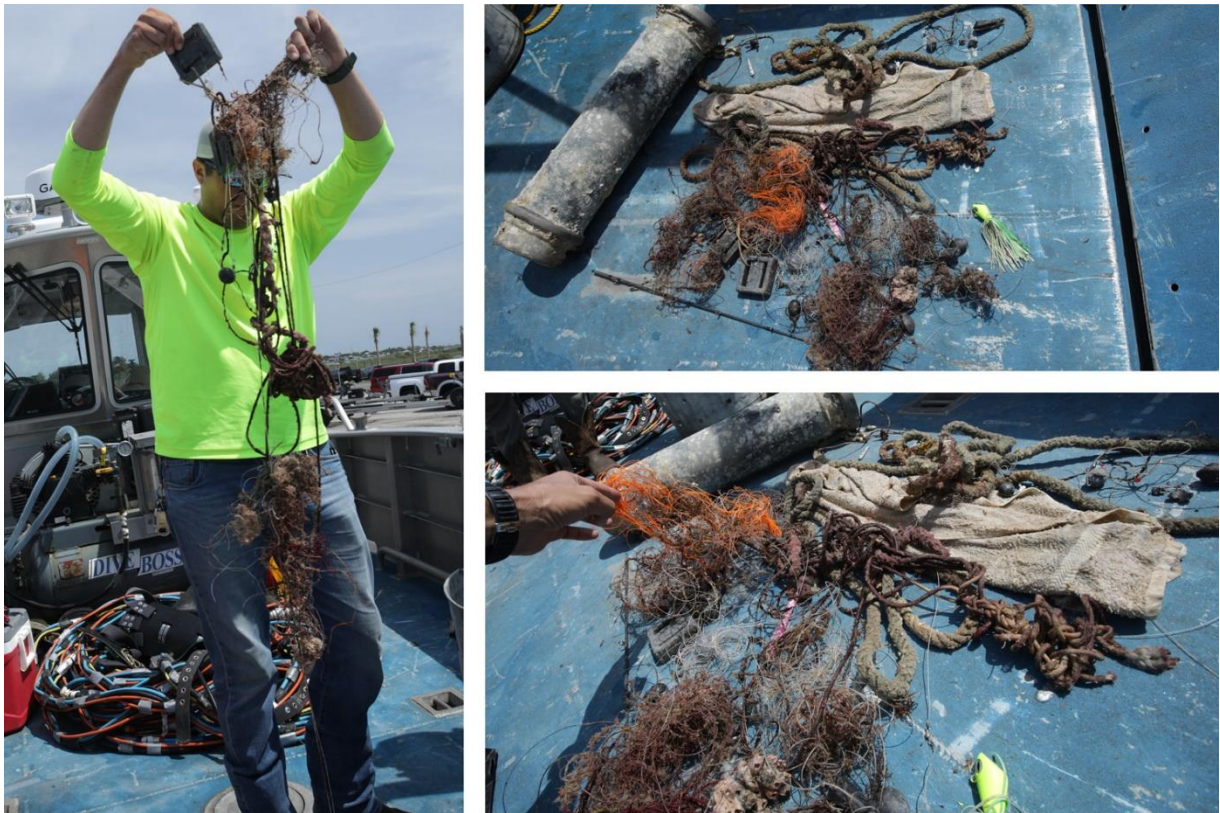
Figure 7. Items Removed from Capo Reef South 6-22-22
