MISC 1794: REEF MONITORING FOR MOODY, TAYLOR, AND INTRUDER REEF SITES

Subject: Please find the following report dated Feb 7, 2025, which completes the contract. Invoice to be submitted separately.

Project Overview

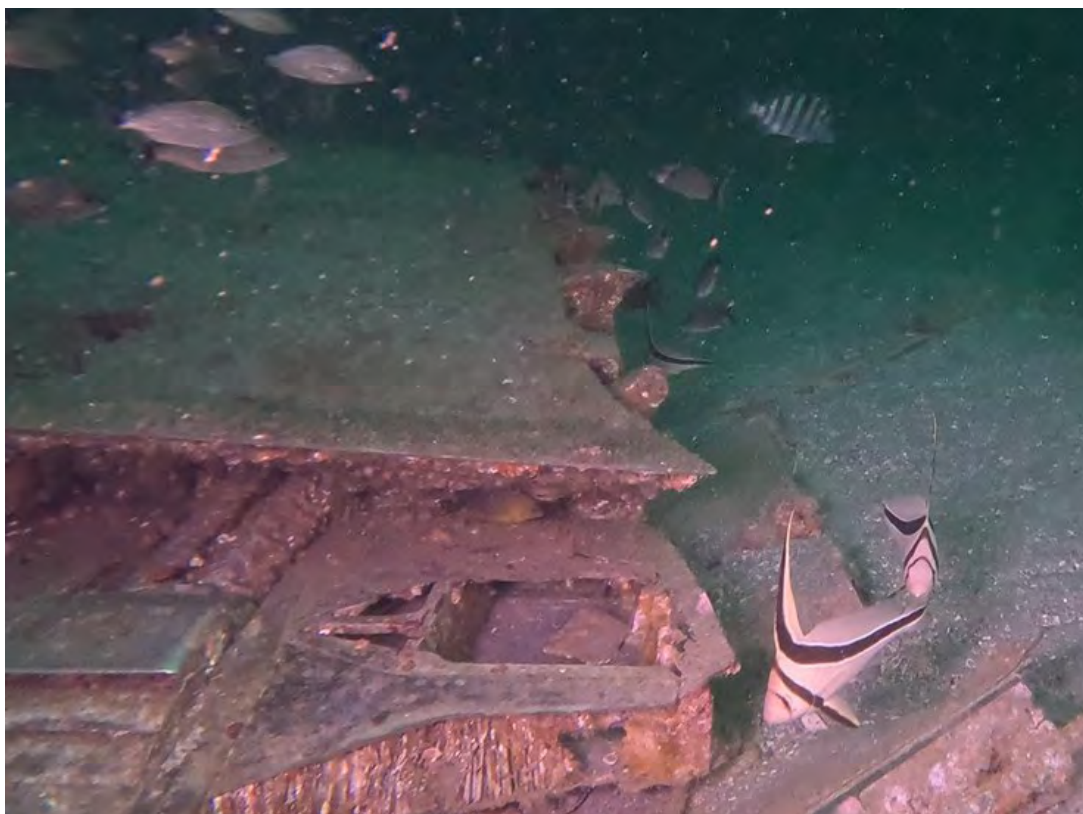
Figure 38 - Fishing line and anchor rope on Tail-section

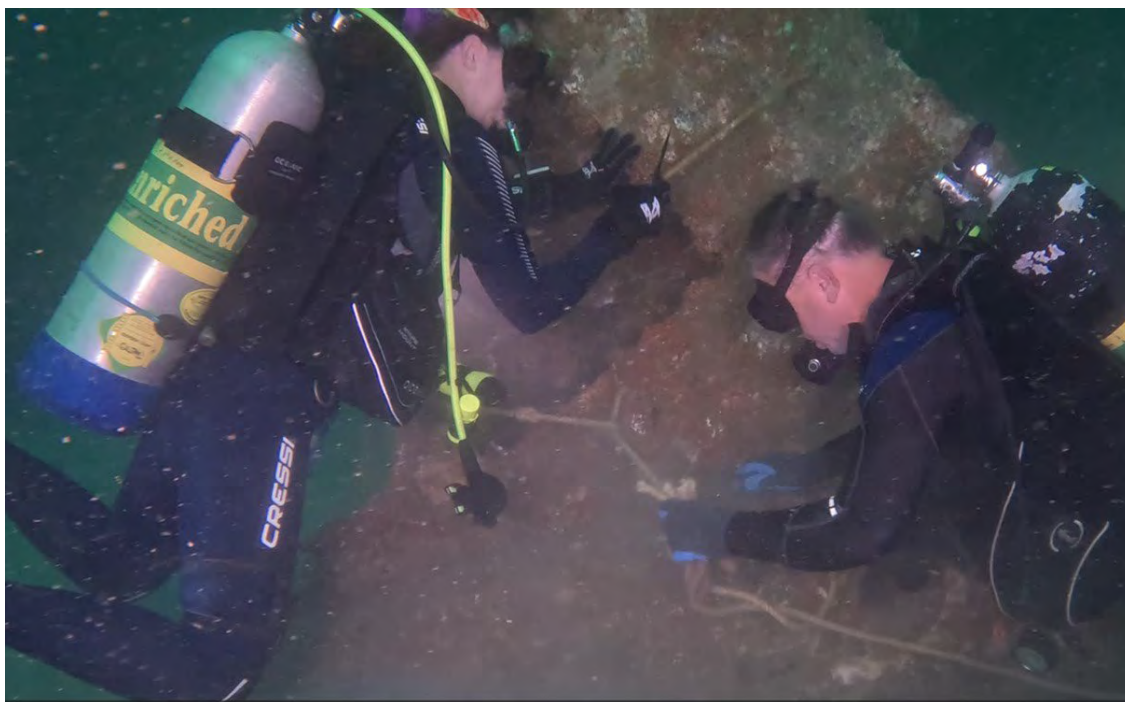
Figure 47 - Removal of anchor rope, fishing line, and fishing jig lures

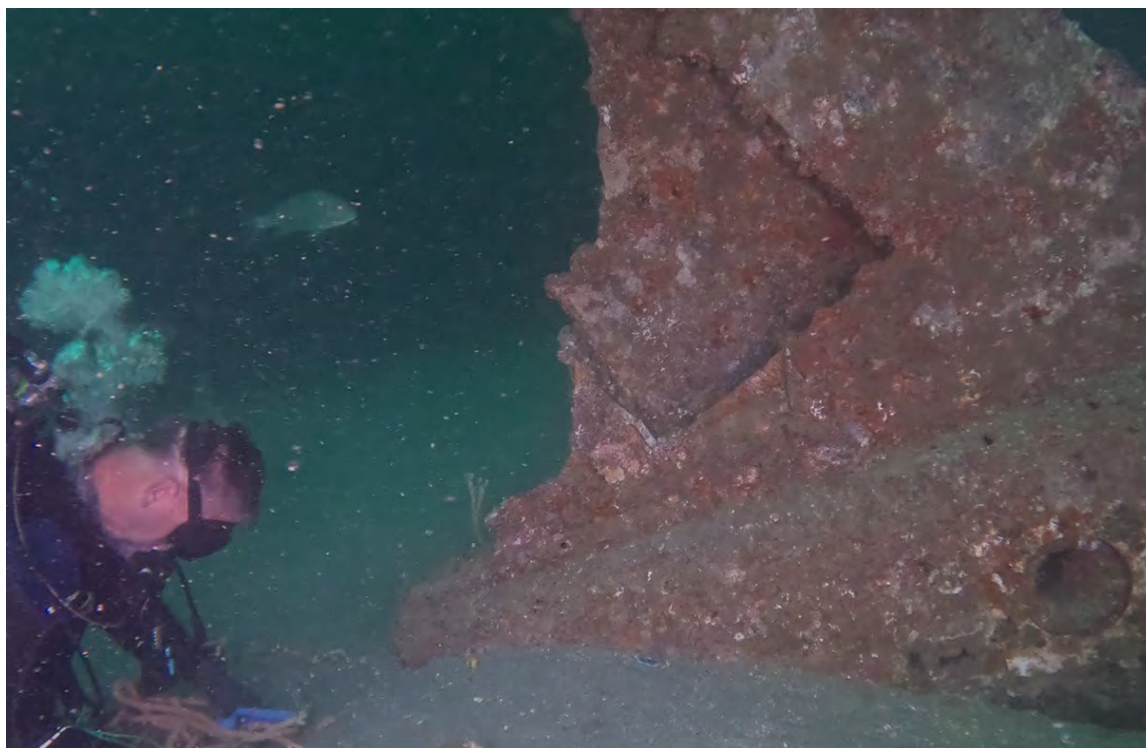
Figure 48 - Removal of anchor rope, fishing line, and fishing jig lures (1 Stone Crab Found)

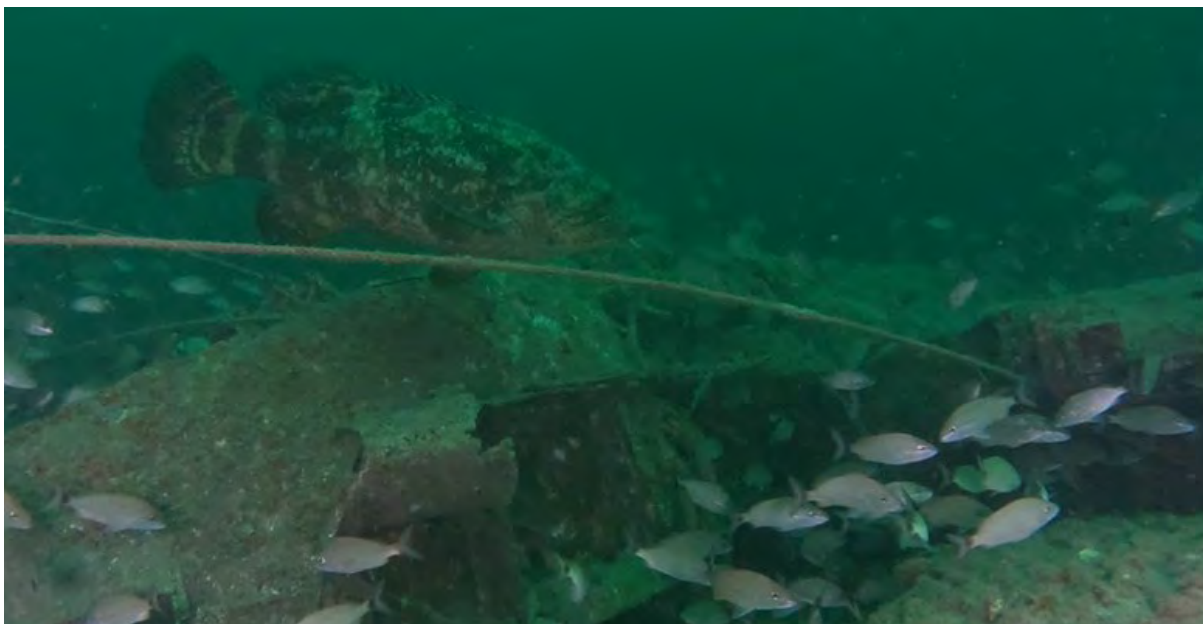
Figure 53 - Goliath Group and lots of anchor lines

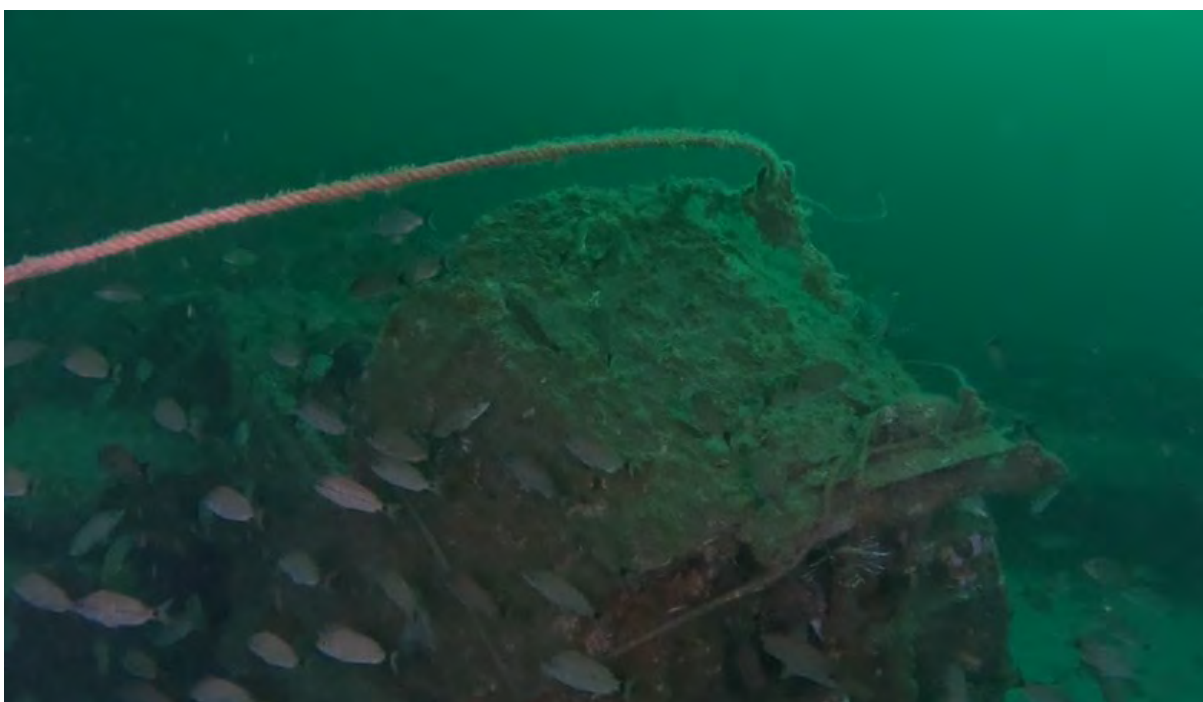
Figure 54 - Anchor stuck in hole in airplane wing

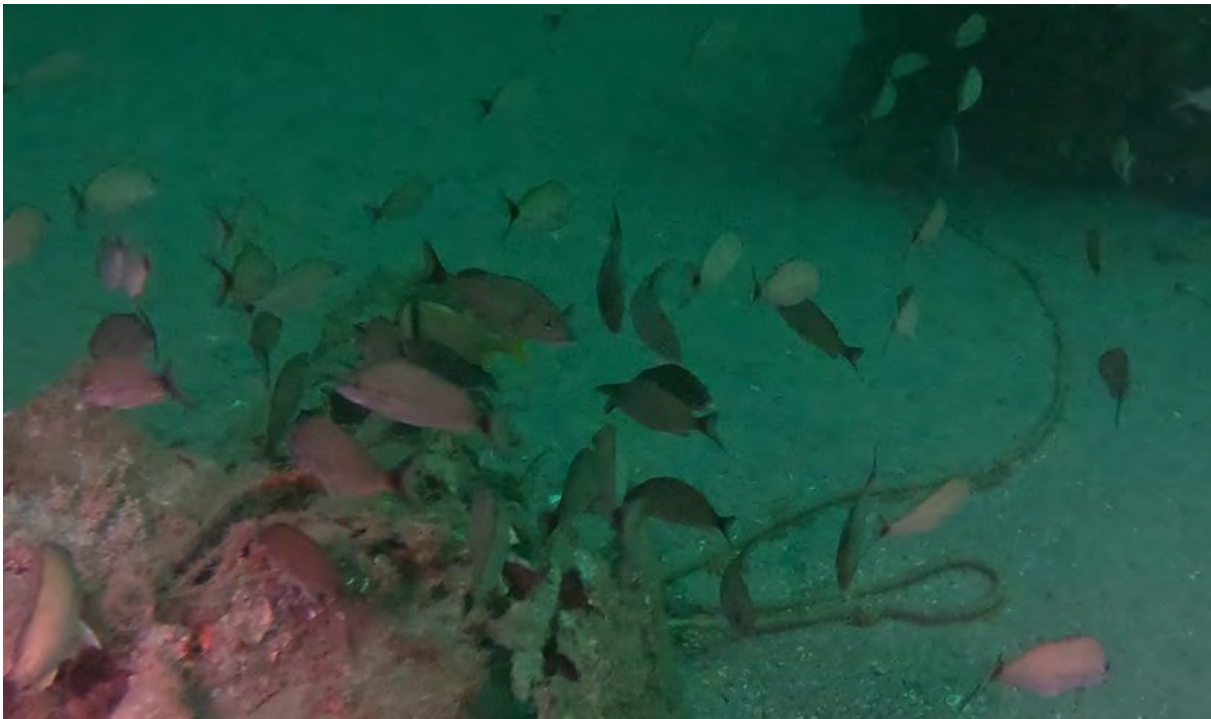
Figure 66 - More Anchor Rope

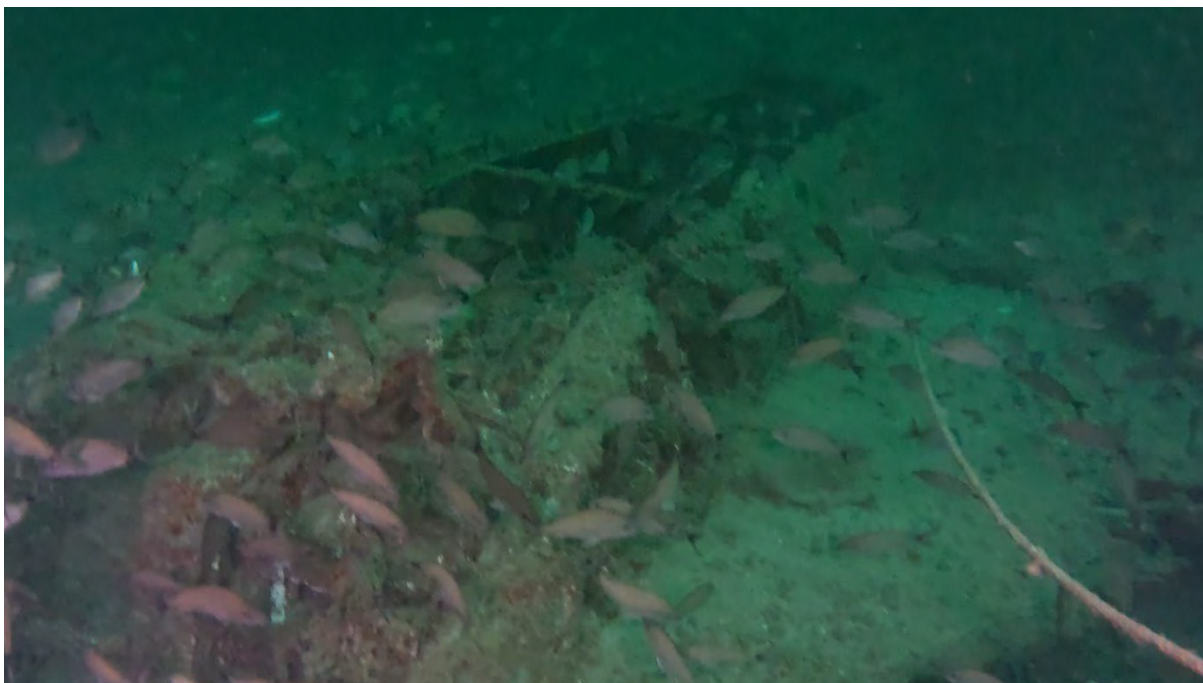
Figure 73 - More Anchor Rope on Wing

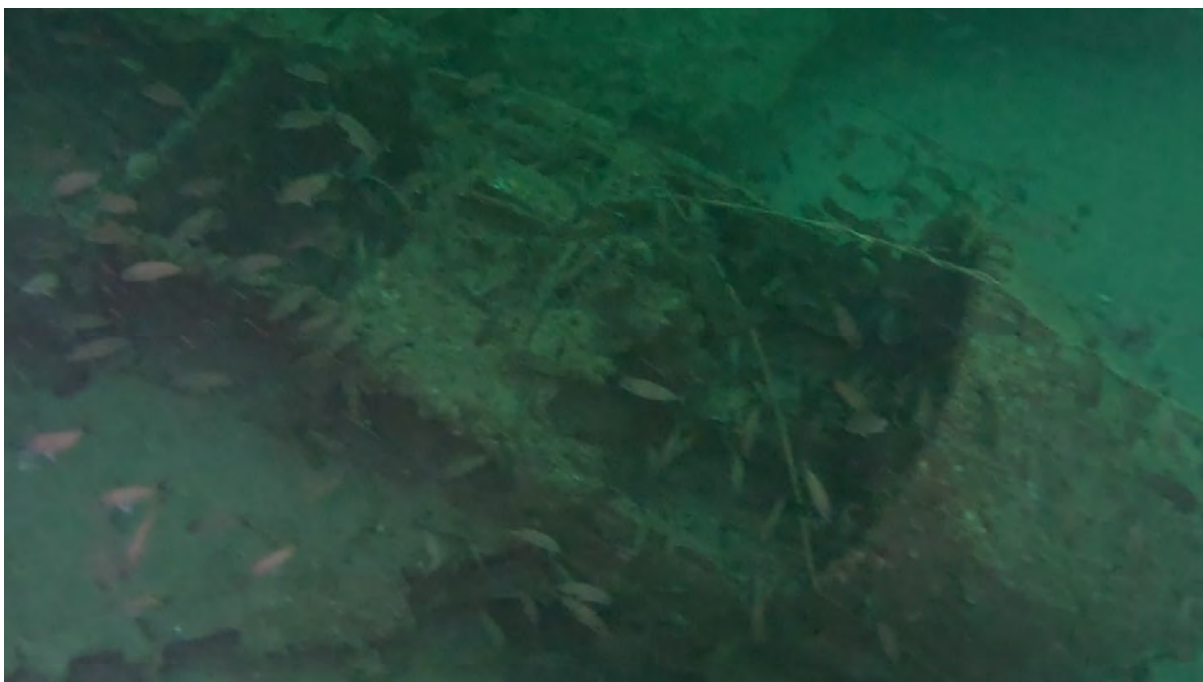
Figure 74 - More Anchor Rope on Cockpit

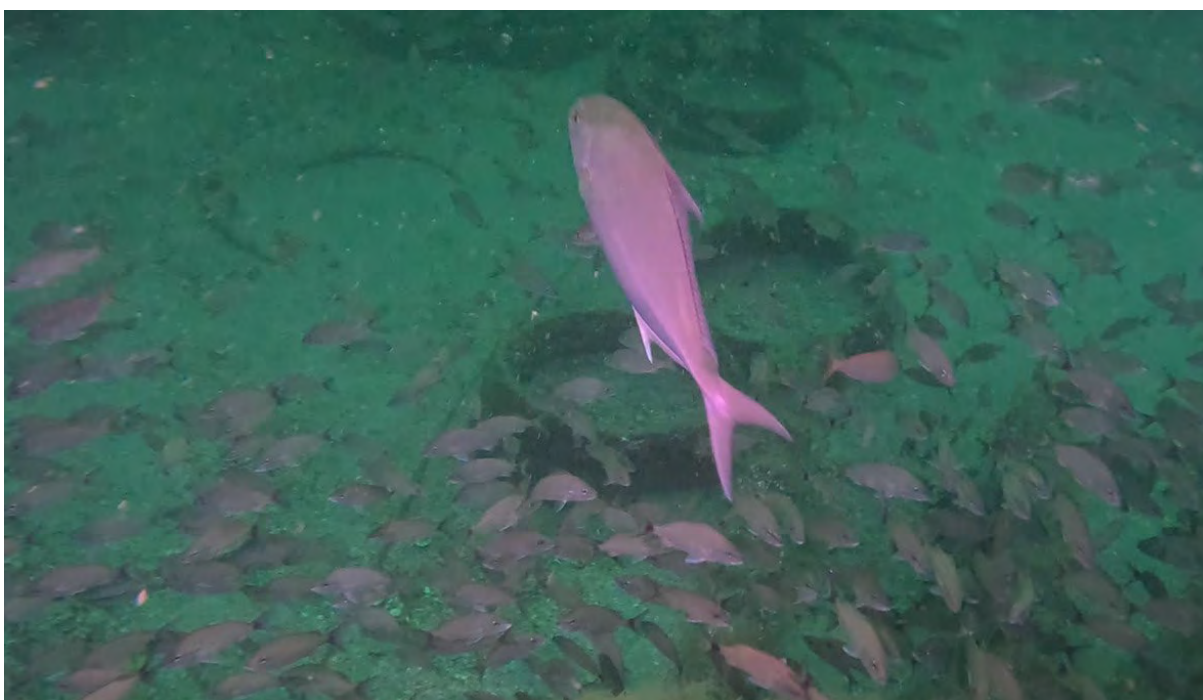
Figure 94 - Almaco Jack with abandoned anchor rope in background

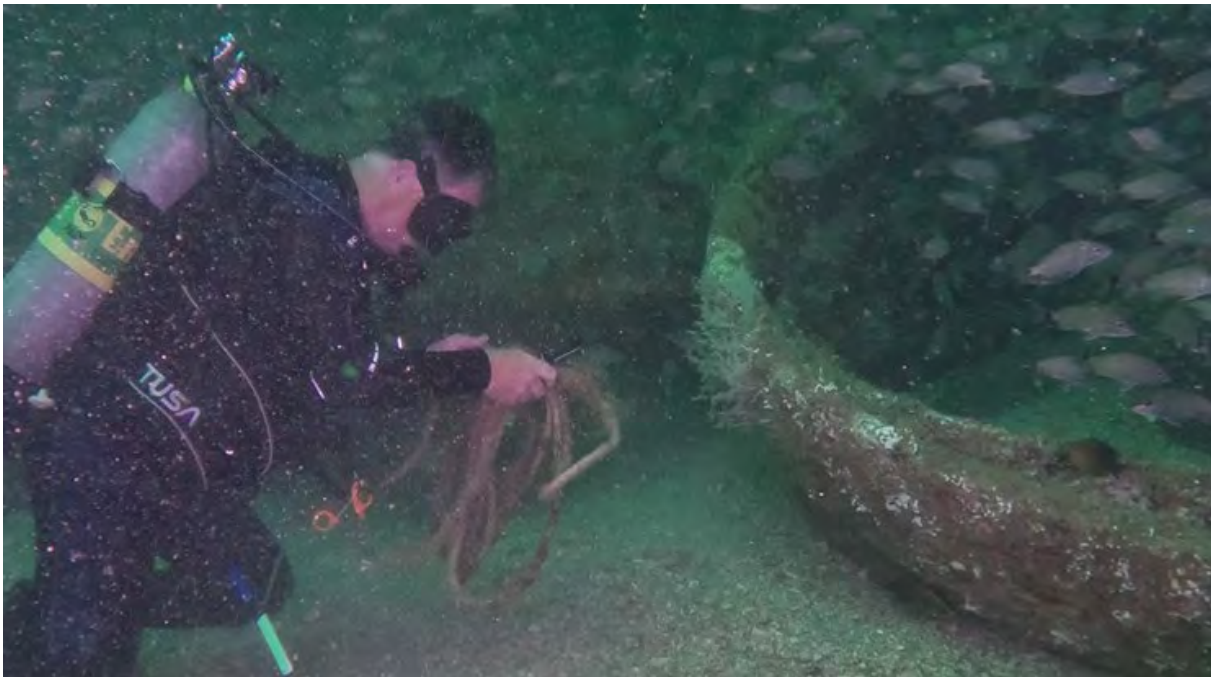
Figure 96 - Reef Cleanup Efforts, removal of anchors, anchor ropes, and fishing line

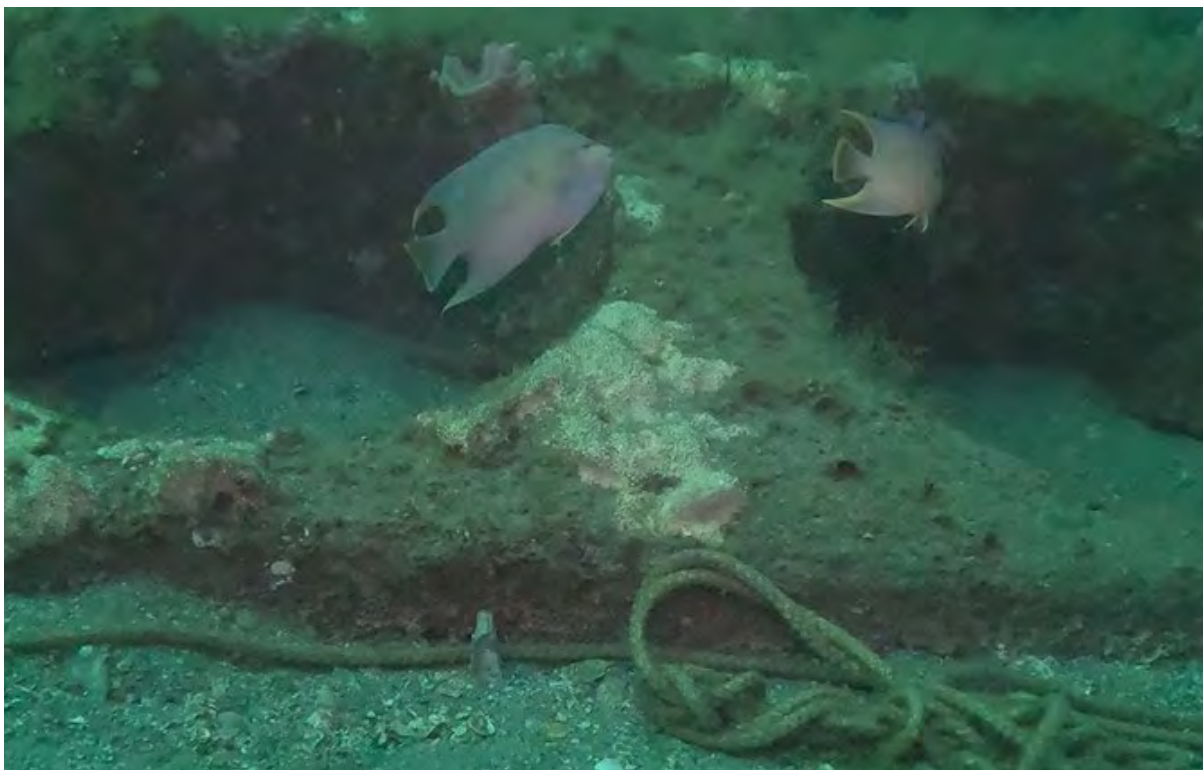
Figure 133 - Abandoned anchor rope

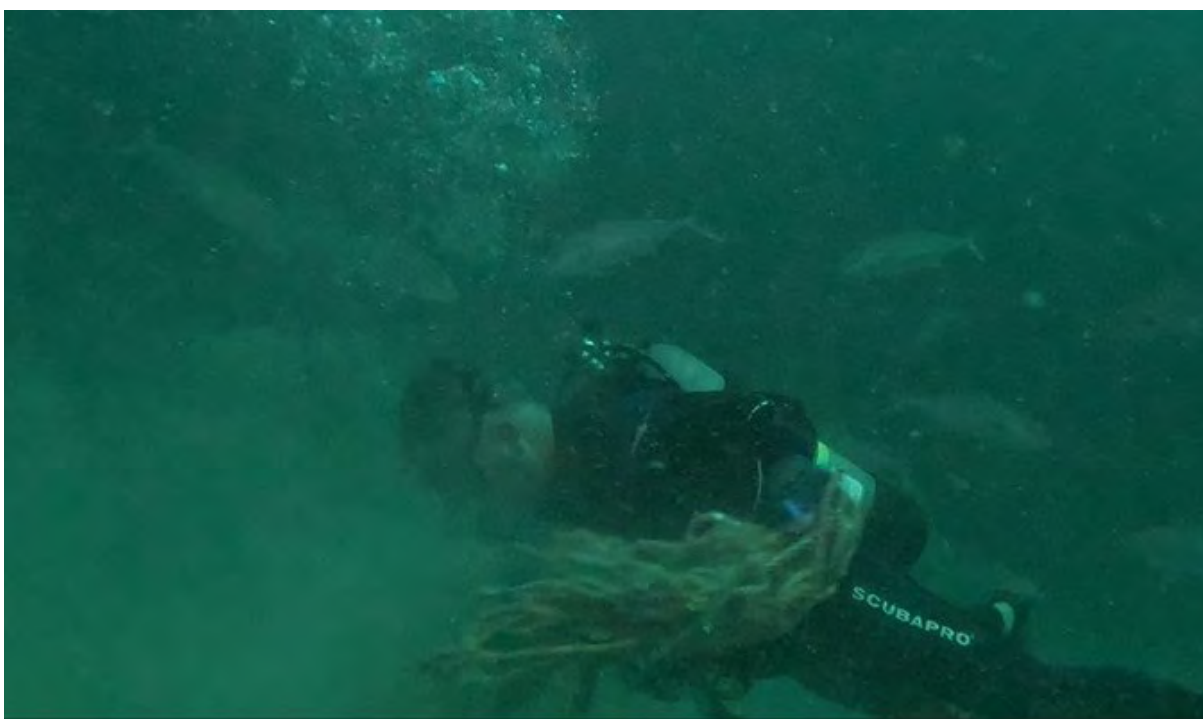
Figure 134 - Removal of Abandoned Rope

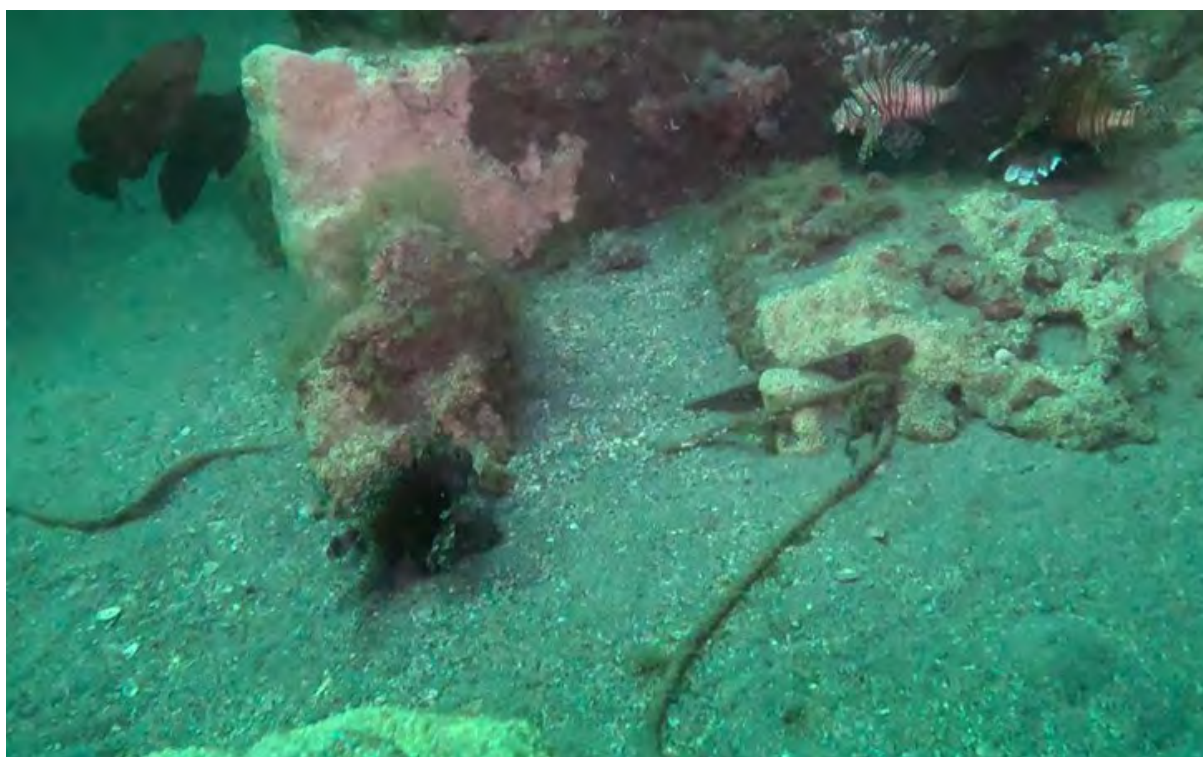
Figure 140 - Anchor, rope, grouper, lionfish

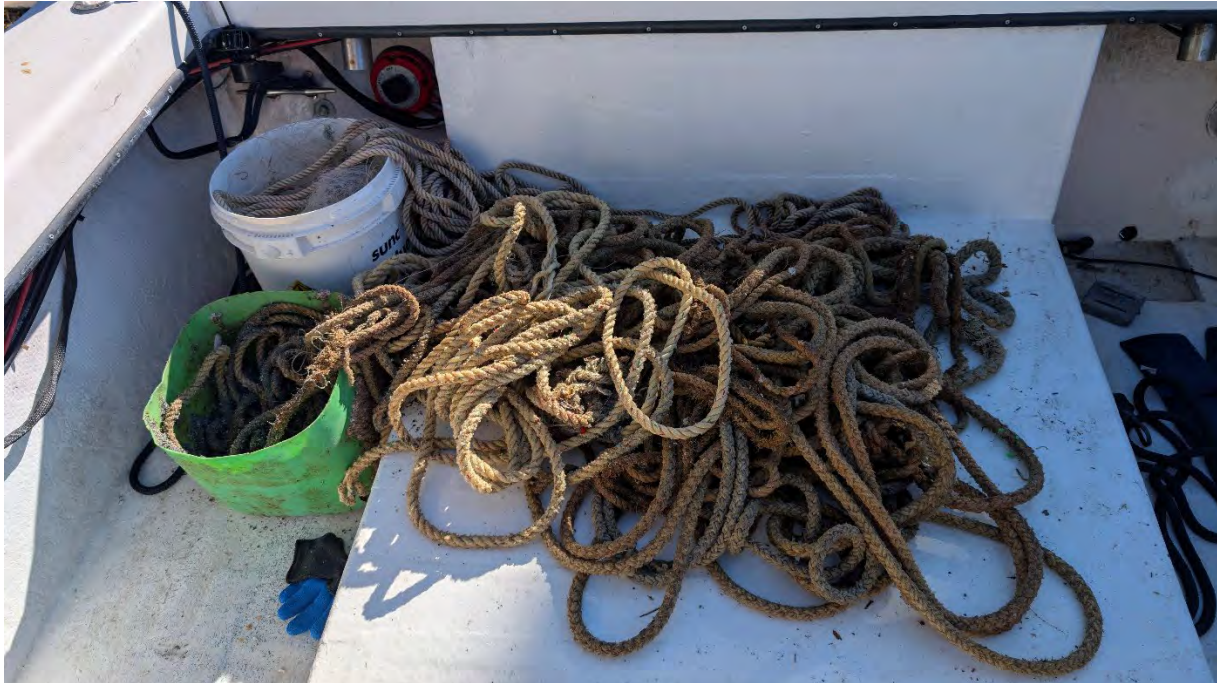
Following the fish count operations, the divers returned to the site for Debris Removal Operations. All fishing lines and boat anchor ropes that created a hazard for marine life and scuba divers as well as snagged fishing line from above fishermen were removed.

Figure 143 - Debris removed from the reef sites combined.
