# St. Johns County State Route A1A

## Historic Resources Survey Report St. Johns County, Florida

GAI Project Number: R210889.00

July 2022

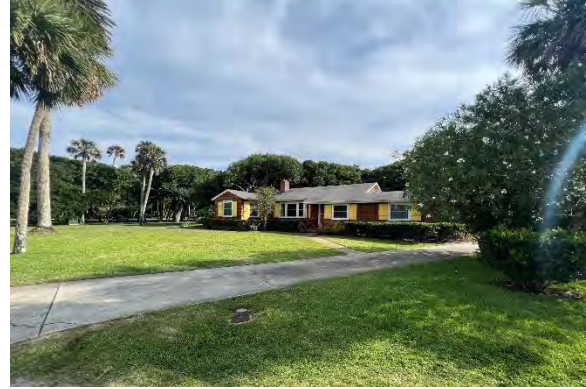
The resource is a one-story, 1942 frame vernacular dwelling (Photograph 21). The dwelling rests on a concrete foundation, is clad in horizontal wood board, and capped by a side-gable roof covered in asphalt shingle. An interior, brick chimney interrupts the roof surface. Two one-bay additions, capped by a gable roof, are located on the north and west elevation. The primary single entrance, atop a one bay porch and sheltered beneath an extended roof supported by a wood post, is located on the north elevation. Fenestration includes one-over-one, double-hung, vinyl-sash windows.

**Photograph 21. SJ03769, 1 Ponte Vedra Circle.**

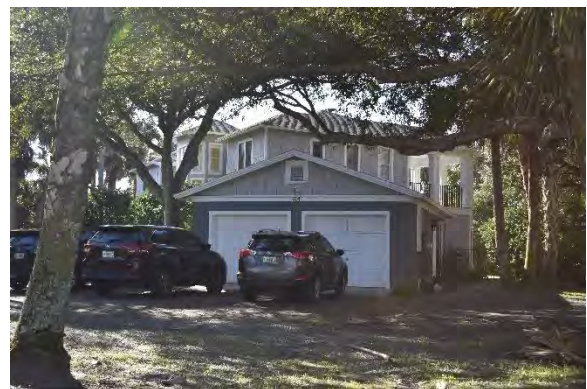
The resource is a two-story, 1947 frame dwelling with a sprawling, irregular plan and a single-story, front-gabled two-bay attached garage (Photograph 25). The foundation material is not visible from the public right of way. The dwelling is largely clad in cement-mineral fiber shingles, with painted brick exterior walls used throughout the garage, which has board and batten siding in the gable end. An irregular, hipped roof covered in asphalt shingles caps the two-story portion of the resource, which includes an octagonal turret on the north side of the east elevation, adjacent to the primary entrance. A shed-roofed porch on large wooden pillars with square-cut trim shelters the entry door, and a second-story covered porch with identical pillars and a metal balustrade is located on the west elevation. A single interior chimney punctuates the roof, and fenestration consists of vinyl one-over-one double-hung windows throughout.

**Photograph 25. SJ03774, 51 San Juan Drive.**

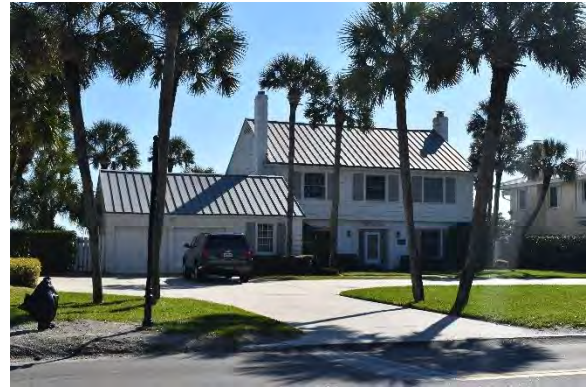
The resource consists of a two-story, 1940, Georgian Revival dwelling standing three bays wide with a three-bay wide, single-story addition (Photograph 28). The dwelling has a concrete foundation, is clad with aluminum siding, and capped by a side-gable roof covered with standing seam metal. An external chimney is located at the north and south gable ends. The single-story addition is appended to the north corner of the west elevation and includes a two-car garage. The primary entrance is located on the west elevation with sidelights and pilasters. Fenestration includes eight-over-eight and six-over-six, double-hung, wood-sash windows.

**Photograph 28. SJ03794, 301 Ponte Vedra Boulevard.**

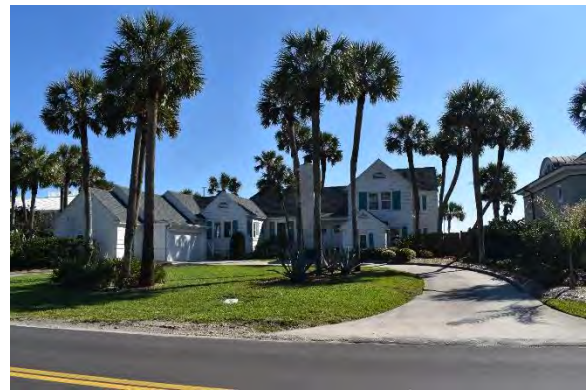
The resource consists of a one-and-a-half-story, 1938, Frame Vernacular dwelling standing seven bays wide (Photograph 29). The dwelling has a concrete foundation, is clad with wood shingle siding, and capped with a cross-gable roof covered with asphalt shingles. An exterior, brick chimney is located on the west elevation. A two-car garage is appended to the west elevation. The primary entrance is located on the west elevation sheltered beneath a shed-roof hood. Fenestration includes simulated, four-over-four and six-over-six, double-hung, vinyl-sash windows. A semicircular driveway is located in front of the dwelling.

**Photograph 29. SJ03795, 305 Ponte Vedra Boulevard.**

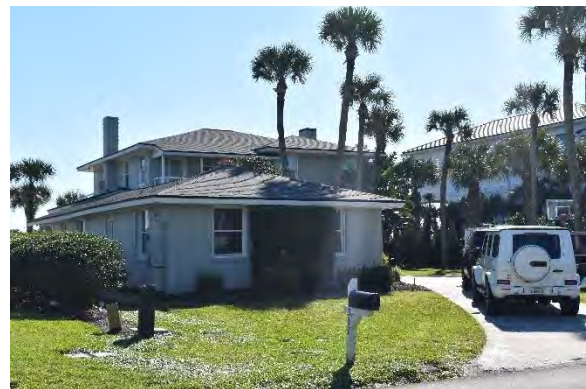
The resource consists of a 1940, two-story Masonry Vernacular dwelling (Photograph 32). The foundation material is not visible from the public right of way. The dwelling is clad with brick and capped with hipped roof covered in asphalt shingles. An external brick chimney is located on the north elevation. The eaves have a wide overhang. The primary entrance is recessed within the west elevation. A balcony is located above the entrance, recessed beneath the roofline. Fenestration includes one-over-one, double-hung, vinyl-sash windows, and horizontal-sliding windows. A one-story apartment is located adjacent to the west elevation.

**Photograph 32. SJ03798, 311 Ponte Vedra Boulevard.**

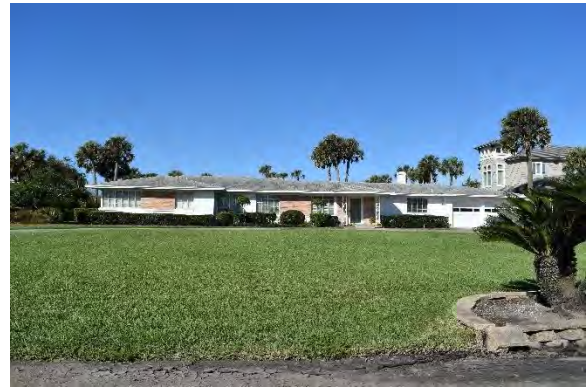
| FMSF ID | Site Name | Location | Date Built | Style | Recommendation |
|---|---|---|---|---|---|
| SJ03811 | Searcy House | 336 Ponte Vedra Blvd | 1953 | Ranch | Recommended Eligible – Criterion C |

The resource consists of a one-story 1953 Ranch residence with a low-sloped hipped roof sheathed in asphalt shingles set over wide eaves (Photograph 37). The dwelling has a roughly rectangular footprint which parallels the road, and an attached two-bay garage is situated at the northern extent of the resource. The foundation material is not visible from the public right of way. Exterior walls are clad in painted brick veneer, with variegated rusticated stacked stone veneer accenting walls surrounding the entry door and between windows on the east elevation. The primary entrance door is set beneath a small hipped-roof entry porch on paired, painted wrought iron posts flanking geometric ornamental ironwork. Fenestration consists of eight- and twelve-light metal casement windows, some of which are set beneath two-light fixed metal transoms. An internal painted brick chimney punctuates the roof ridge near the northern garage wing.

**Photograph 37. SJ03811, 336 Ponte Vedra Boulevard.**

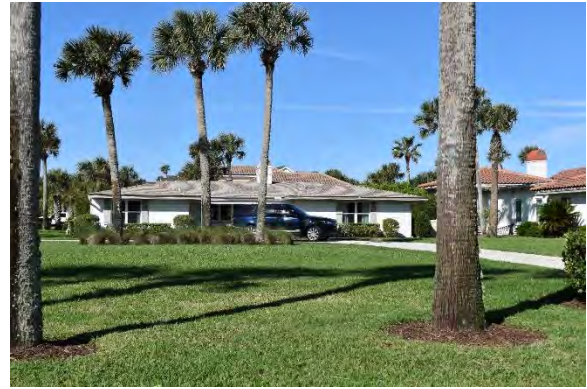
The resource consists of a one-story, 1950 Ranch residence with low-slope hipped roof sheathed in asphalt shingles (Photograph 41). The foundation material is not visible from the public right of way; however, exterior brick veneer walls are painted. The primary entrance door is roughly centered and recessed beneath the main roof form, with board and batten wooden siding on the surrounding wall. Fenestration consists of vinyl one-over-one double-hung and single-pane casement windows throughout. A painted brick interior chimney punctuates the roof ridge and has an arched hood. A two-bay garage is accessed from the west elevation adjacent to a single-story hipped-roof addition.

**Photograph 41. SJ03818, 422 Ponte Vedra Boulevard.**

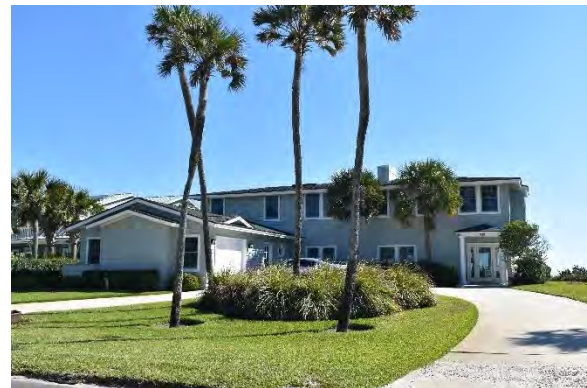
The resource is a two-story, 1937 frame vernacular dwelling (Photograph 44). The dwelling rests on a concrete foundation, is clad in weatherboard siding and capped with a hipped roof covered in asphalt shingle. An obscured one-story hipped roof addition is appended to the east elevation. A one-car garage capped by a gable roof is appended to the north elevation. An interior brick chimney interrupts the roof surface. The primary single entrance with sidelights, sheltered beneath a hipped roof supported by Doric columns, is located on the south end of the west elevation. Fenestration includes six-over-one, and one-over-one double-hung, vinyl-sash and an octagon window.

**Photograph 44. SJ03823, 411 Ponte Vedra Boulevard.**

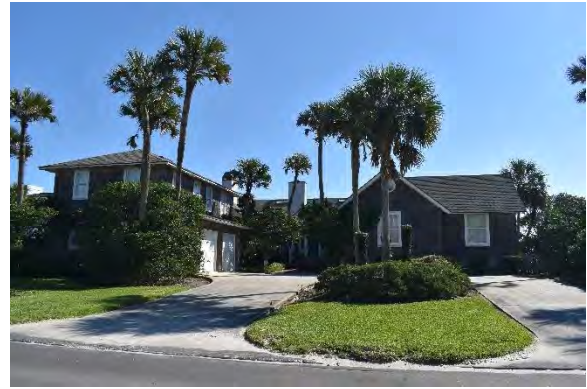
The resource is a one-story, 1935 U-shaped frame vernacular dwelling (Photograph 45). The dwelling rests on a concrete foundation, is clad in wood shingle and capped with a cross-gable roof covered in asphalt shingle. A two-story addition, capped by a hipped roof with exposed rafters, is appended to the west elevation. Two single-car garages are located on the south elevation of the addition. Two interior brick chimneys interrupt the roof surface. The primary single entrance with sidelights, atop a two-bay porch and sheltered beneath a gable roof supported by wood posts, is located on the west elevation. Fenestration includes six-over-six, and twelve-over-twelve double-hung, wood-sash windows.

**Photograph 45. SJ03824, 413 Ponte Vedra Boulevard.**

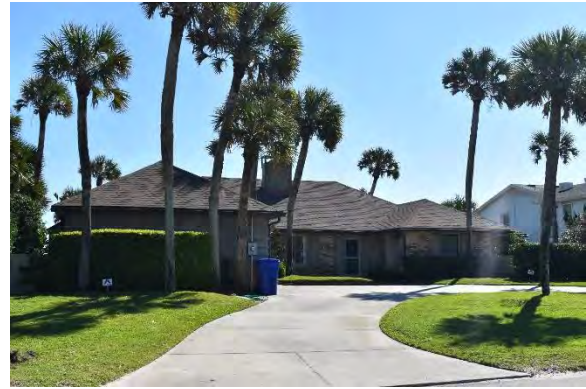
The resource is a one-story, 1935 masonry vernacular dwelling (Photograph 47). The dwelling rests on a concrete foundation, is clad in brick and aluminum siding and capped with a hipped roof covered in asphalt shingle. An obscured one-story addition, capped by a hipped roof is appended to the west elevation. An intersecting hipped roof addition with two single-car garages, is appended to the west elevation. An interior concrete chimney interrupts the roof surface. The primary single entrance is located on the west elevation. A secondary single entrance is located on the south elevation of the garage addition. Fenestration includes six-over-six, double-hung, wood-sash windows.

**Photograph 47. SJ03827, 419 Ponte Vedra Boulevard.**

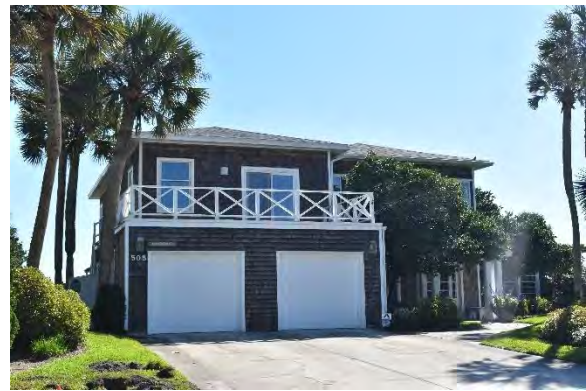
The resource is a two-story, 1935 frame vernacular dwelling (Photograph 49). The dwelling rests on a concrete foundation, is clad in wood shingle and capped with an irregular roof covered in asphalt shingle. A one-story addition, capped with a second-story wraparound deck includes two single-car garages. An interior brick chimney interrupts the roof surface. An obscured second-story porch is located on the south elevation. The primary single entrance with sidelights sheltered beneath a gable roof with an arch and supported by wood posts is located on the west elevation. A sliding glass door is located above the garage addition. Fenestration includes one-over-six, double-hung, wood-sash and vinyl fixed frame windows.

**Photograph 49. SJ03833, 505 Ponte Vedra Boulevard.**

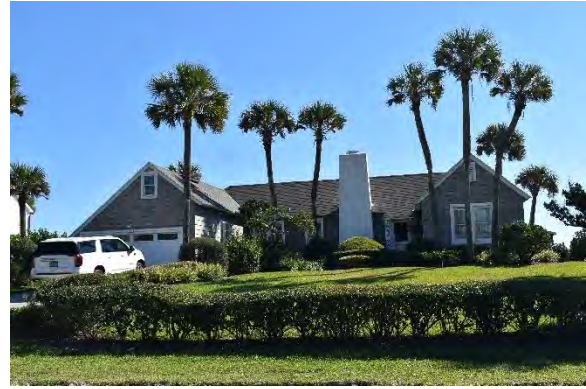
The resource consists of a one-story, 1942 frame dwelling with Craftsman style elements (Photograph 50). The foundation material is not visible from the public right of way. The dwelling is clad with wood shingle siding, and capped with a cross gable roof covered with asphalt shingles. A large exterior brick chimney is located on the west elevation. A front-gable, one-and-a-half-story, two-car garage addition is appended to the north end of the west elevation. The primary entrance is located on the west elevation, beneath a shed roof hood supported by a decorative metal column. Fenestration includes six-over-six, eight-over-eight, and four-over-four, double-hung, vinyl-sash windows.

**Photograph 50. SJ03837, 511 Ponte Vedra Boulevard.**

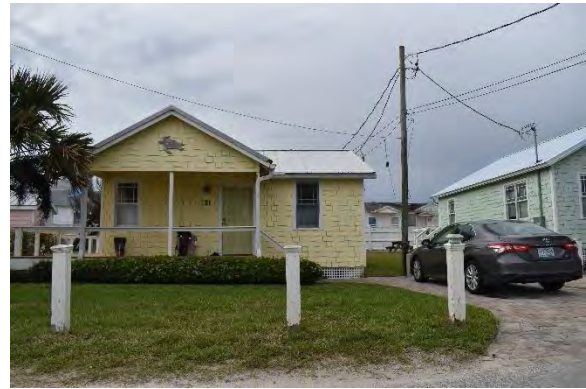
| FMSF ID | Site Name | Location | Date Built | Style | Recommendation |
|---|---|---|---|---|---|
| SJ03905 | Maguire House | 21 Surfside Ave | 1973 | Frame Vernacular | Recommended Contributing to Potential Historic District |

Photograph 71. SJ03905, 21 Surfside Avenue.

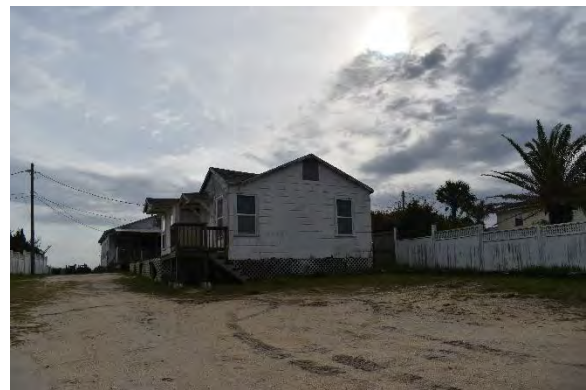
| FMSF ID | Site Name | Location | Date Built | Style | Recommendation |
|---|---|---|---|---|---|
| SJ03907 | Maguire House | 3056 Coastal Hwy | 1930 | Frame Vernacular | Recommended Contributing to Potential Historic District |

Photograph 72. SJ03907, 3056 Coastal Highway.

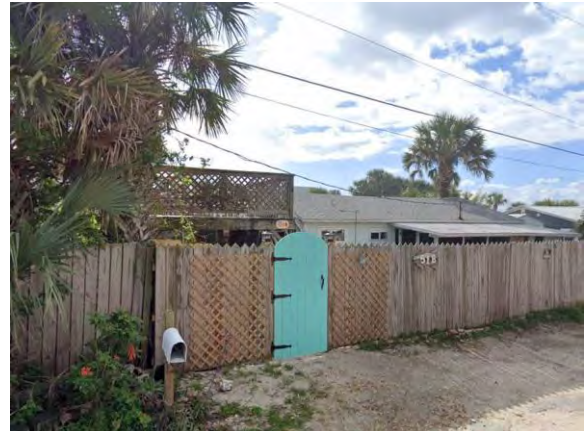
| FMSF ID | Site Name | Location | Date Built | Style | Recommendation |
|---|---|---|---|---|---|
| SJ03915B | Covert House | 51B Beachcomber Way | 1970 | Frame Vernacular | Recommended Contributing to Potential Historic District |

**Photograph 79. SJ03915B, 51B Beachcomber Way.**

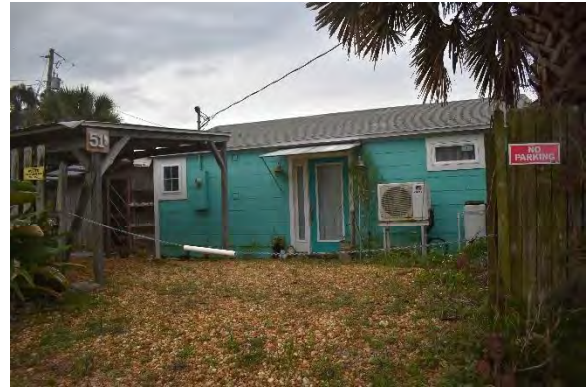
| FMSF ID | Site Name | Location | Date Built | Style | Recommendation |
|---|---|---|---|---|---|
| SJ03915D | Engsberg House | 51D Beachcomber Way | 1970 | Frame Vernacular | Recommended Contributing to Potential Historic District |

**Photograph 81. SJ03915D, 51D Beachcomber Way.**

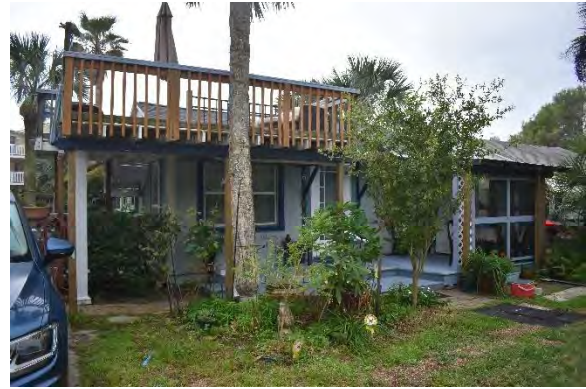
| FMSF ID | Site Name | Location | Date Built | Style | Recommendation |
|---|---|---|---|---|---|
| SJ03917 | Squillace House | 2854 #6 Coastal Hwy | 1970 | Frame Vernacular | Recommended Contributing to Potential Historic District |

**Photograph 83. SJ03917, 2854 #6 Coastal Highway.**
