Section 8

Conservation Zone

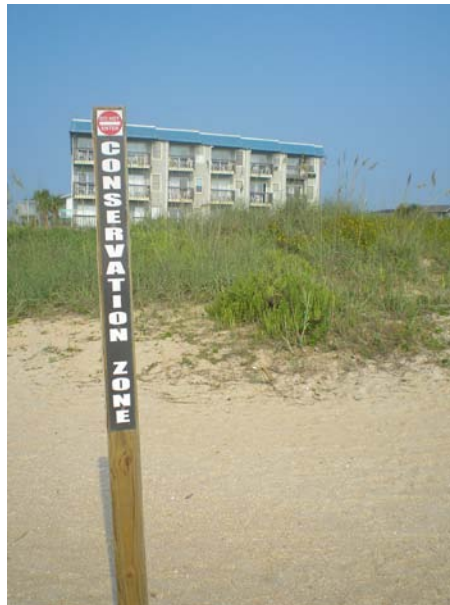
Object 5.

The CZ posts are affixed with two different sign designs as shown in Objects 5 and 6 below. The first design has proven to be ineffective in certain high use areas because it tends to blend in with the post on which it is installed. The second design has proven to be very effective and has been increased in high use areas. They both present the universal red and white “Do Not Enter” symbol implying that no pedestrians may enter beyond the sign.
