FINAL REPORT

Study of Summer Haven River and Surrounding Areas

St. Johns County, Florida

Prepared by: **INTERA - GEC**
A joint venture of INTERA and G.E.C.

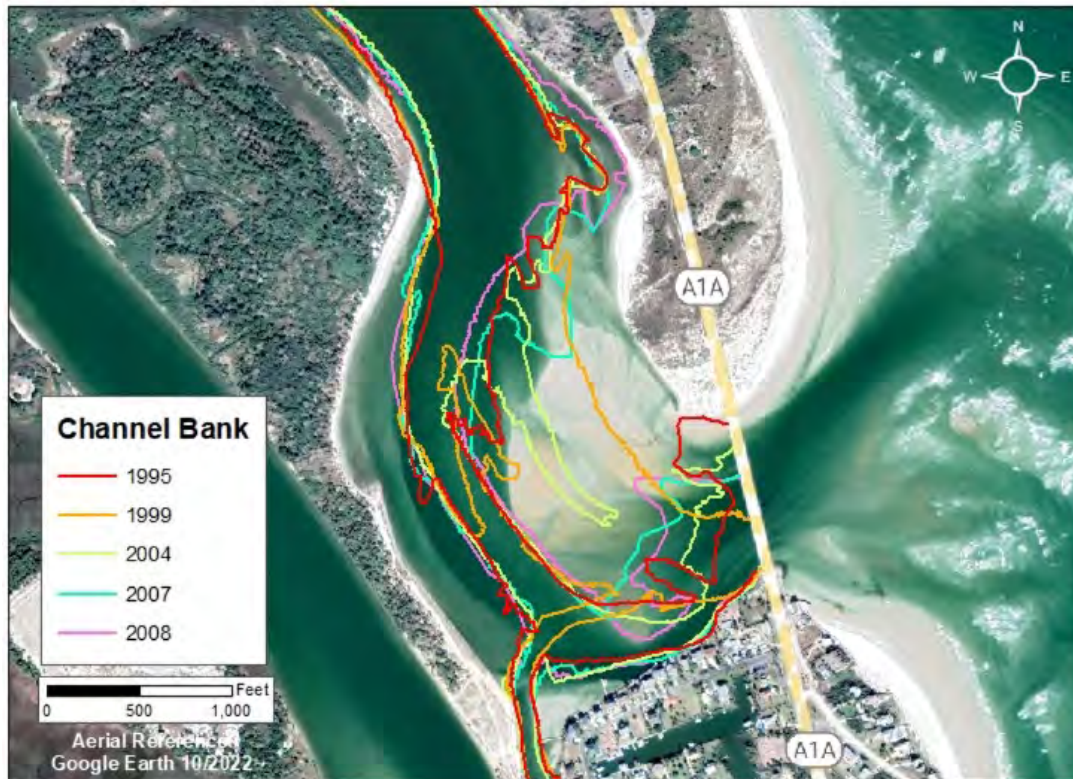
Figure 4.12 Matanzas Inlet Primary Channel Positions from 1995–2008

Interestingly, the opening of the inlet entrance after 2012 coincides with the southern inlet channel migrating southwestward after 2012 (i.e., beginning with the 2016 channel position). As shoaling at the inlet entrance peaked in 2012, the flood shoal also seems to have peaked in size along the northern portion of the inlet, possibly forcing a greater proportion of flow through the inlet's southern channel. As the inlet reopened post-2012, it is possible that increased flow through the southern channel, particularly during the severe storm events, predominantly caused the channel to begin its westwardly migration. Of note, the channel migration does not appear to coincide with the SHR's closure beginning in 2008 (see Section 4.6 for more detailed information on the SHR's effects on the surrounding waterways).

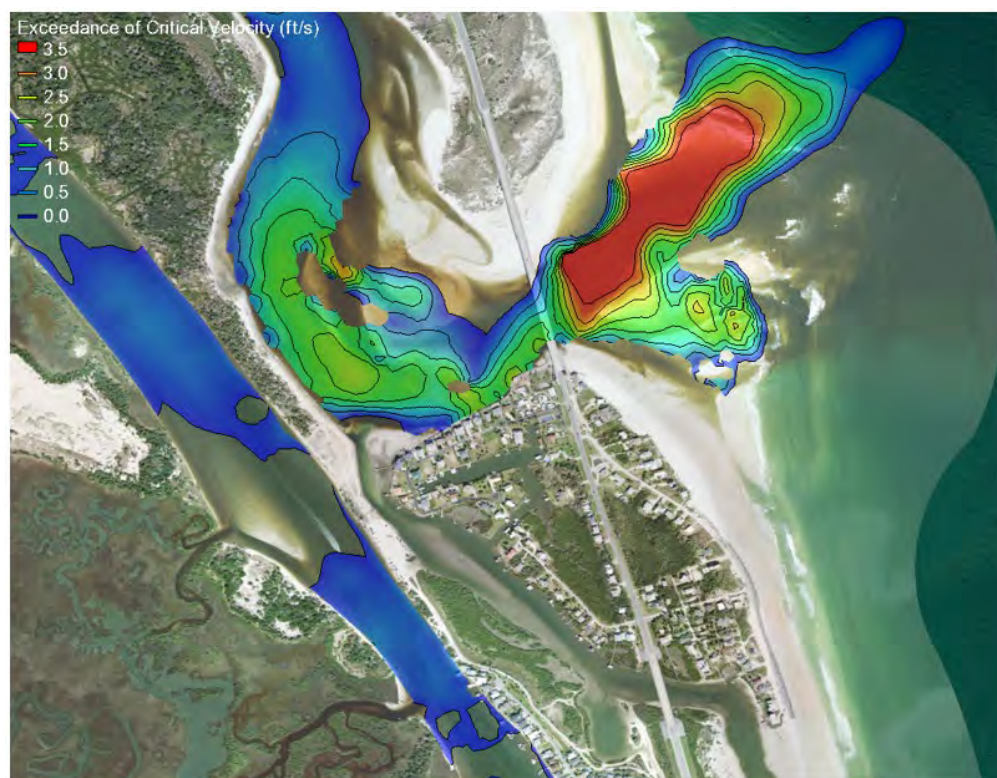
Figure 4.28 Exceedance of Critical Velocity at Peak Ebb Flow – Existing Conditions

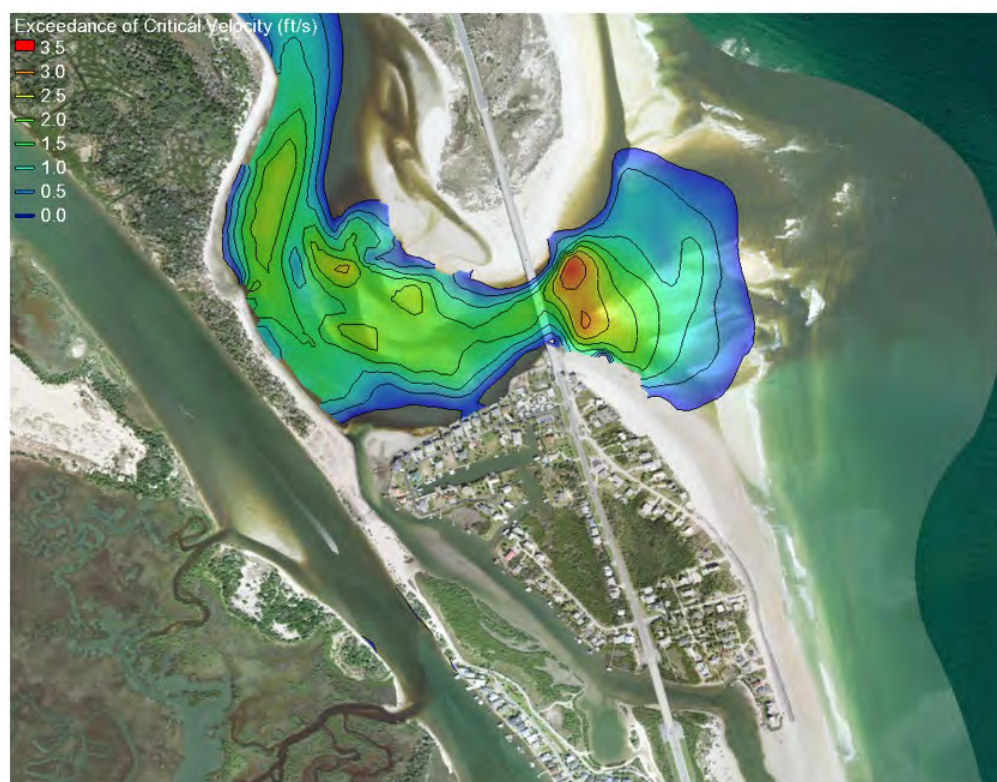
Figure 4.29 Exceedance of Critical Velocity at Peak Flood Flow – Existing Conditions

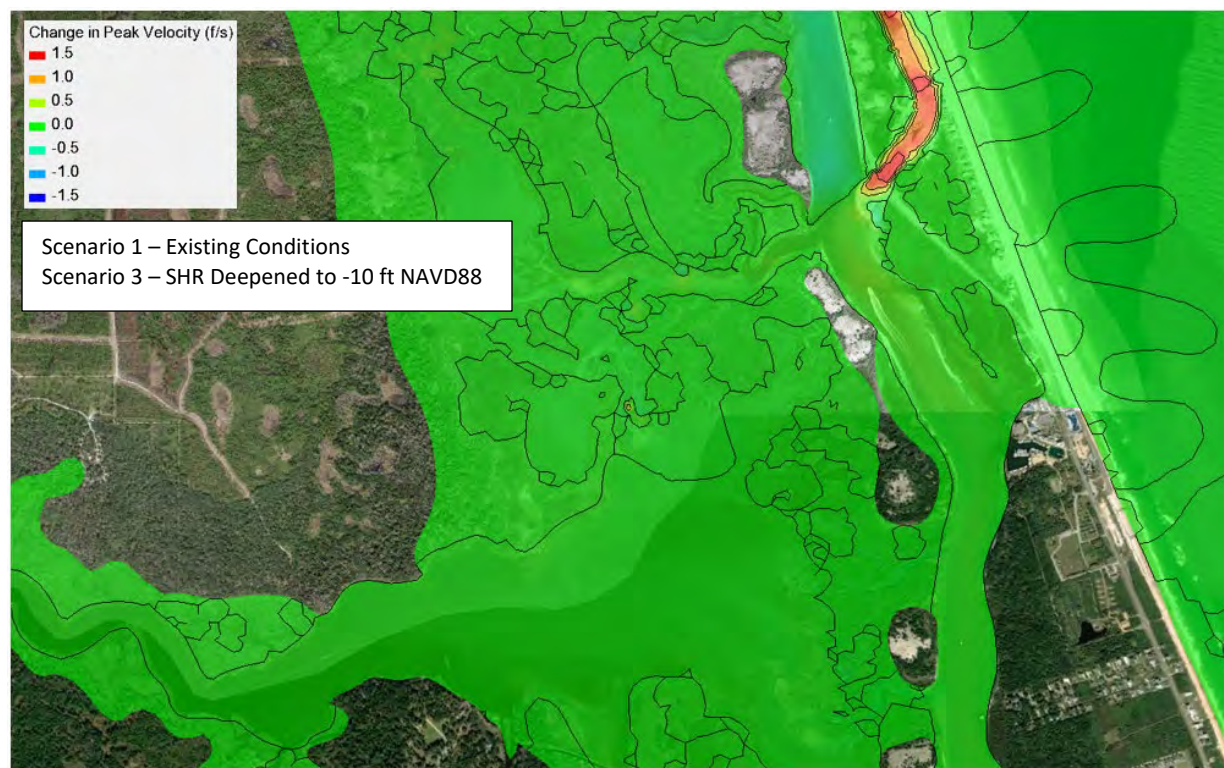
Figure 4.42 Change in Velocity within Inlet at Peak Ebb Flow – Scenario 3 vs. Existing Conditions

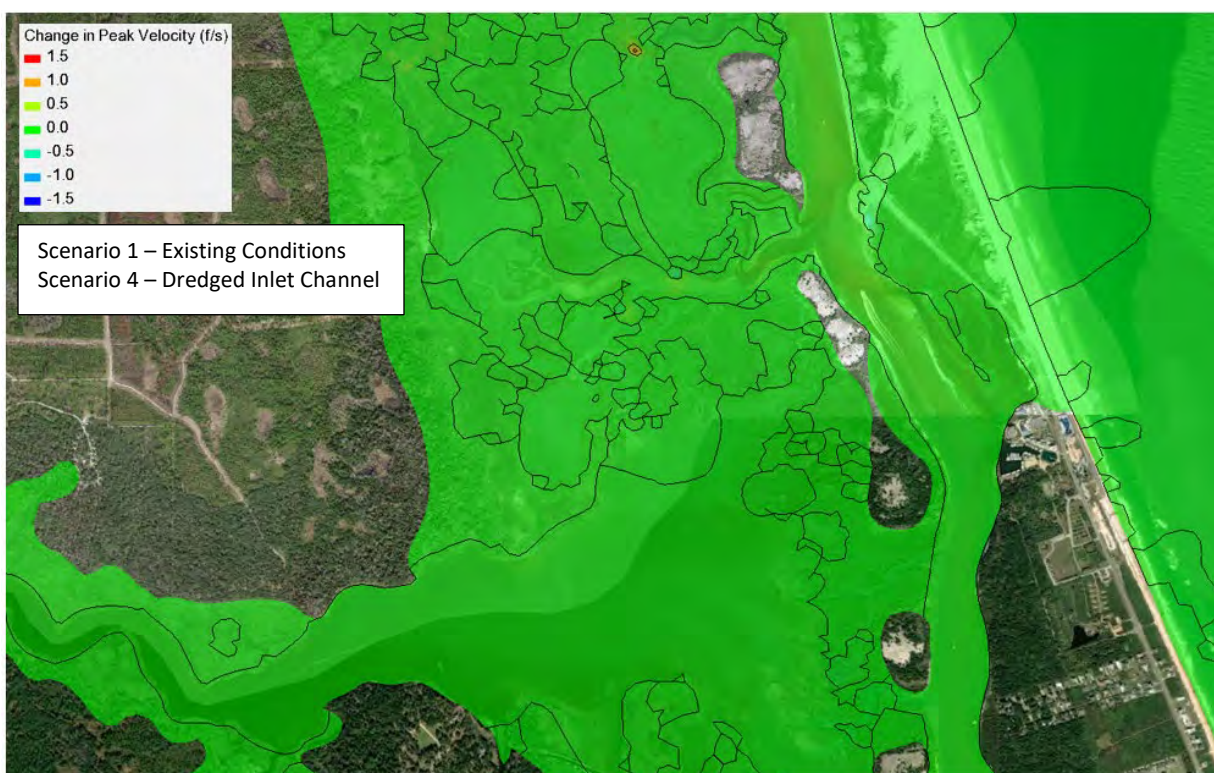
Figure 4.43 Change in Velocity within Inlet at Peak Ebb Flow – Scenario 4 vs. Existing Conditions

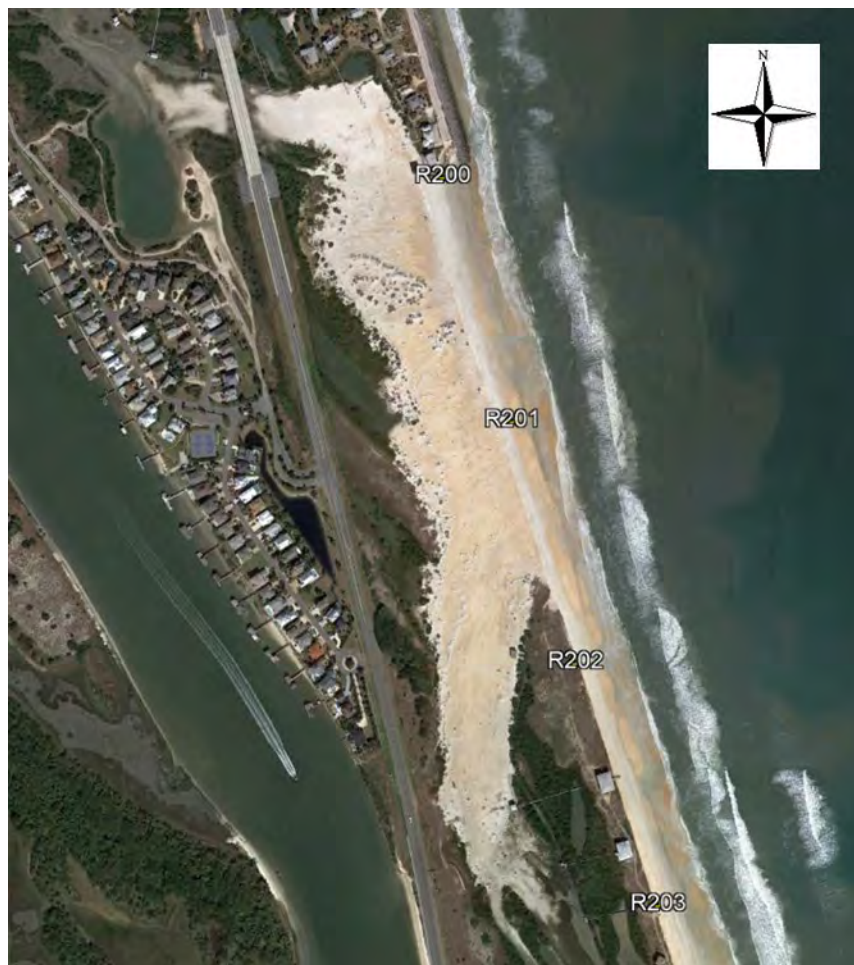
Figure 5.10 Conditions Approximately Eight Years after the T.S. Fay (2008) Breach

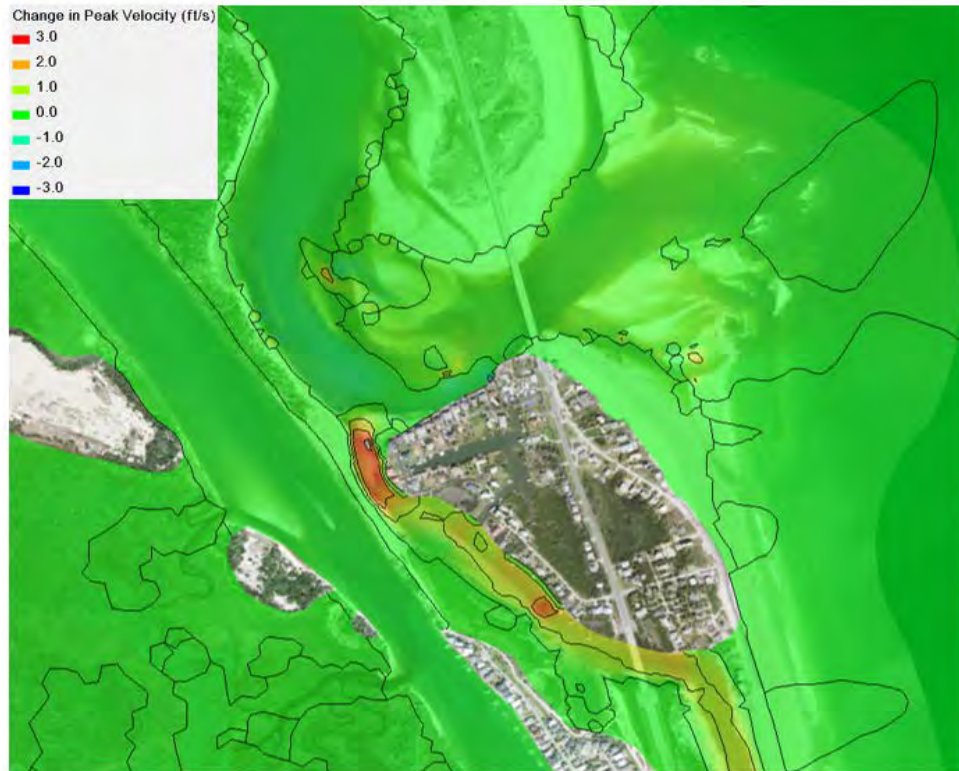
Figure 1.16 Change in Velocity within Inlet at Peak Ebb Flow — Scenario 2 vs. Existing Conditions

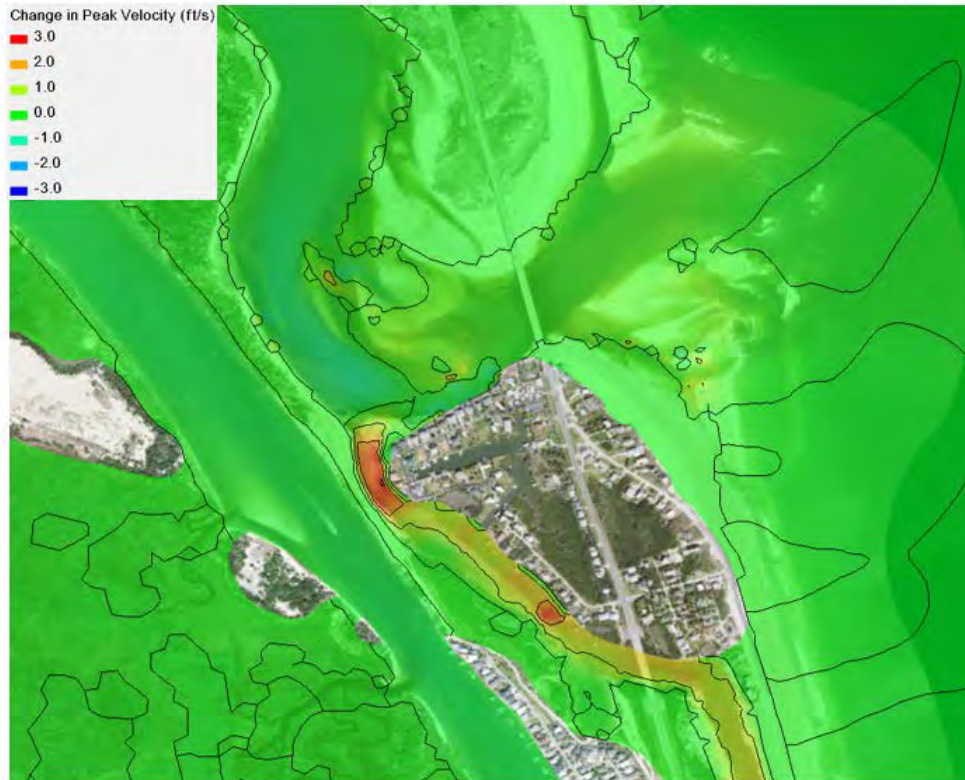
Figure 1.20 Change in Velocity within Inlet at Peak Ebb Flow – Scenario 3 vs. Existing Conditions

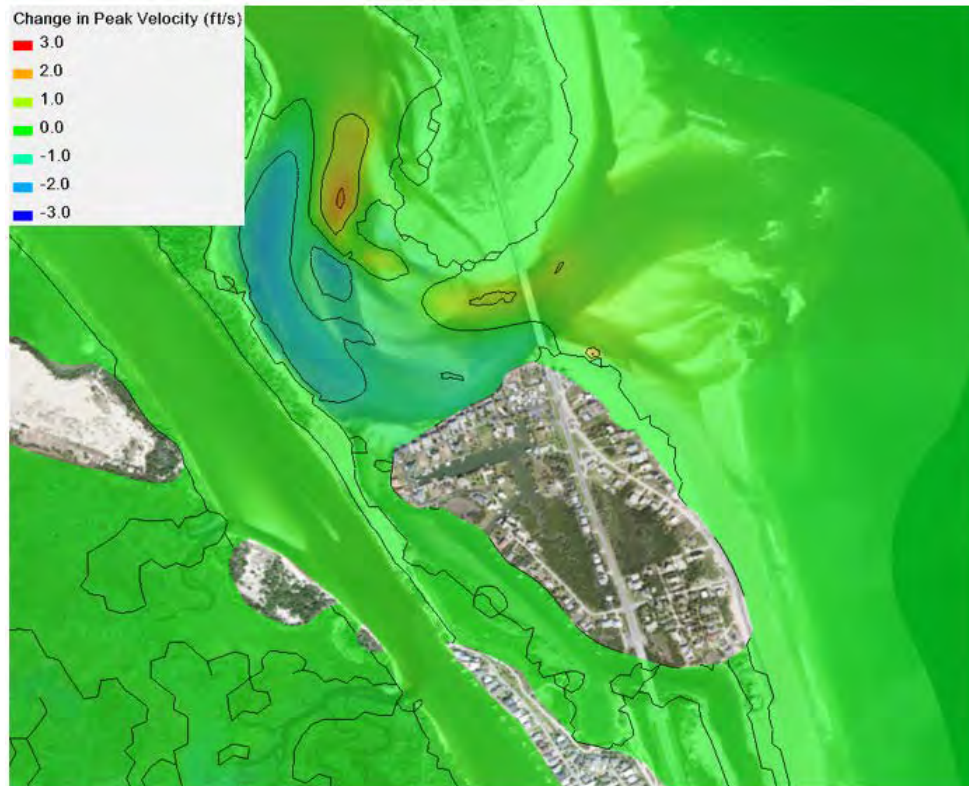
Figure 1.25 Change in Velocity within Inlet at Peak Flood Flow – Scenario 4 vs. Existing Conditions

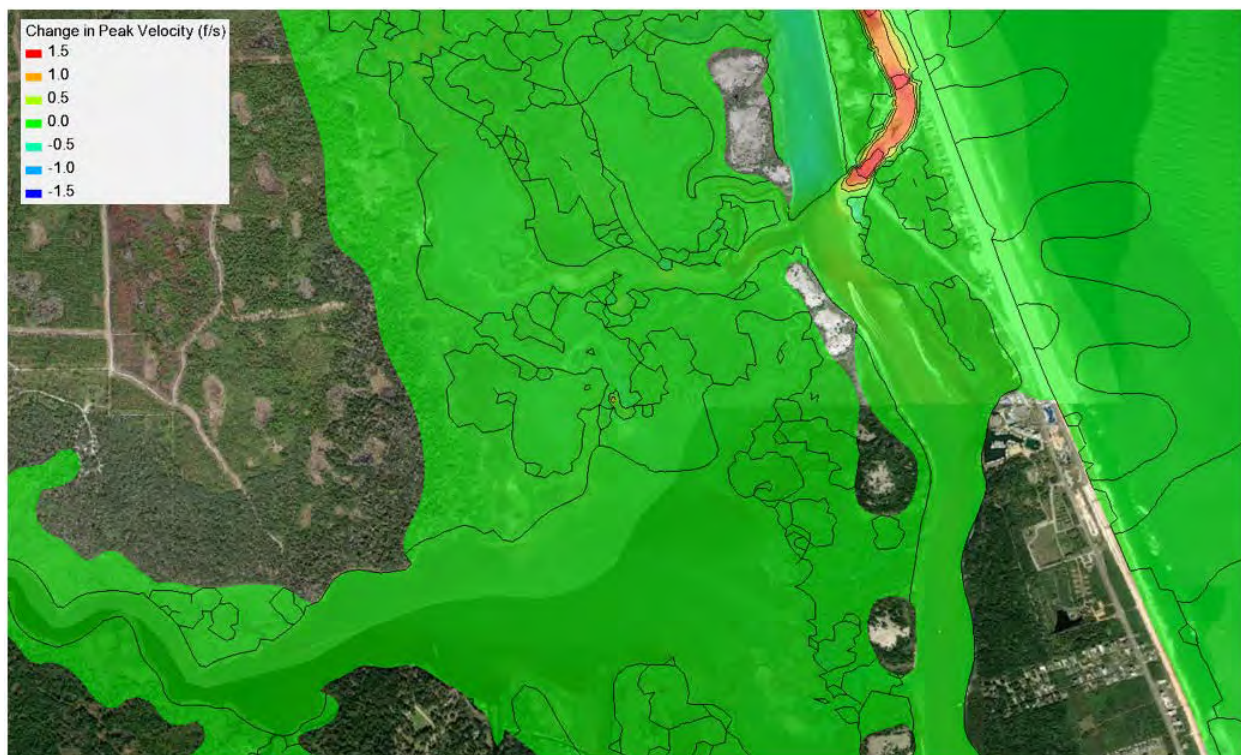
Figure 1.44 Change in Velocity within Inlet at Peak Ebb Flow – Scenario 3 vs. Existing Conditions
