St. Johns County Standish Reef

2022 Reef Observations and Report

Authored by: Joe Kistel, Kistel Media LLC

7-11-22

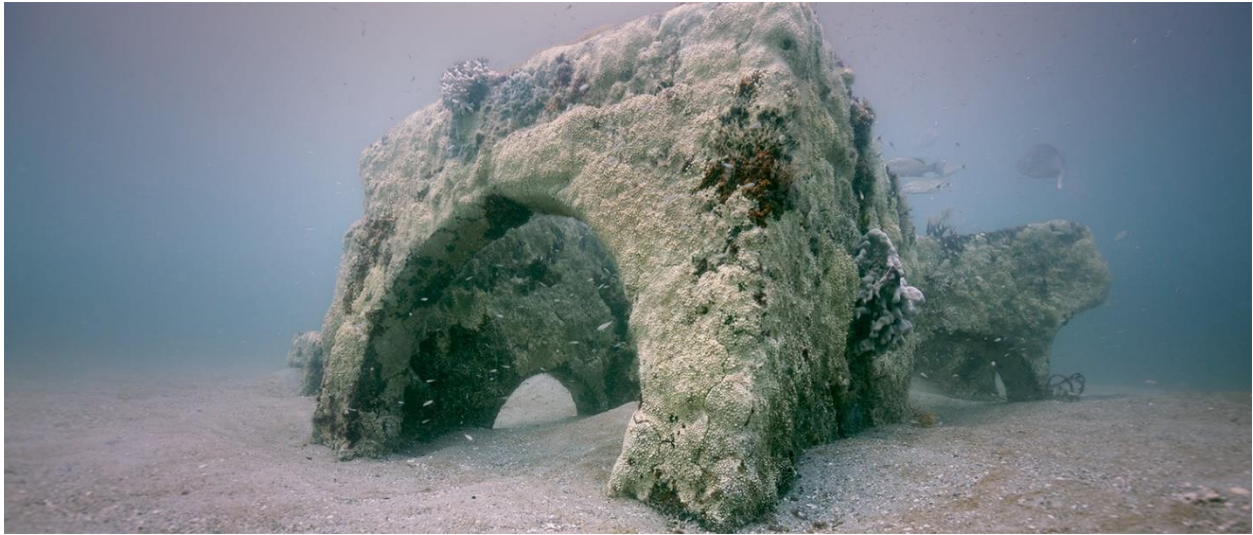
Figure 1 - Underwater Image Captured by Joe Kistel at Standish Reef on 5-19-22

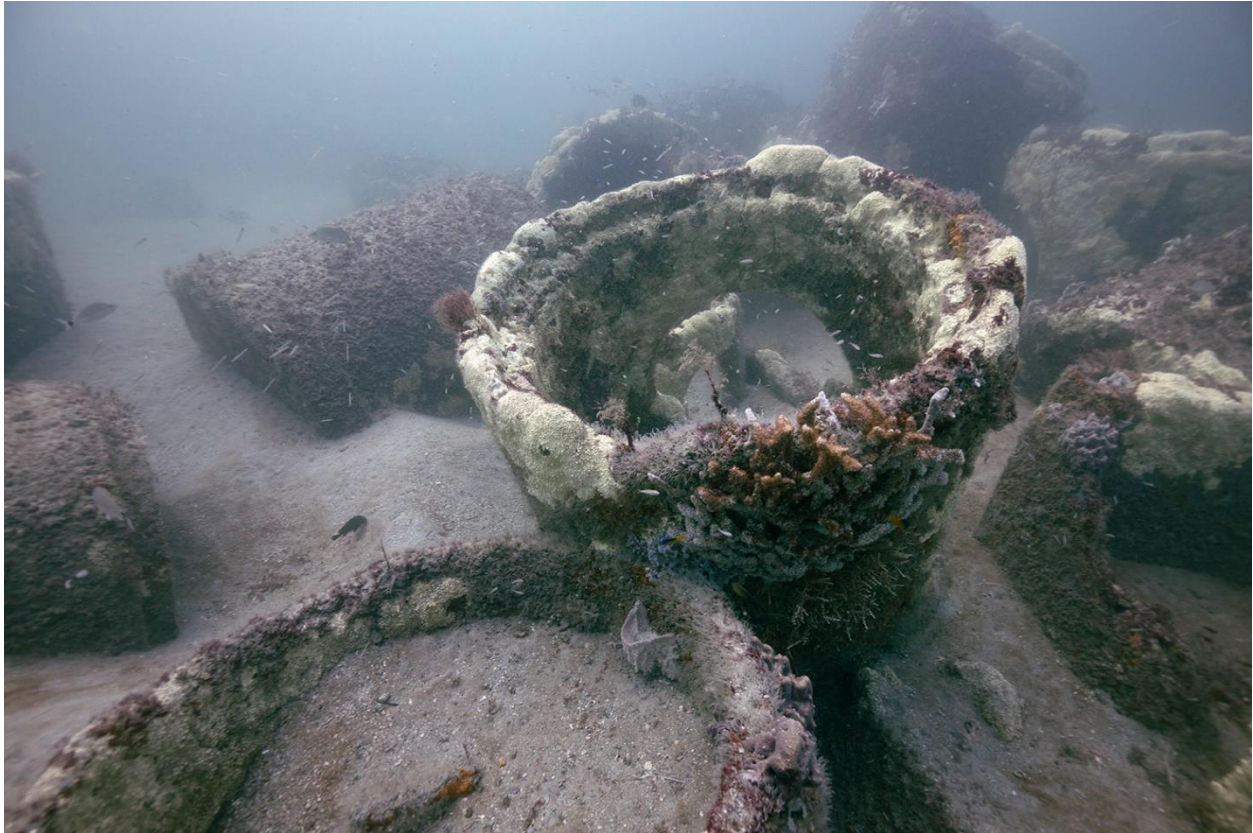
Figure 4 Underwater View of Encrusted Concrete Culverts During the Dive Investigation

A variety of fish species were present and the sunken concrete structures were completely grown over with marine life. Every inch of concrete surface was hidden under coral, sponge, algae and other encrusting life forms that would not exist in the absence of a solid foundation.

Foundationally, it appears the concrete structures are fixed in a stable orientation. Concrete pieces are lying on the seafloor somewhat sporadically. Some pieces are congregated together slightly stacked,

while others are independently scattered about. The sea floor seemed relatively stable however the sand bottom was somewhat soft. It appears evident that the sand shifts here regularly, likely do to biological activity such as snapper (and other fish) excavations. Major storm activity may cause sand shifts as well. Some of the structures are partially buried due to this sand shifting. The depth recorded was between 71 and 73 feet deep.

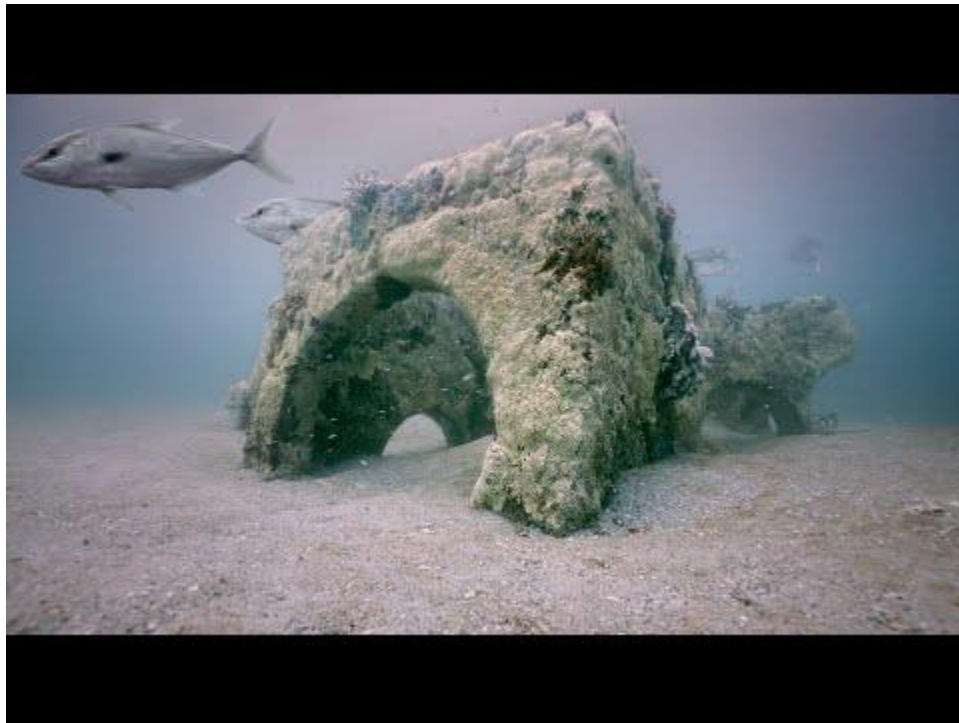
The video below shows a detailed underwater look of the Standish reef, its inhabitants, and some of the marine debris removal efforts... (Best viewed in HD which may need to be selected in video player settings)

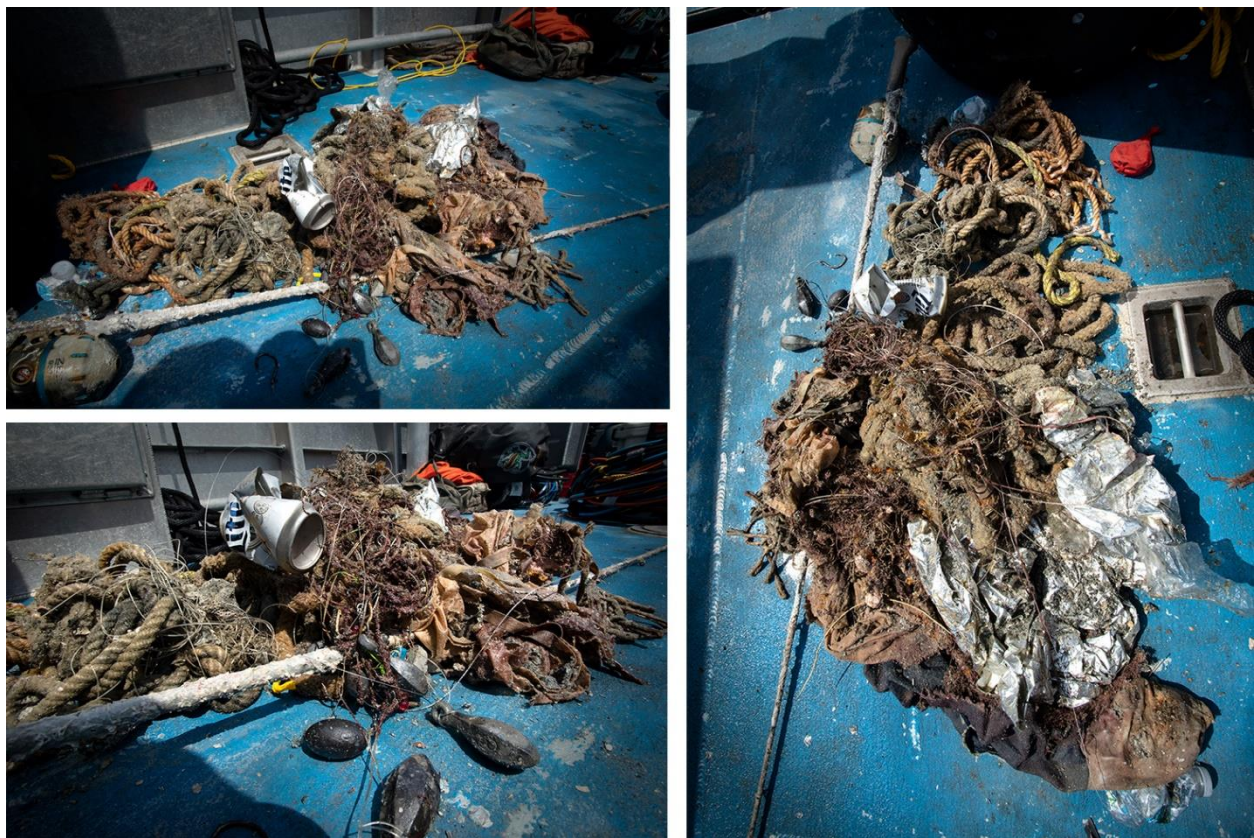
Figure 5. Debris and Entanglement Hazards Removed from the Standish Reef

The Standish Reef is located a moderate distance from the St. Augustine Inlet and has likely received consistent fishing use since its deployment in the late 90's. This was evident by items encountered down below. Fishing line was observed and some of the monofilament had attached fishing tackle including lead weights and hooks. Several sections of rope were found and recovered. A lost fishing pole with a reel and line was retrieved. A few types of cloth were also recovered, as well as some unidentifiable materials. An inflated balloon was found adrift near the reef site as well.

Note: It is thought that some debris and entanglement items on the Standish reef are buried and entrapped due to the shifting sands the reef experiences. Monofilament was often found around the base edges of structures and many base edges were buried. It is feasible to think that when these edges were exposed they also entrapped line, and then the line was buried as the structure edges became covered with sand. We also observed what looked like blades of grass sticking up out of the sand in some areas. These were pieces of exposed fishing line with marine growth covering them. When we pulled on these lines we found longer sections of line, and often tackle, buried in the sand.

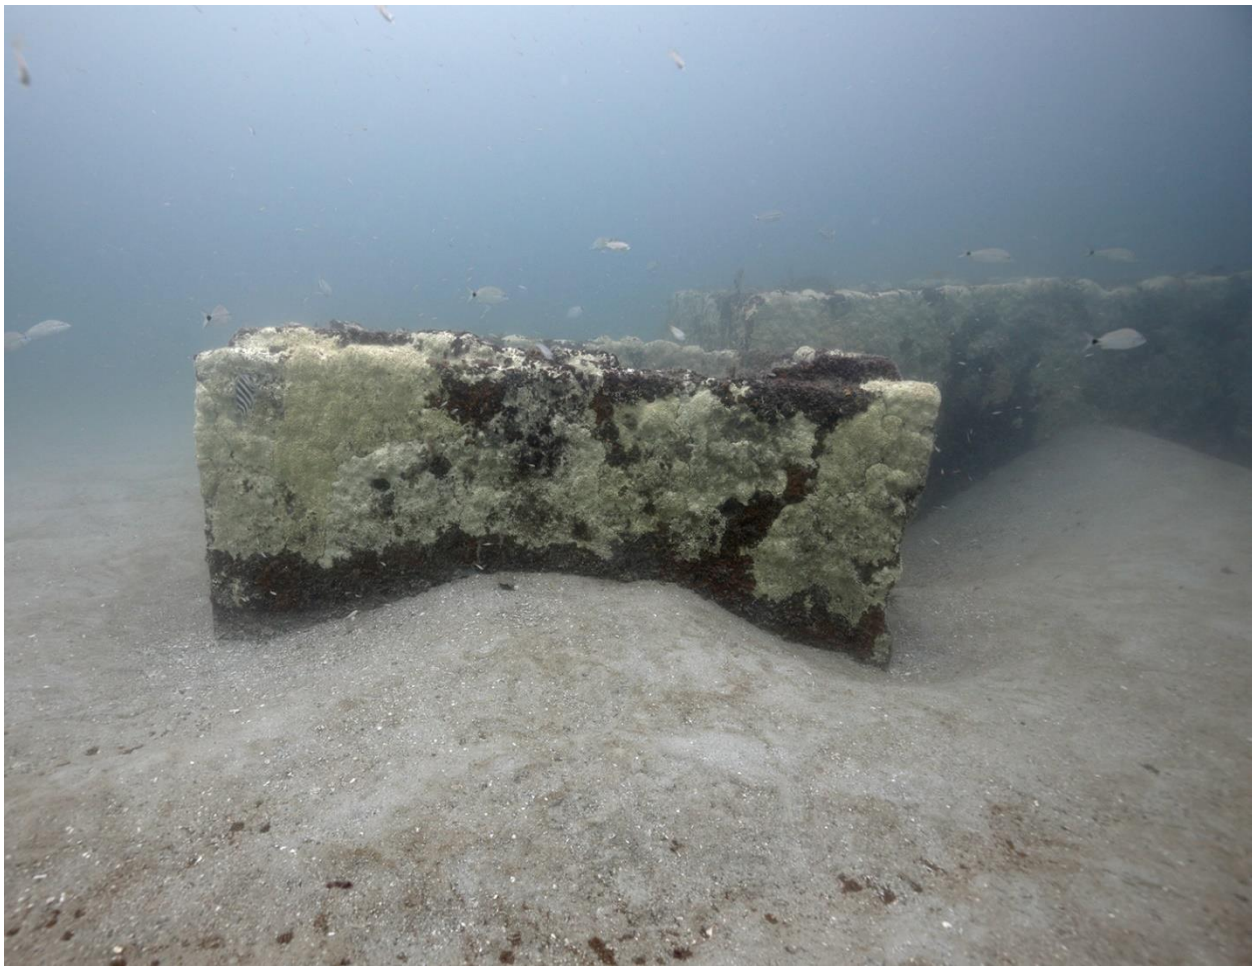
Figure 6: Sand Excavations Caused by Marine Life

The image below shows an example of observed sand movement around structures likely caused by marine life. Red Snapper may be the likely culprit.
