FINAL REPORT

# Study of Summer Haven River and Surrounding Areas

St. Johns County, Florida

Prepared by: **INTERA - GEC**  
A joint venture of INTERA and G.E.C.

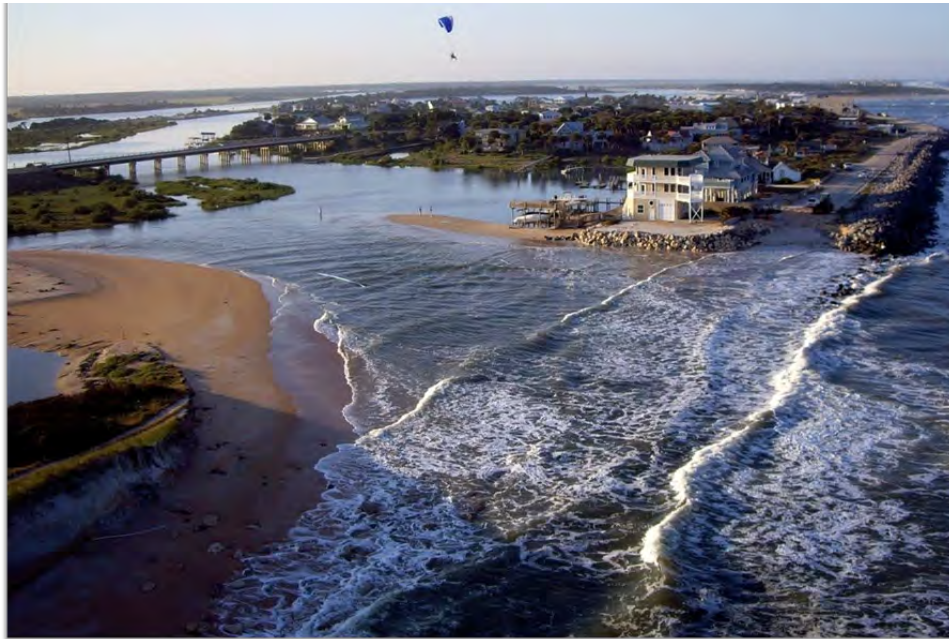
Figure 2.4 North End - 2008 Tropical Storm Fay Breach (Taylor Engineering, 2018)

As mentioned, a breach located at R-200 initially created by Tropical Storm Fay in 2008 caused over 300,000 cy of sand to eventually infill the river and completely block its tidal flow (**Figures 2.4 and 2.5**). With the goal of restoring the river, Friends of the Summer Haven River formed and — with the SAPWBD as the local government sponsor — successfully obtained funding through a special appropriation from FDEP for construction of the SHRRP. In 2016, with state and federal permits issued and a construction contractor under contract with SAPWBD, the SHRRP was set to commence November 1, the first day after turtle nesting season.

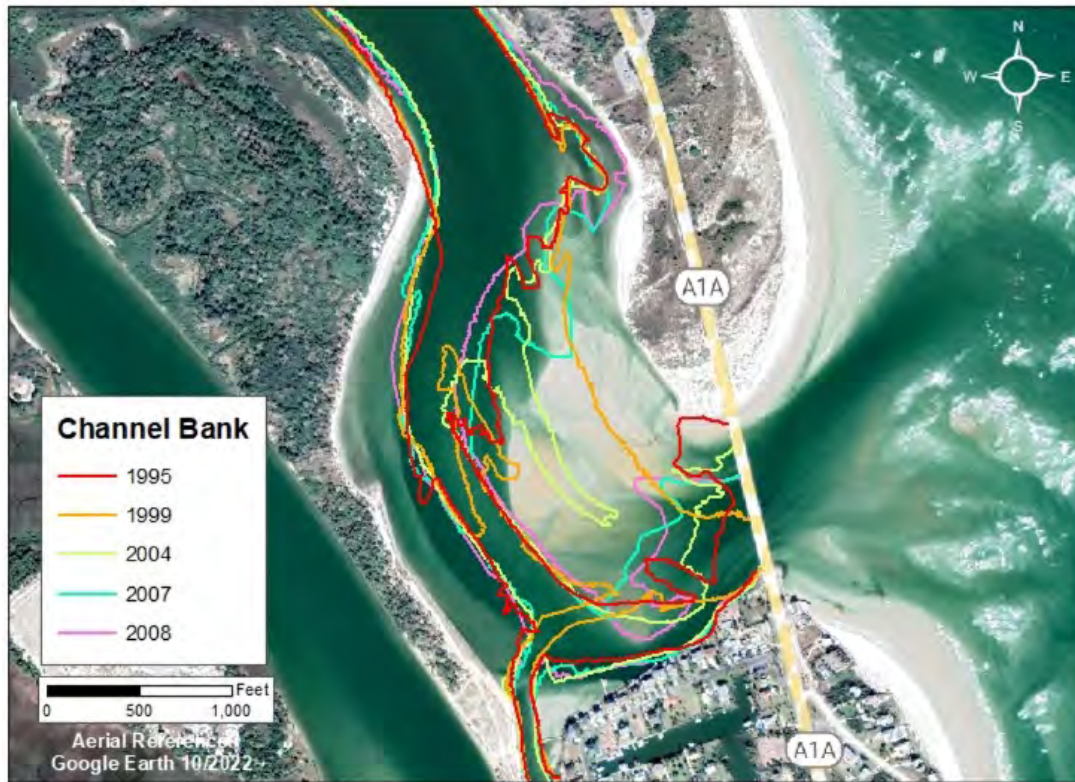
Figure 4.12 Matanzas Inlet Primary Channel Positions from 1995–2008

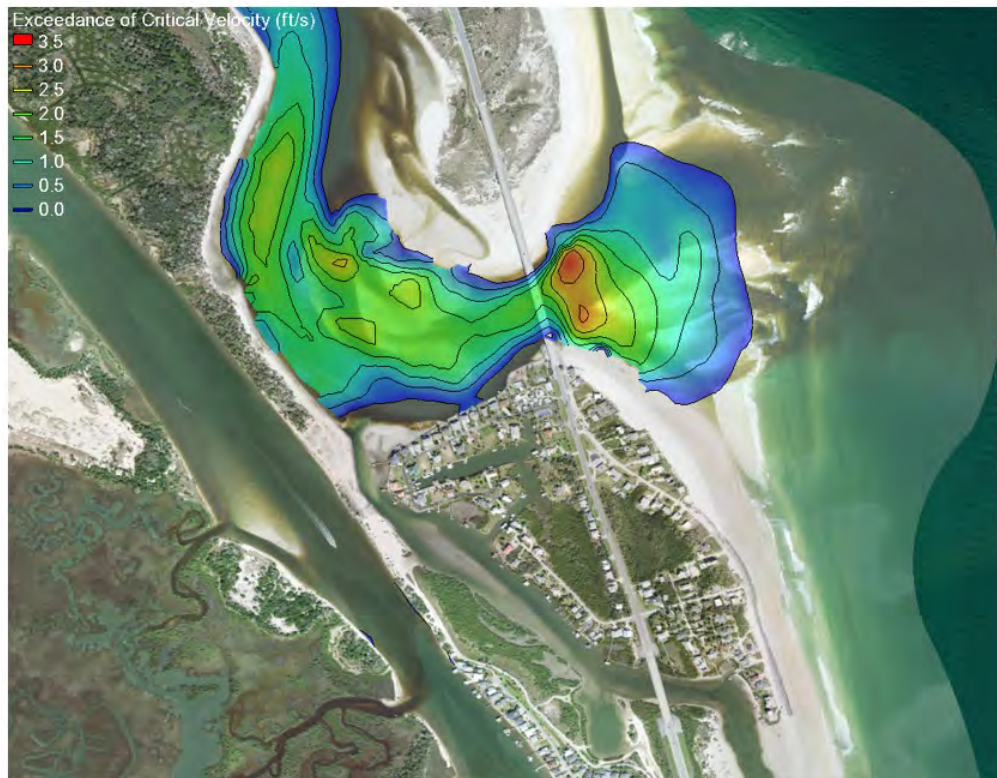
Figure 4.29 Exceedance of Critical Velocity at Peak Flood Flow – Existing Conditions

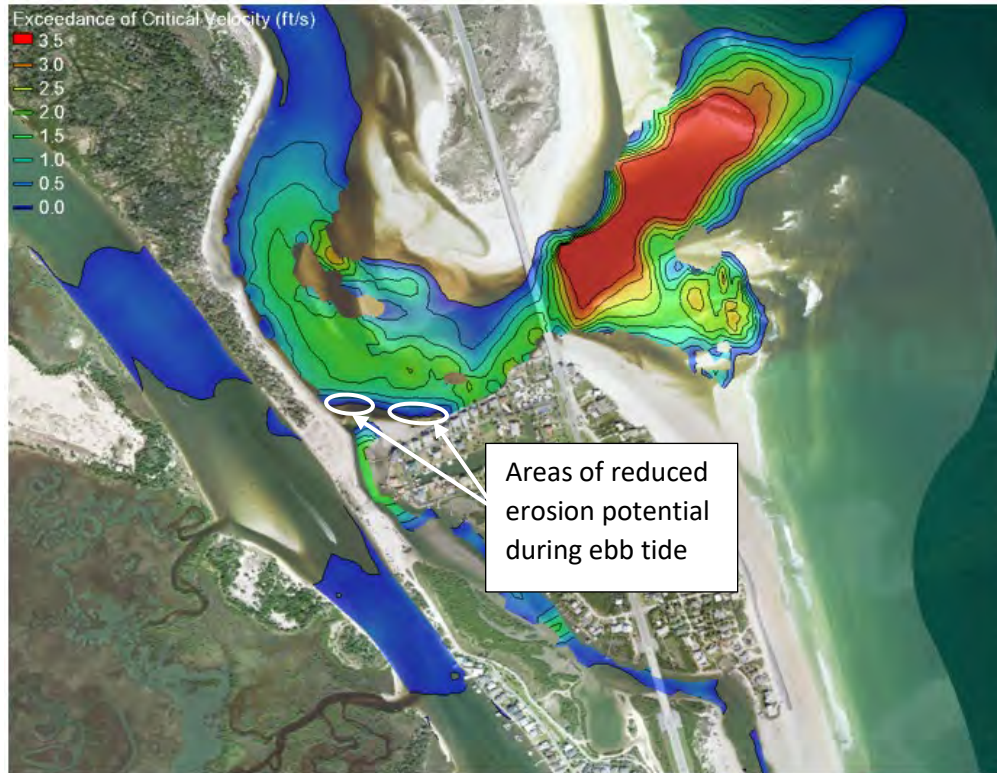
Figure 4.30 Exceedance of Critical Velocity at Peak Ebb Flow – Scenario 2 (SHR Deepened to -6 ft NAVD88)

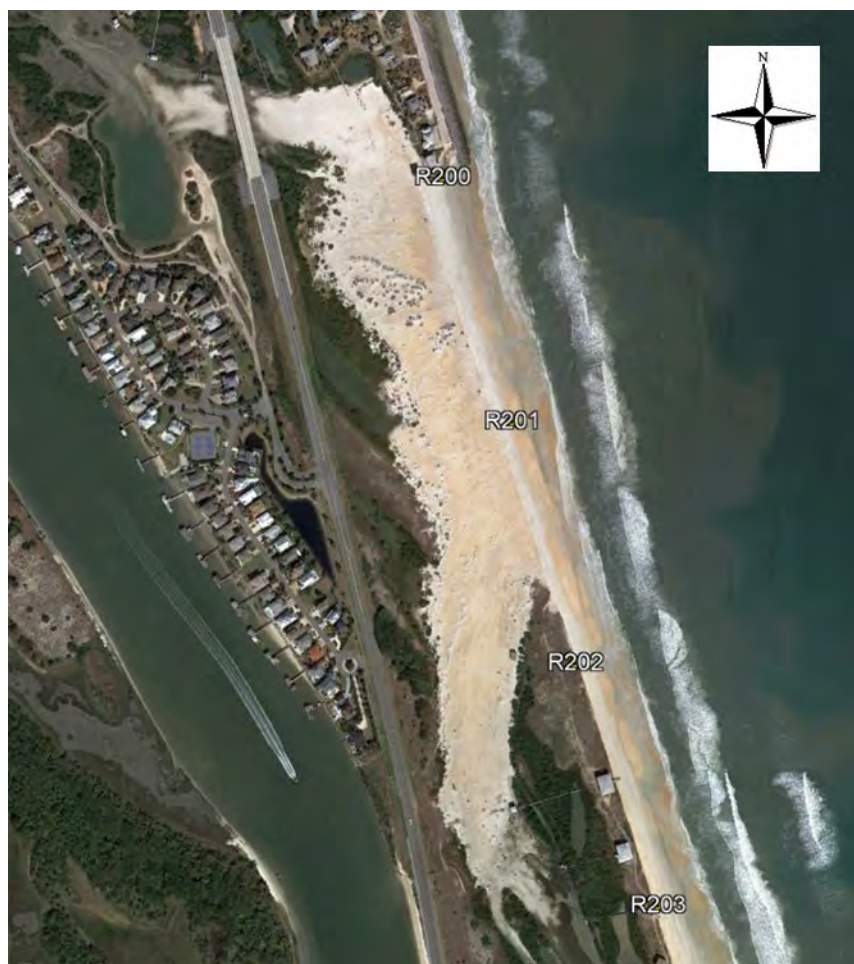
Figure 5.10 Conditions Approximately Eight Years after the T.S. Fay (2008) Breach

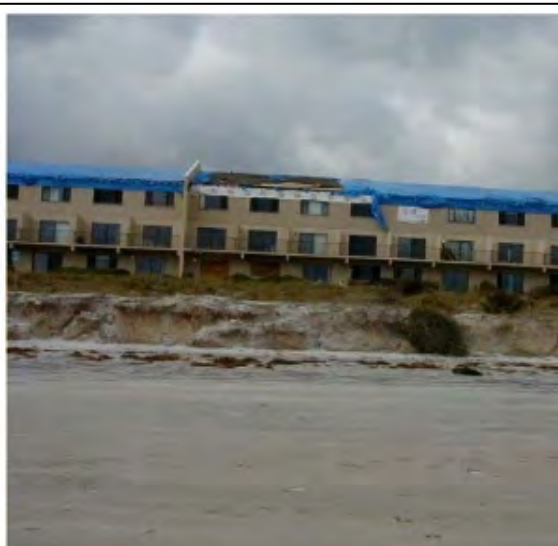
Photo 1 Anastasia Island Erosion at R-193

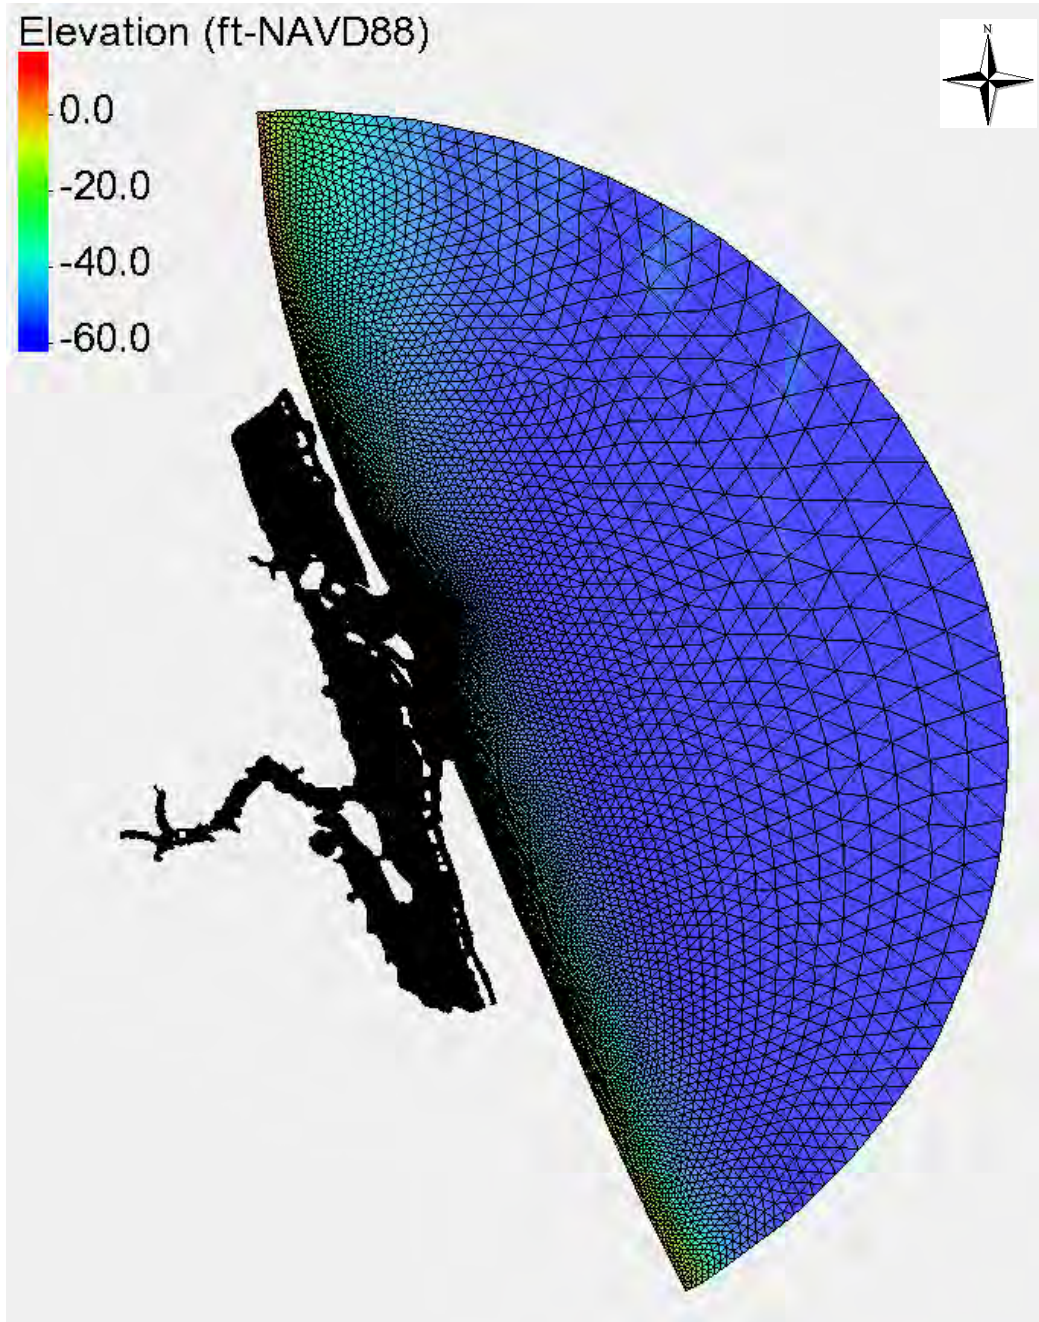
Figure 1.1 ADCIRC Model Mesh Extent and Elevation Contours

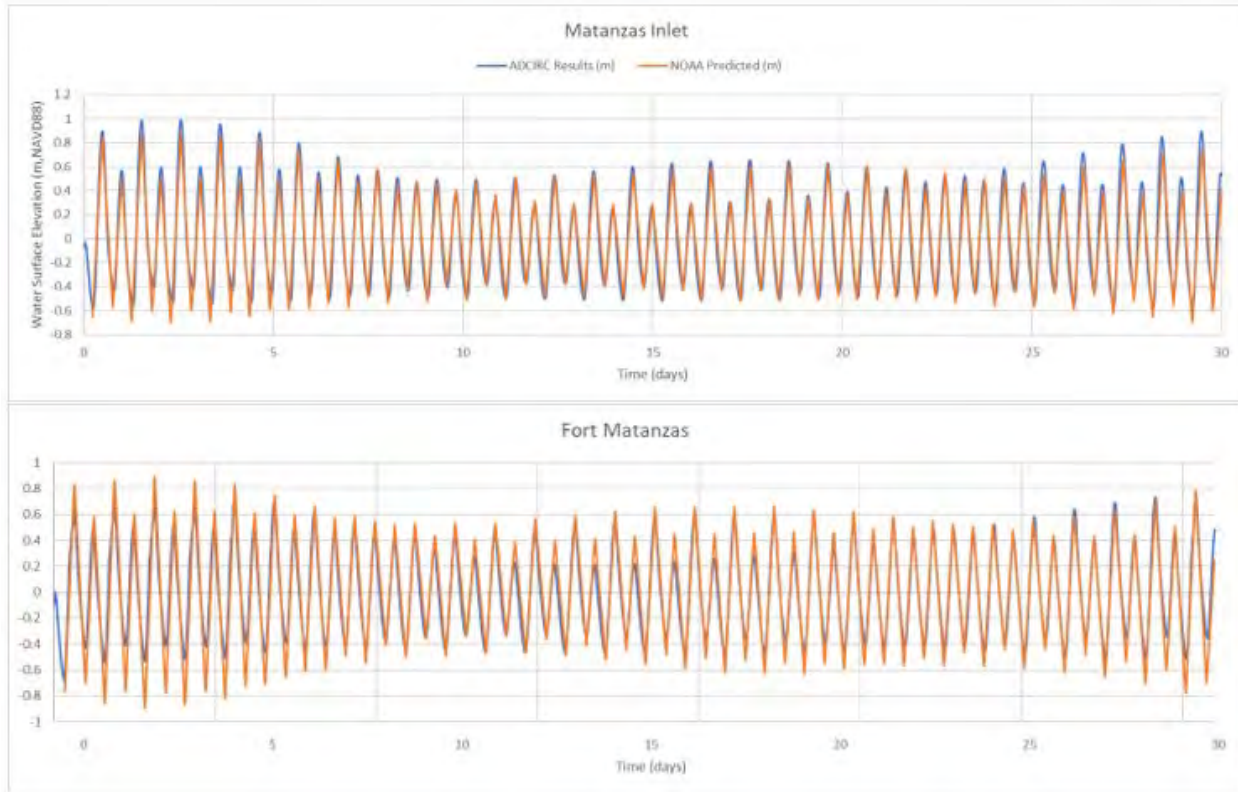
**Figure 1.7 Calibration Comparison Plot at Matanzas Inlet (top) and Fort Matanzas (bottom)**

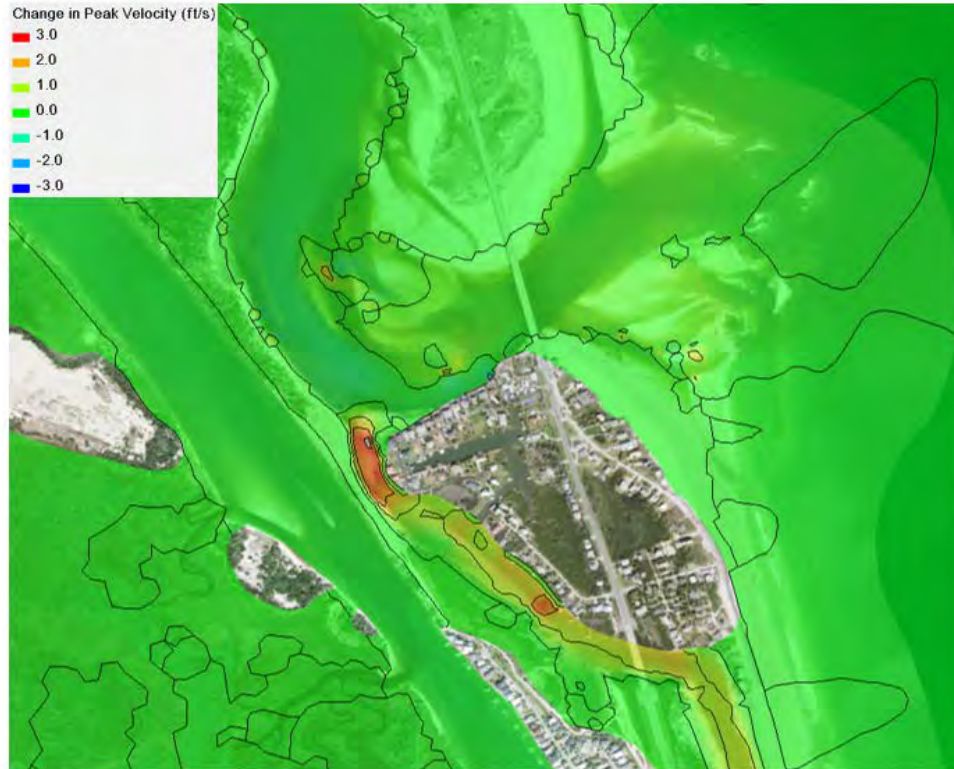
Figure 1.16 Change in Velocity within Inlet at Peak Ebb Flow – Scenario 2 vs. Existing Conditions

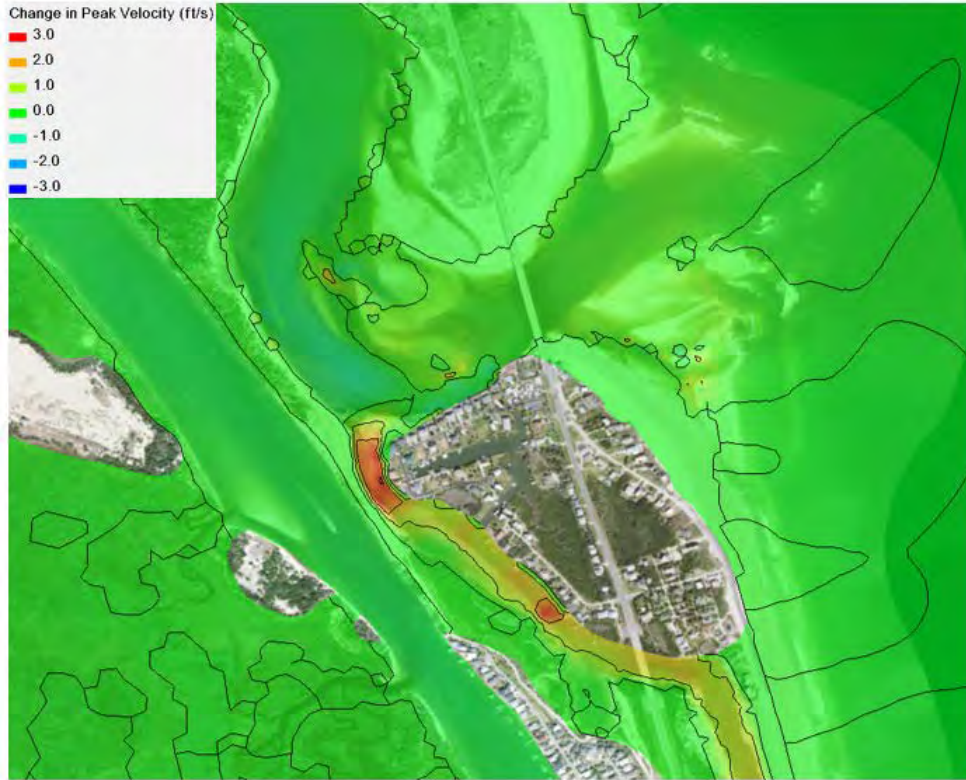
Figure 1.20 Change in Velocity within Inlet at Peak Ebb Flow – Scenario 3 vs. Existing Conditions

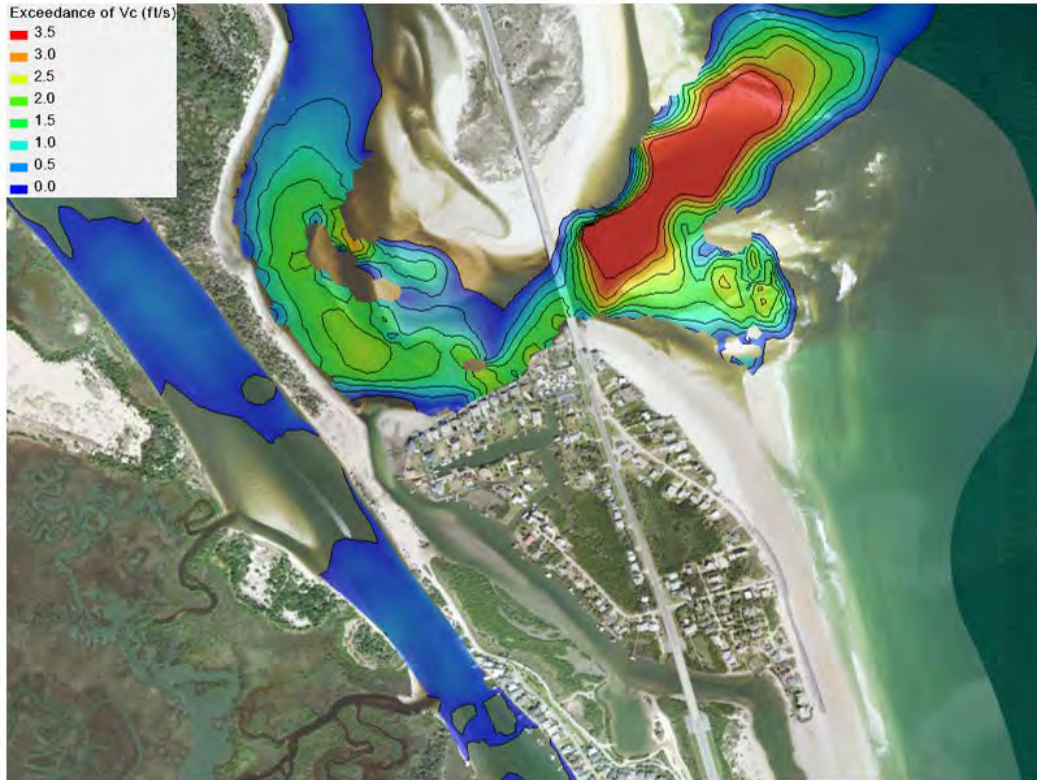
Figure 1.26 Exceedance of Critical Velocity at Peak Ebb Flow – Existing Conditions

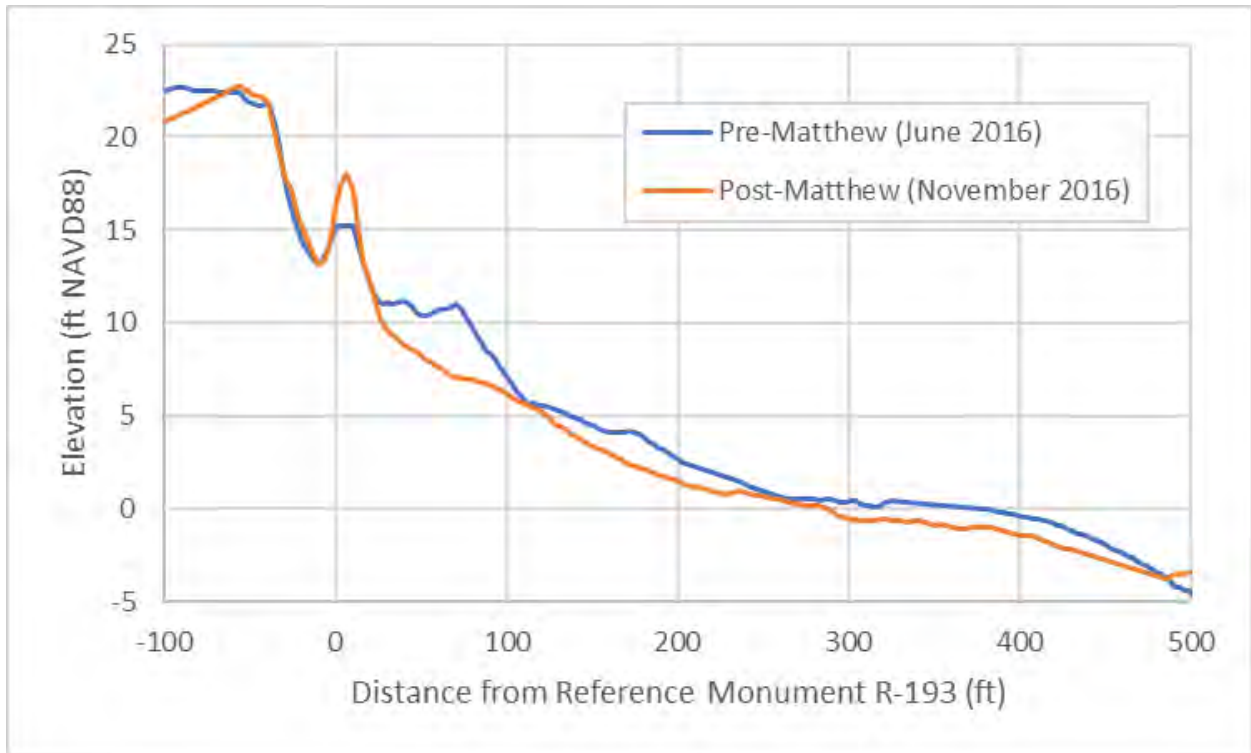
Figure 1 Pre- and Post-Storm Profiles at R-193 for Hurricane Matthew

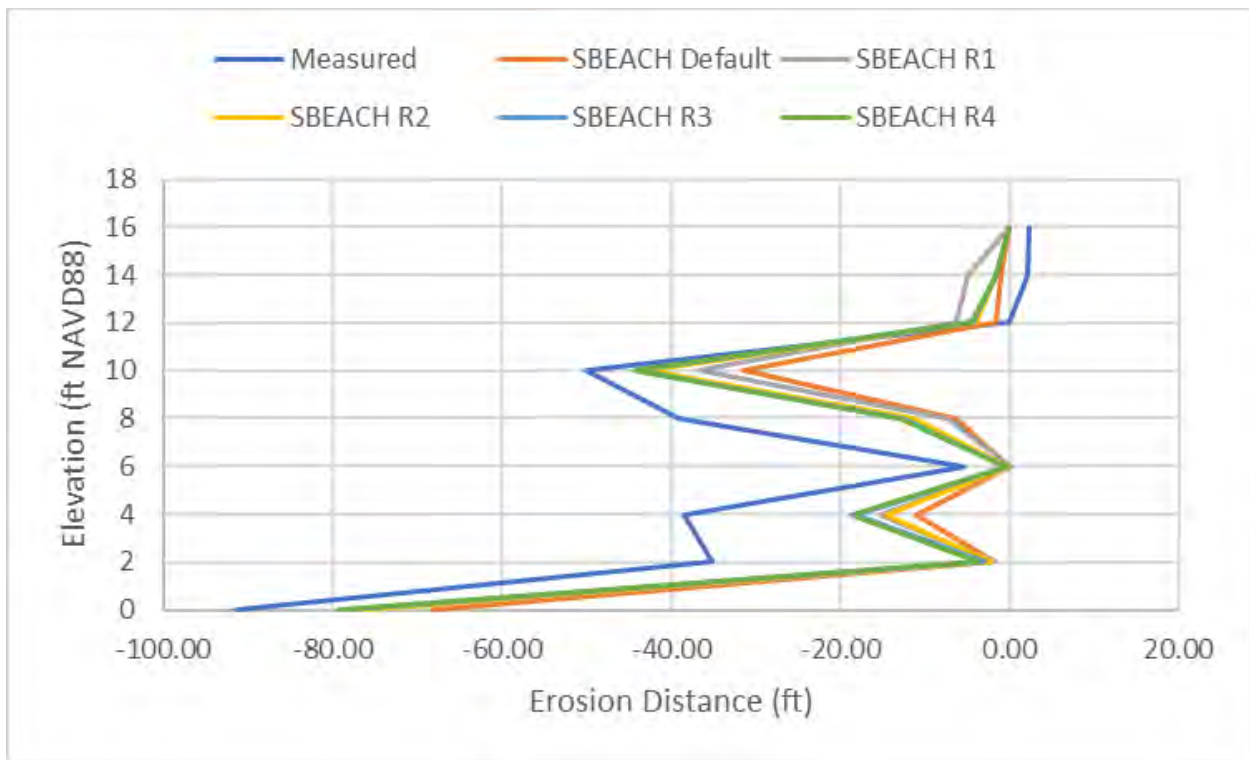
Figure 3 Measured and Predicted Contour Changes for Hurricane Matthew

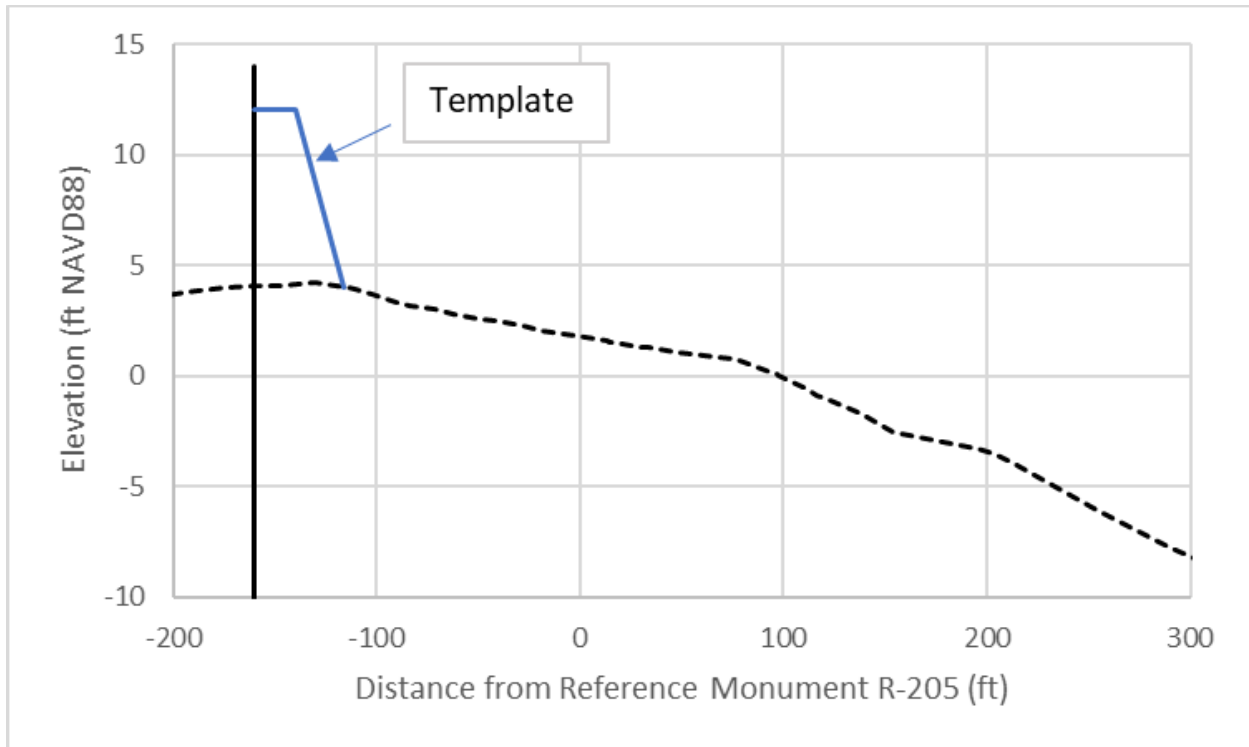
Figure 12 Seawall with Small Dune Concept
