FINAL REPORT

# Study of Summerhouse and Surrounding Areas

St. Johns County, Florida

Prepared by: **INTERA - GEC**  
A joint venture of INTERA and G.E.C.

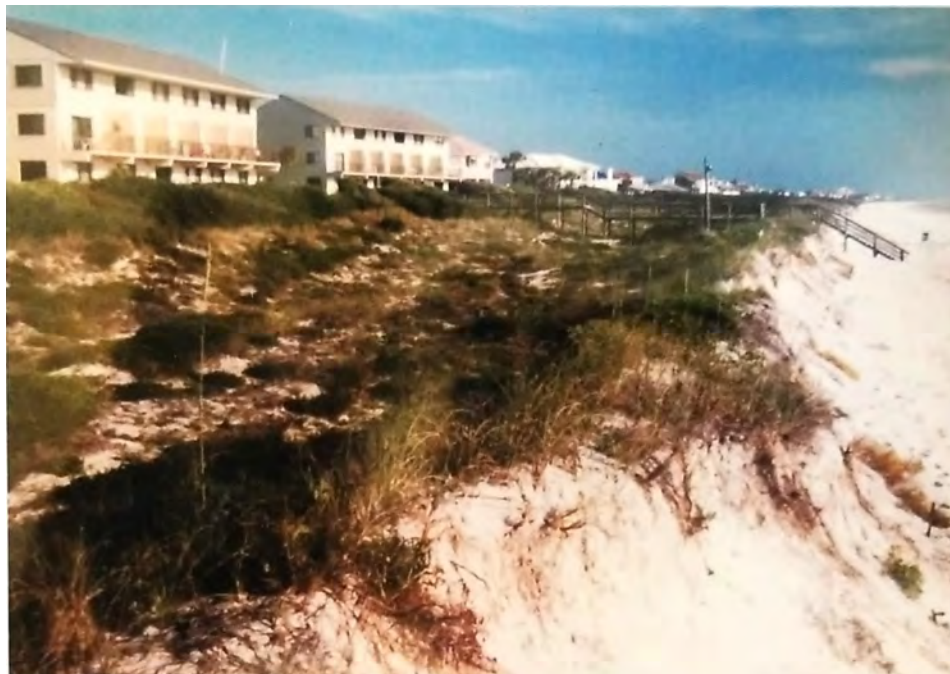
Figure 2.1 Looking North near North End of Summerhouse Property Circa 2000 (Source: Summerhouse)

Historically, the dune system fronting Summerhouse consisted of a wide series of three dunes with varying crest elevations. **Figure 2.1** shows the dune system near the north end and **Figure 2.2** shows the dune system at the south end of the Summerhouse property circa 2000. From a 1993 aerial, the distance from buildings to the seaward edge of the dune vegetation measured nominally 150 feet (ft) (**Figure 2.3**). Before Hurricane Matthew eroded the beaches and dunes in October 2016, this distance was very similar (**Figure 2.4**). Given the shoreline orientation relative to the line of construction, the oceanfront buildings lie closer to the shoreline as you move north to south. Hurricanes and other storms in 2004 and 2005 caused some erosion of the most seaward dune as evidenced by the dune scarp (**Figure 2.5**). The 2016 aerial suggests the dune subsequently naturally recovered.

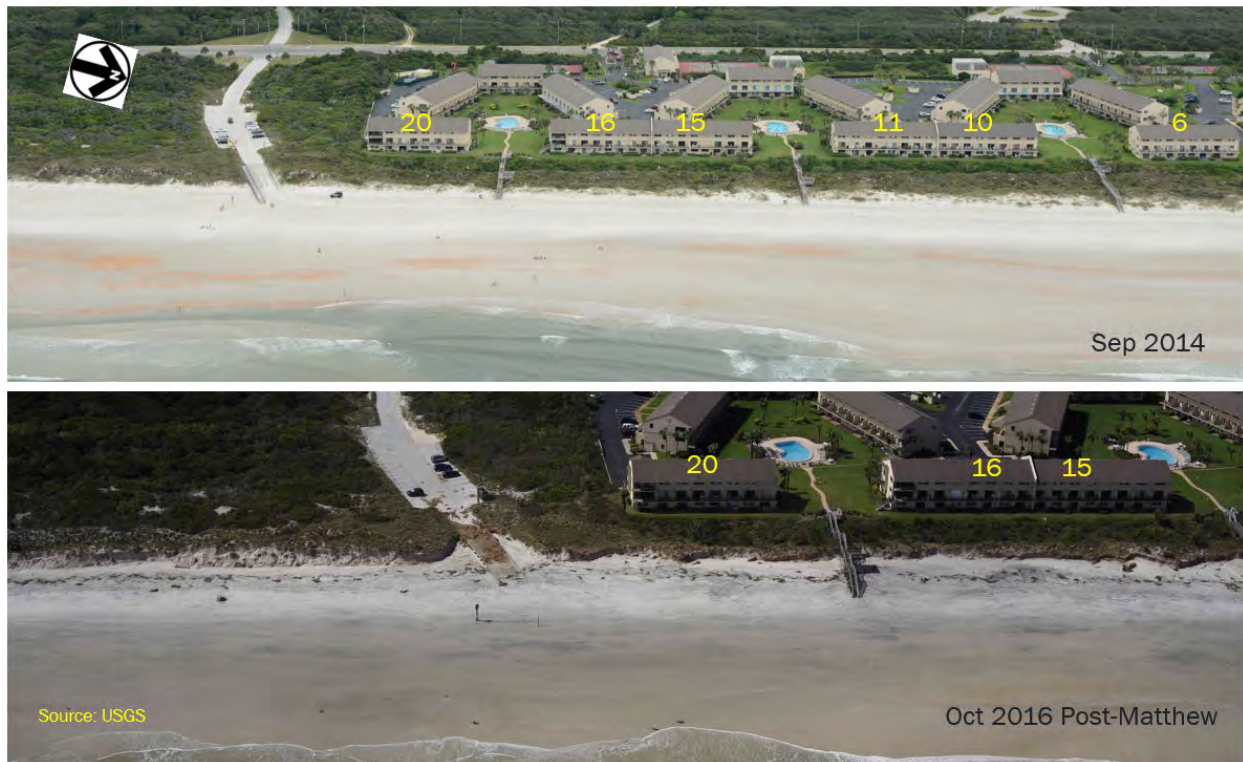
Figure 2.6 Comparison of Pre- and Post-Matthew Conditions near South End of Summerhouse

Hurricane Matthew eroded the frontal dune and generally lowered the beach elevations in October 2016. The FDEP (2017) characterized the erosion in the area as Condition IV, meaning major dune erosion occurred. **Figure 2.6** shows a comparison of United States Geological Survey (USGS) aeriels ([https://geodesy.noaa.gov/storm\\_archive/storms/matthew/index.html](https://geodesy.noaa.gov/storm_archive/storms/matthew/index.html)) taken in September 2014 and October 2016 (post-Matthew). Note that the dune lost approximately 30-40 ft of width.

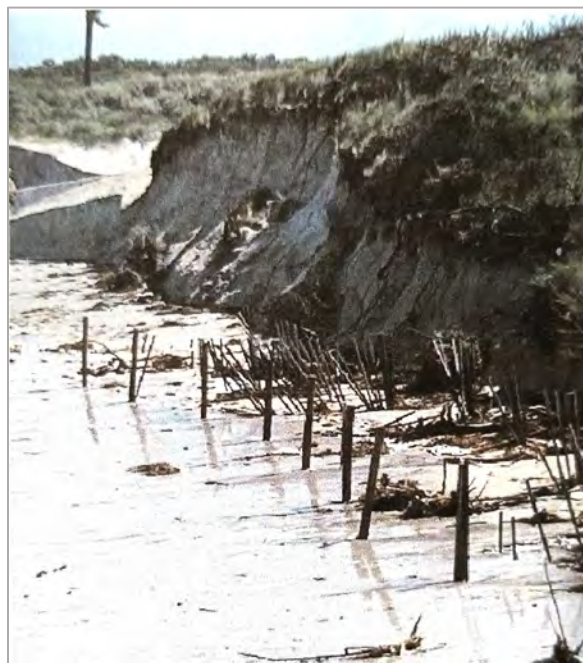
Figure 2.7 Post-Fall 2020 Northeaster Damage near Building 20 (source: Summerhouse)

Anecdotal evidence suggests that the tertiary, frontal dune was rebuilding during the late summer months the year following Hurricane Matthew. However, Hurricane Irma subsequently eroded the dune again in September 2017. Without this tertiary dune feature, the remaining beach and dune system became vulnerable to more frequent, less intense storms such as Hurricane Dorian (2019) and a northeaster in fall 2020. These lesser storms began eroding the secondary dune feature. **Figure 2.7** shows the dune damage after the northeaster.

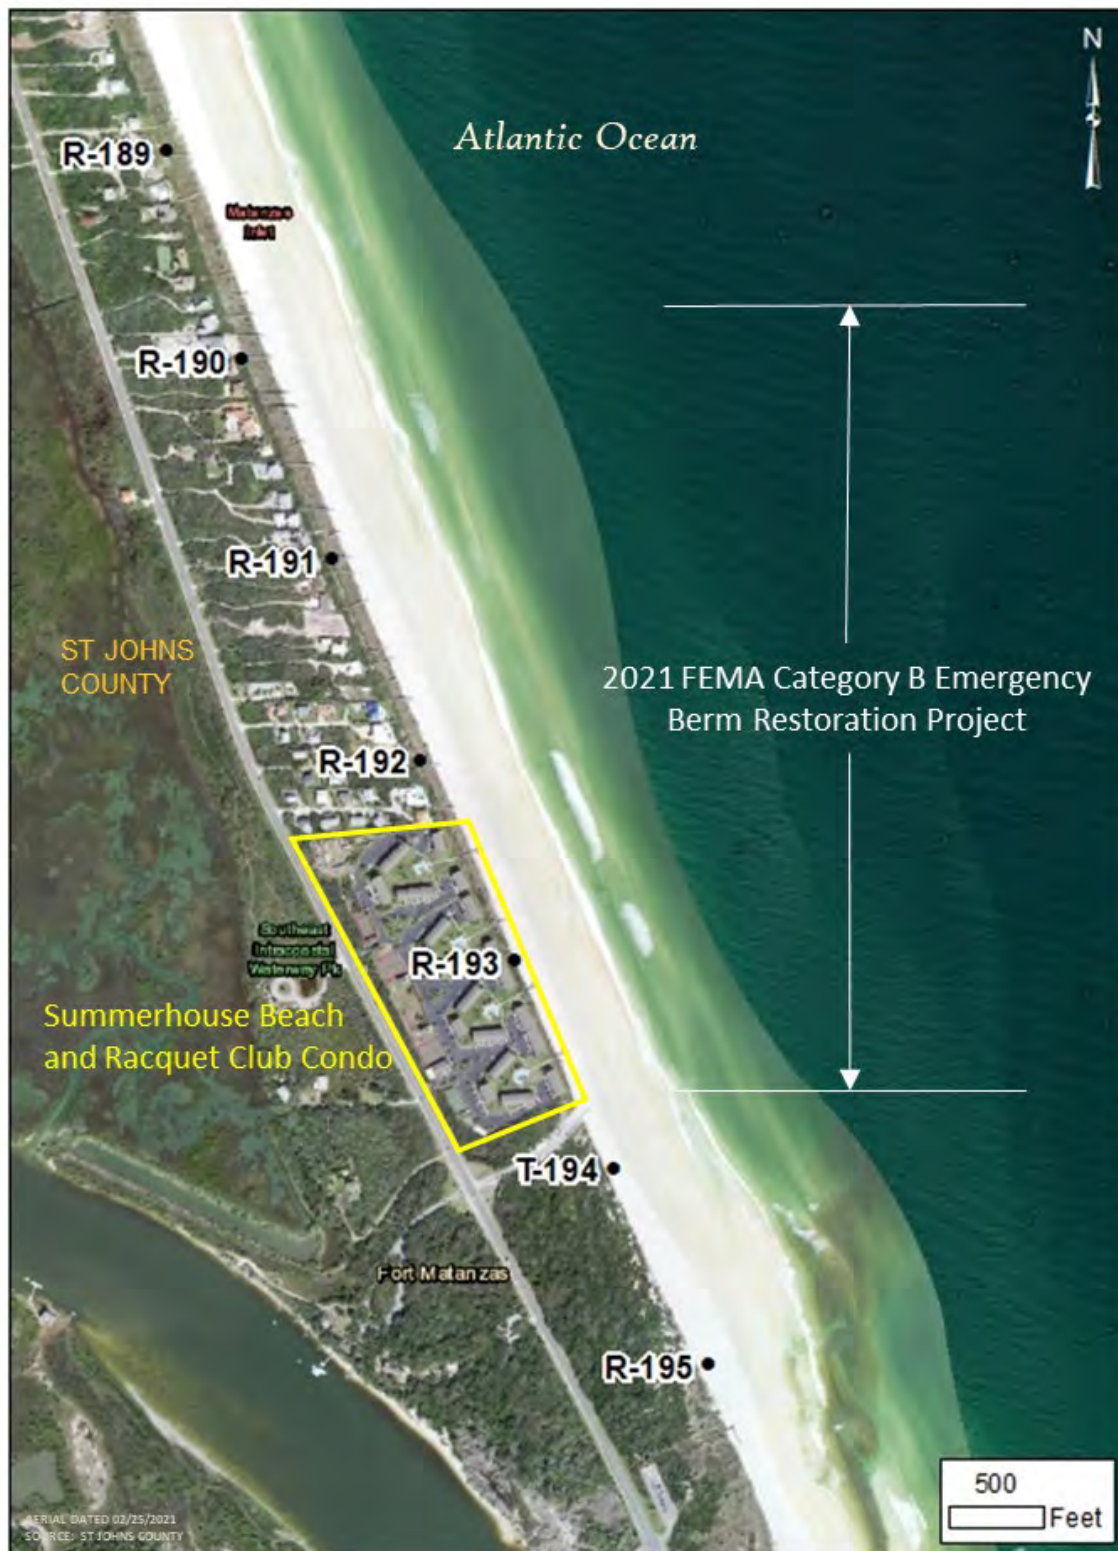
Figure 2.8 Overview of 2021 FEMA Beach Fill Placement Area

In response to Hurricane Matthew, the County's FEMA Category B Emergency Berm Restoration Project, authorized by FDEP Permit No 0402841-001-JC, restored part of the lost dune sand. The project area (**Figure 2.8**) included, in part, R-189.85–R-193.65, extending 3,821 ft northward from Summerhouse's southern property line. Constructed in late 2021, the project placed approximately 26,405 cubic yards (cy) (6.9 cy/ft) of dune fill in this area from upland sand sources according to the County's reported values (Stephen Hammond, St. Johns County Coastal Environment Project Manager, personal communication, March 28, 2023). This sand only partially restored the secondary dune and raised the beach elevation because of funding and permitting constraints (**Figure 2.9**). **Figure 2.10** shows select historical and current beach profiles taken along R-193, the only long-term reference monument along the Summerhouse shoreline. The profiles show the healthy dune and beach system represented by May 2011 conditions, the effects of hurricanes Matthew and Irma, the conditions before (December 2020)

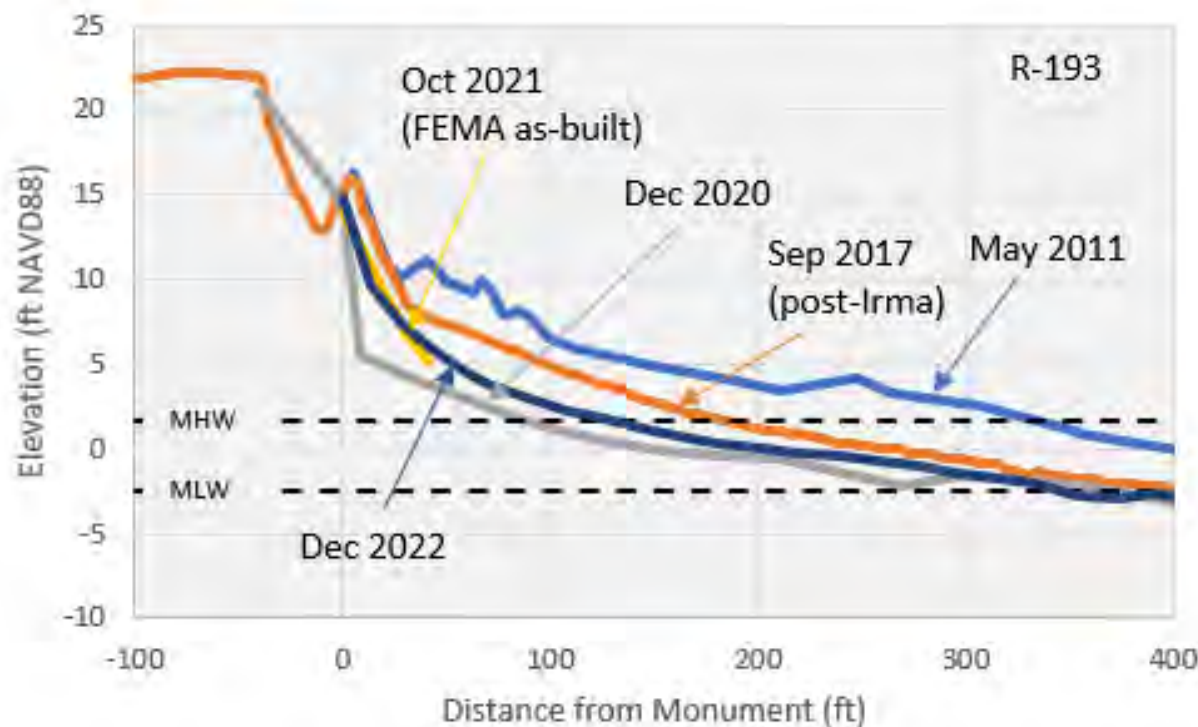
**Figure 2.10** Select Historical and Current Beach Profiles along Reference Monument R-193

and immediately after the FEMA dune project, and December 2022 (current) conditions. The May 2011 profile shows the primary dune near elevation +22 ft NAVD88, the secondary, middle dune near elevation +16 ft NAVD88, and the tertiary dune near elevation +10 ft NAVD88.

Hurricanes Ian and Nicole affected the study area in September (**Figure 2.11**) and November of 2022 (**Figure 2.12**). The storms eroded some of the FEMA dune sand. Interestingly, **Figure 2.10** shows that the beach had recovered some of the lost material and improved conditions over those in December 2020. However, it is still deflated relative to the May 2011 condition and even the post-Irma condition.

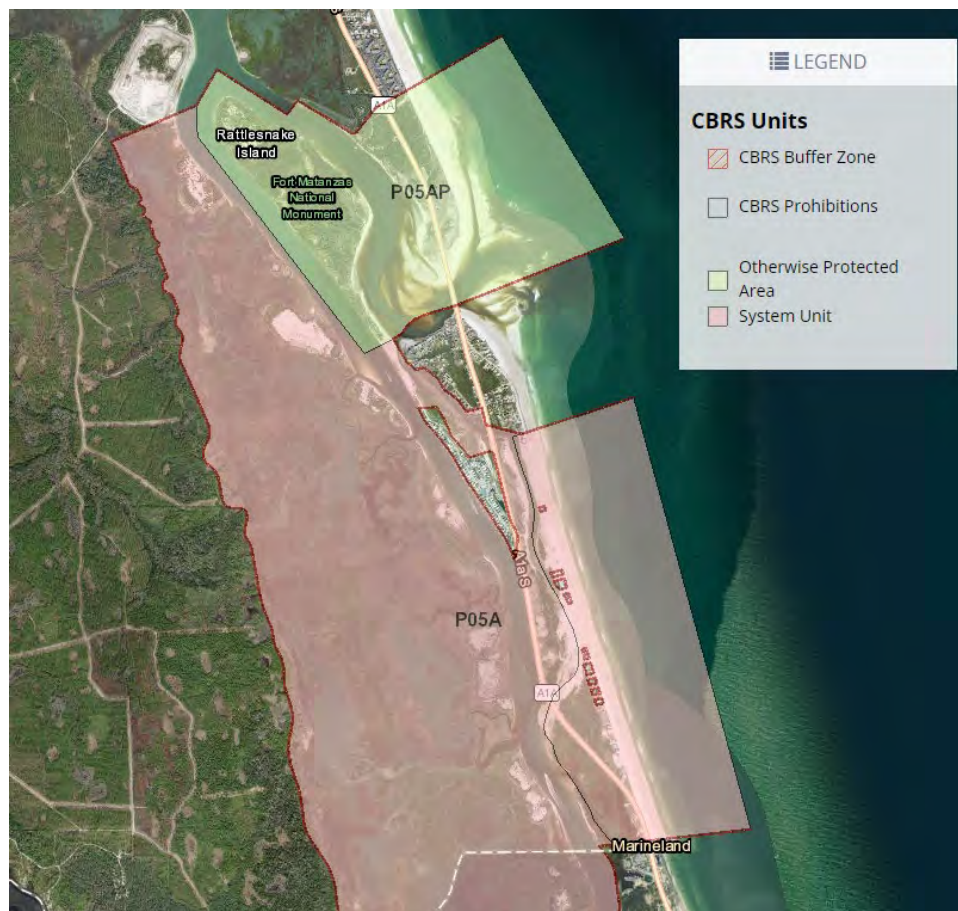
Figure 3.1 Coastal Barrier Resources (<https://fwsprimary.wim.usgs.gov/CBRSMapper-v2/>)

Summerhouse lies along the northern boundary of OPA P05AP (Fort Matanzas National Monument) as shown in **Figure 3.1**. The CBRA does not appear to prohibit federal funding of any projects at or north of Summerhouse that USACE may consider eligible for federal authorization.

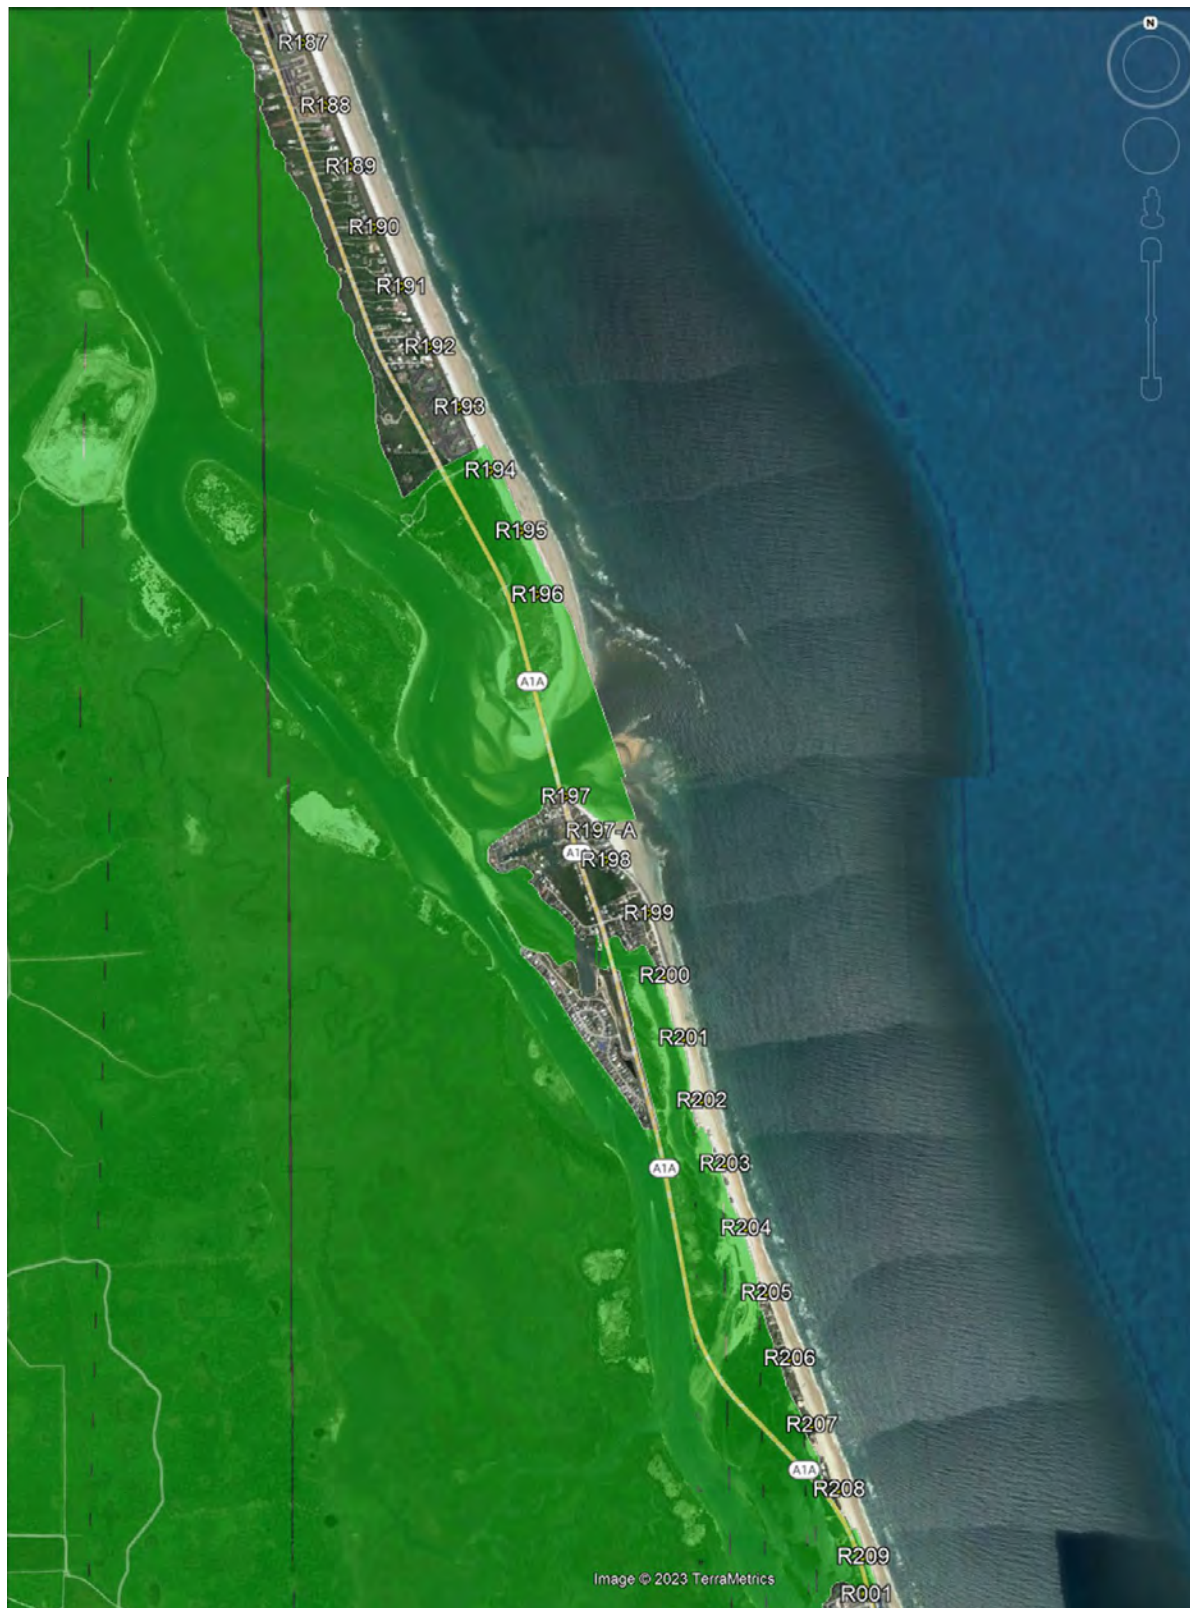
Figure 3.2 GTMNERR Boundaries near the Study Area

The Guana Tolomato Matanzas National Estuarine Research Reserve (GTMNERR), a collaboration between the FDEP and NOAA for the purposes of research, education, and stewardship), covers Matanzas Inlet and adjacent waterways (**Figure 3.2**; green shading). Note that the boundaries include some of the dune north of the inlet at the Ft. Matanzas National Monument Park and falls landward of the line of construction on the south side of the inlet. Summerhouse lies along the edge and outside of the GTMNERR at Ft. Matanzas National Monument Park.

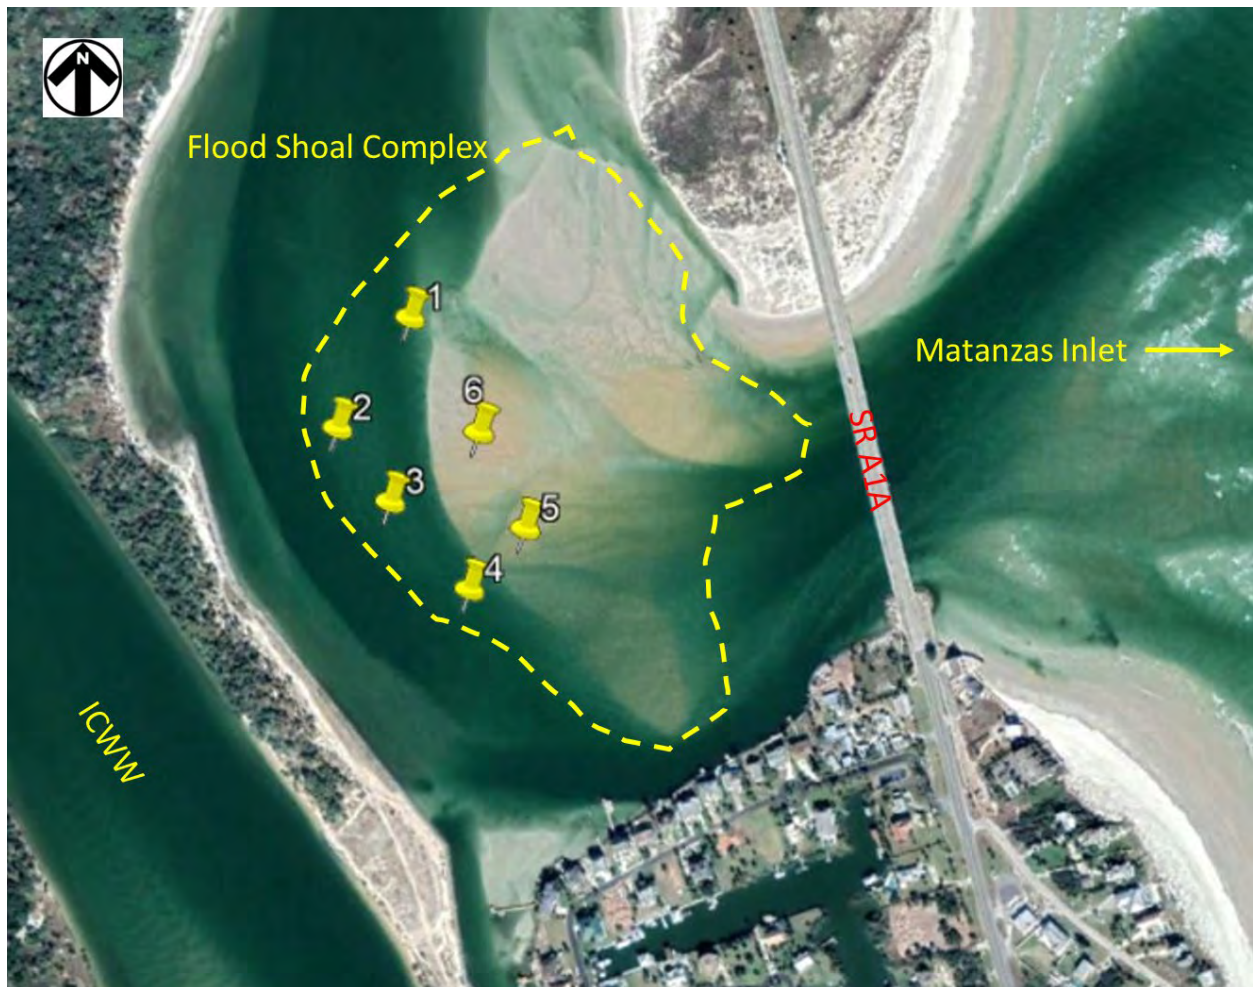
Figure 3.5 Matanzas Inlet Flood Shoal Complex and Location of Sediment Grab Samples

**Figure 3.5** shows the location of the flood shoal complex. No known dredging of the inlet’s flood shoal complex has occurred. INTERA-GEC collected six grab samples from 0-1 ft below top of ground at different areas of the shoal to characterize the material. The median grain sizes of the samples vary from 0.19 to 1.36 mm (composite mean of 0.60 mm) depending on shell content, which varies from 0 to 20%. Of note, the Florida Department of State Bureau of Historic Preservation has confirmed the presence of cultural resources nearby but not within the flood shoal complex; however, future findings of any significant cultural resources within the shoal (e.g., shipwrecks) may affect use of the shoal as a borrow source.

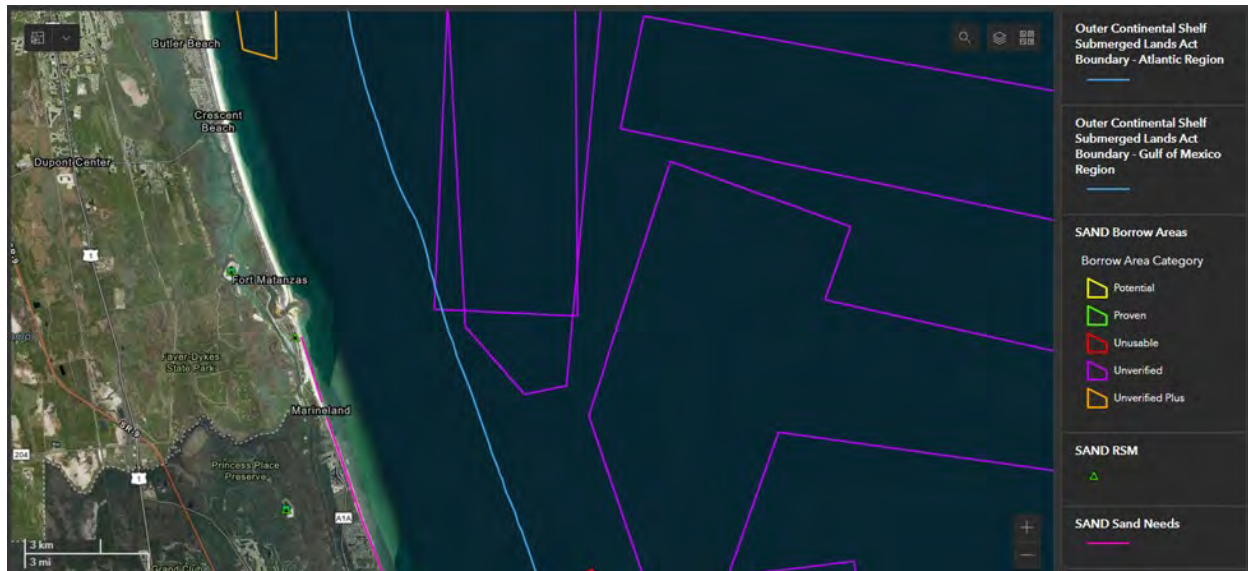
Figure 3.7 Classification of Sand Sources Offshore Summerhouse  
(<https://sacs.maps.arcgis.com/apps/dashboards/46d59434896a464a89d1f3b54d43d0d5>)

**Figure 3.7**, which zooms into the Matanzas Inlet vicinity, shows only unverified sources closer to the study area.

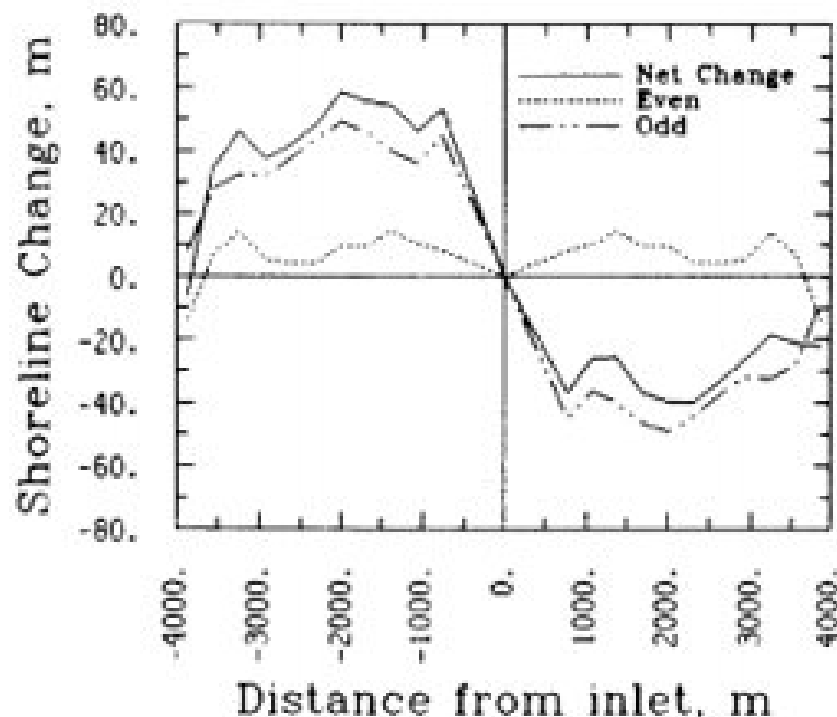
Figure 4.6 1923-1986 Even-Odd Analysis (Work and Dean, 1990)

**Figure 4.6** presents an even-odd analysis published by Work and Dean (1990) for Matanzas Inlet for the period 1923-1986. They decomposed measured shoreline changes into even and odd components. Interruption of longshore sediment transport by the inlet contributes to the odd component whereas storms and sea level rise tend to affect both shorelines adjacent to an inlet similarly, contributing to the even component of shoreline change. Other wave effects, such as refraction and diffraction, could vary across both shorelines. As such, these effects could manifest as both even and odd components. Work and Dean note that for their analysis period, the even component of the shoreline change shows mild accretion on both sides of the inlet. The odd and net shoreline changes show that the inlet helps impound sand north of the inlet to the detriment of the shorelines south of the inlet. Their analysis demonstrates that the inlet's area of influence extends more than two miles north of the inlet.

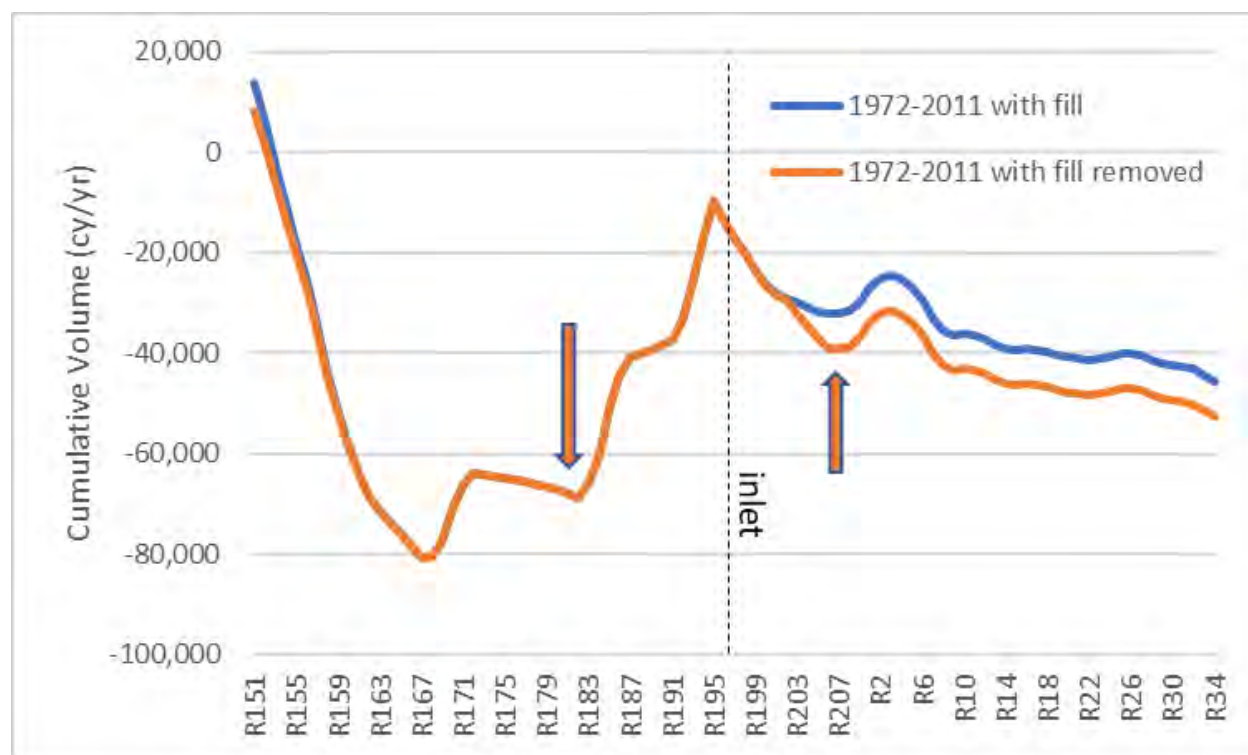
**Figure 4.7** 1972-2011 Cumulative Beach Volume Changes

Following the first method, this study identified the alongshore location where a change in slope of the cumulative beach volume change exists. This study selected the period 1972-2011 as it begins the period of reliable beach survey data and excludes the significant storm activity since 2016. Computation of cumulative beach profile change computed north and south of the inlet allowed for discerning a change in slope (neglecting transects nearest the inlet). **Figure 4.7** shows the cumulative beach volume changes for 1972-2011. The changes in slope occur near R-184 and R-208.

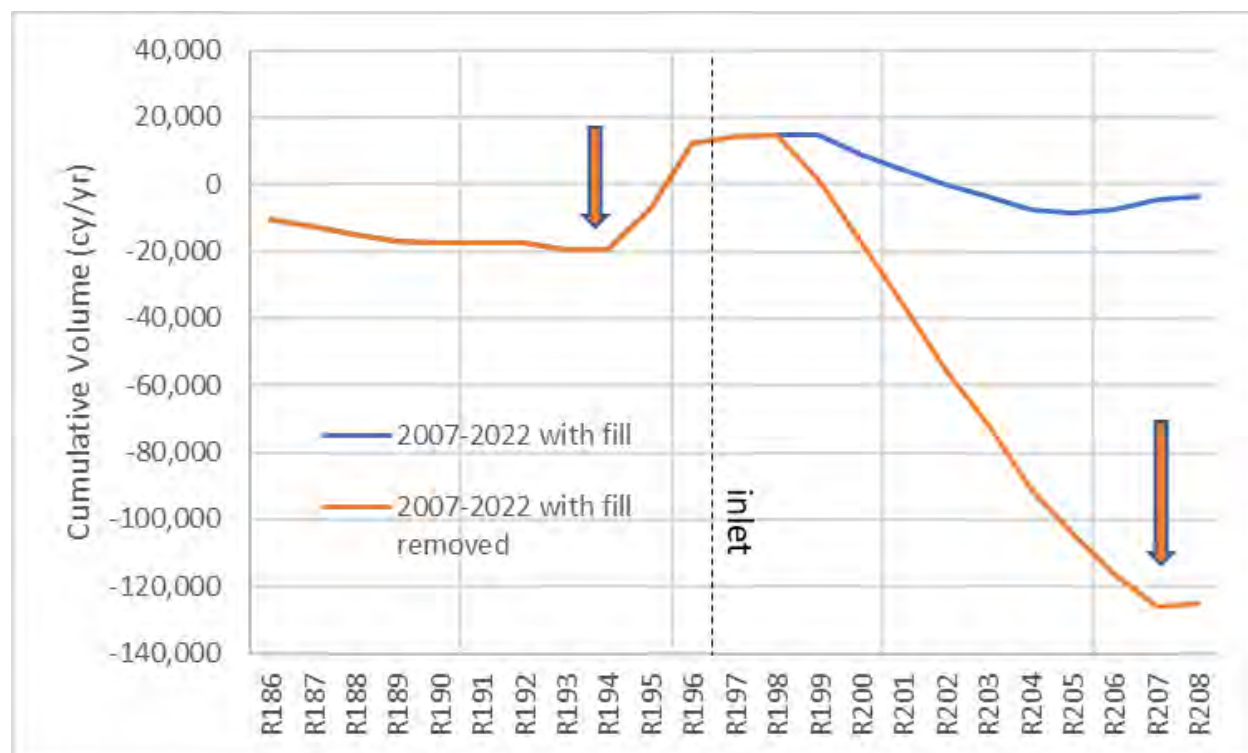
**Figure 4.8** 2007-2022 Cumulative Beach Volume Changes

Following a similar methodology, an examination of the more recent 2007-2022 period discussed in the previous section shows a smaller northern area of inlet influence (**Figure 4.8**). The changes in slope occur near R-194 and R-207 — suggesting that the inlet influences beaches near Summerhouse. Beach fill volumes removed from each profile originated from those presented in INTERA-GEC (2023). Excluding beach fill placements, the data suggest that cumulatively nearly -20,000 cy/yr is lost north of inlet and over -126,000 cy/yr south of the inlet because of the inlet during this period. In total, these values imply that the total sink effect of the inlet is approximately -146,000 cy/yr.

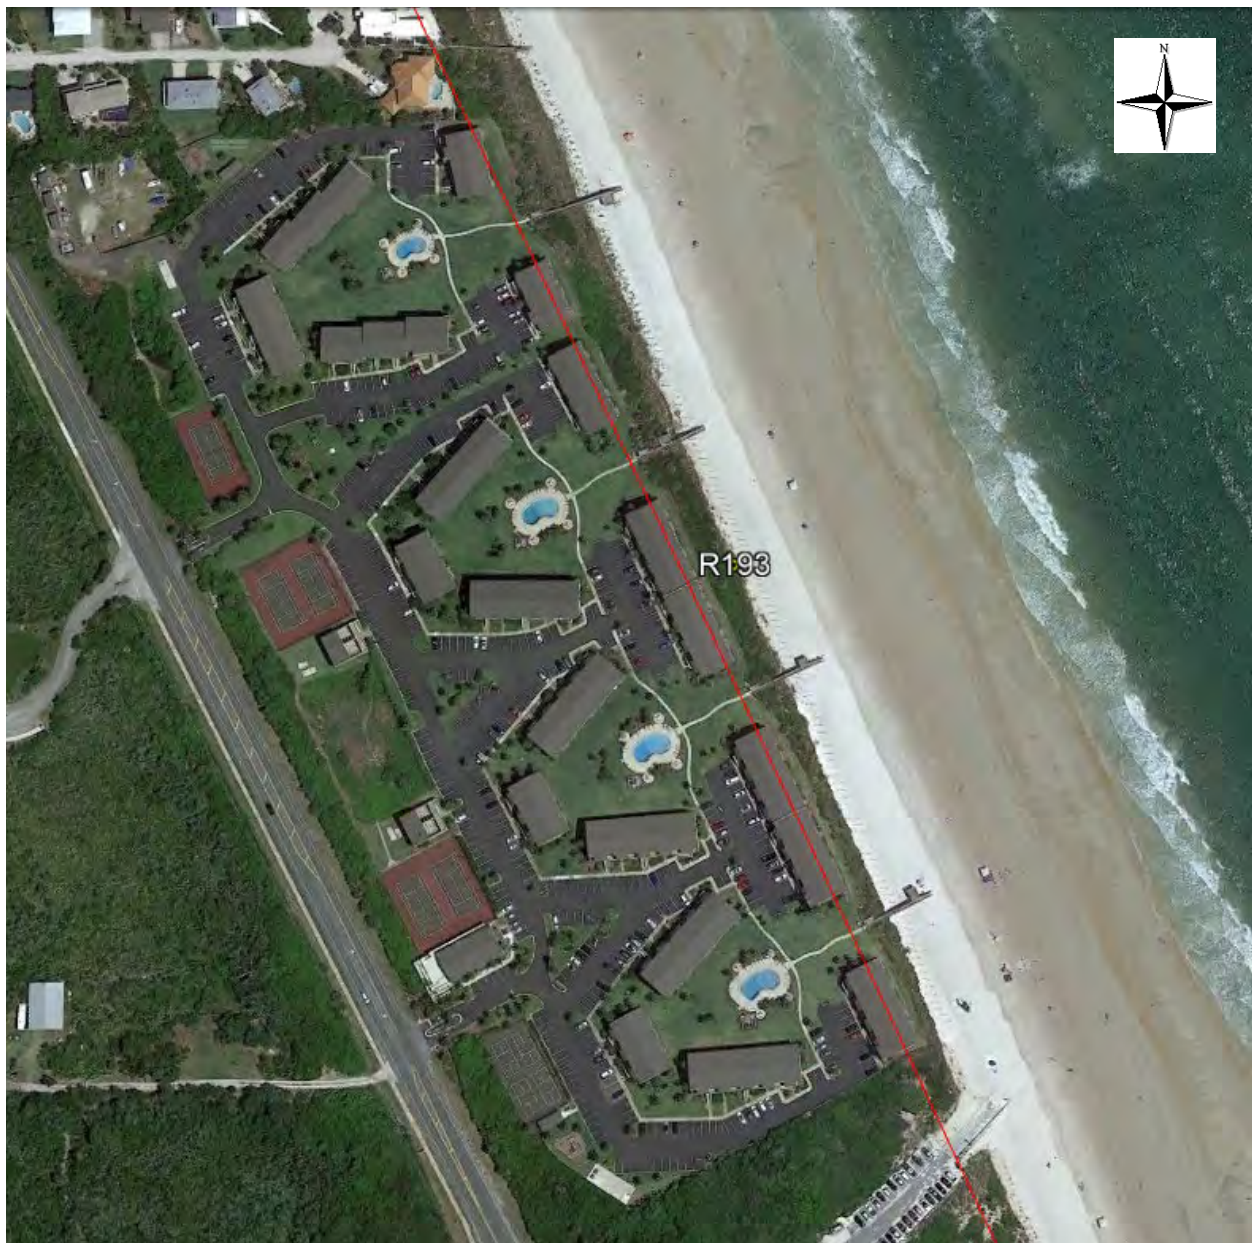
Figure 5.1 Location of the Coastal Construction Control Line

One condition includes when seawalls (or other coastal armoring) locate seaward of the state's Coastal Construction Control Line (CCCL). The CCCL lies within the footprints of Summerhouse's oceanfront buildings (**Figure 5.1**; red line). Regulatory approval for a seawall seaward of the CCCL at Summerhouse would fall under the jurisdiction of the FDEP Beaches, Inlets and Ports Program as a CCCL permit. Obtaining authorization for such a wall pivots on demonstrating that the buildings are statutorily vulnerable.

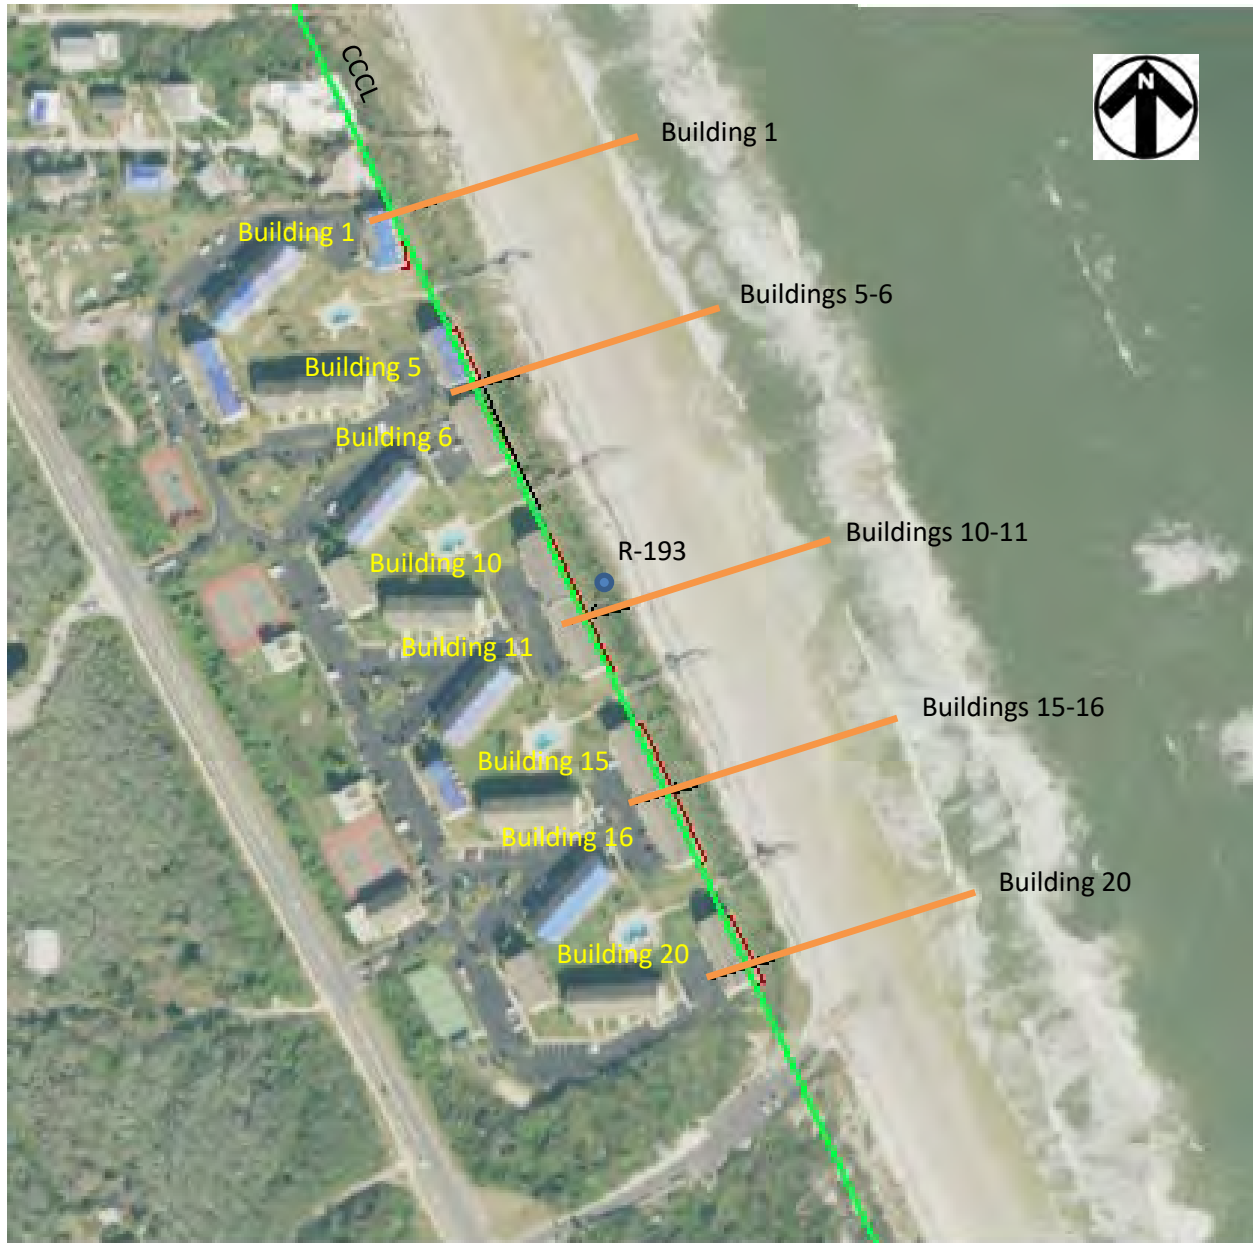
Figure 5.2 Pre-Storm Input Profile Locations

**Figure 5.2** shows the locations of the input pre-storm profiles, which originated from the December 2022 survey collected by Arc Surveying. Three of the five profiles represent the conditions at two buildings given their proximity. **Figures 5.3-5.7** show the predicted erosion from a 15-yr storm at the five locations. Because the storm-induced erosion falls landward of the existing dune escarpment and seaward of the buildings, the figures also show 1V:2H and 1V:3H slopes to approximate stable slopes from the dune toes of the 15-yr storm eroded profile. This exercise indicates that building 20 may become vulnerable as the 1V:3H slope extends into the footprint of the building. As such, this study proposes a conceptual design for a seawall to protect only building 20.

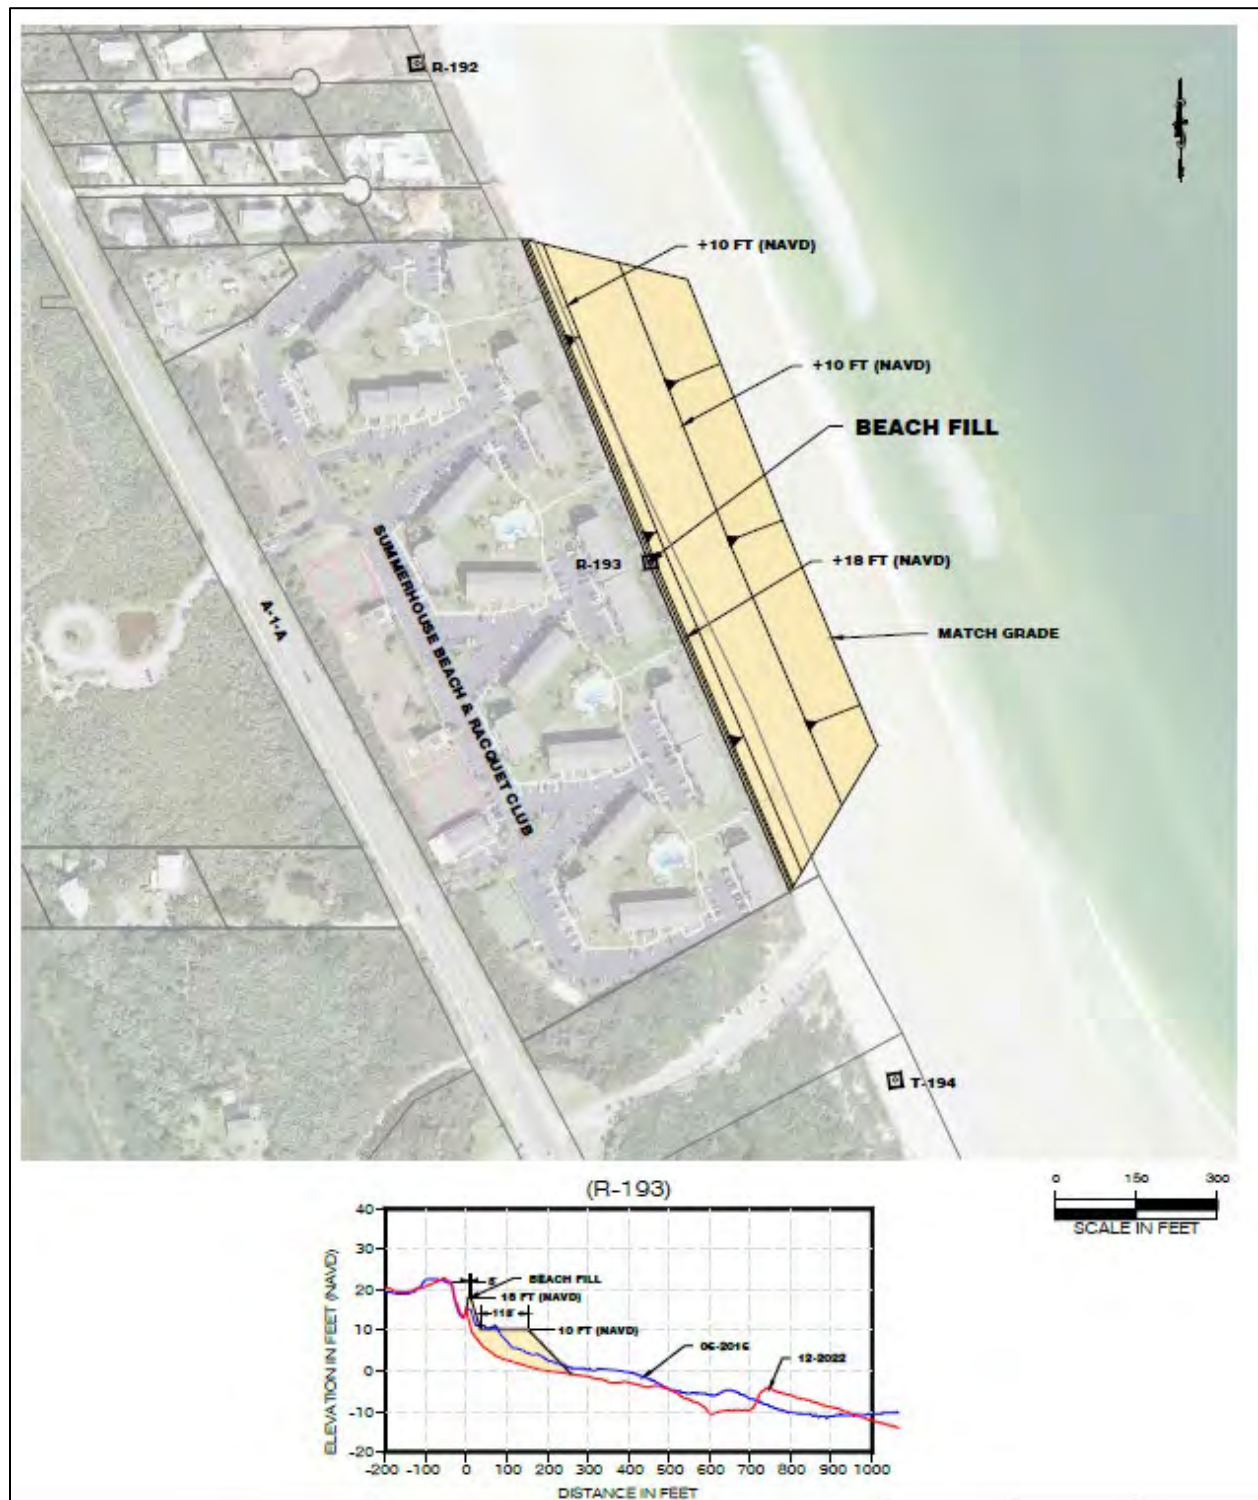
Figure 5.9 Concept Sketch - Beach and Dune Nourishment

**Figure 5.9** shows a conceptual cross section and plan view for a beach and dune nourishment project along the 1,400-ft-long Summerhouse beachfront. This alternative consists of restoring a portion of the secondary dune and completely restoring the seaward tertiary dune that eroded during Hurricane Matthew. The secondary dune crest reaches an elevation of +18 ft NAVD88 and the tertiary dune crest reaches +10 ft NAVD88 to match the peak historical dune conditions. The beach consists of a 118-ft wide beach crest at elevation +10 ft NAVD88 with a 10H:1V seaward slope until intersecting existing grade. Overall, the beach and dune nourishment project has an approximate fill density of 54 cy/ft for a total initial nourishment volume of approximately 87,500 cy including tapers.

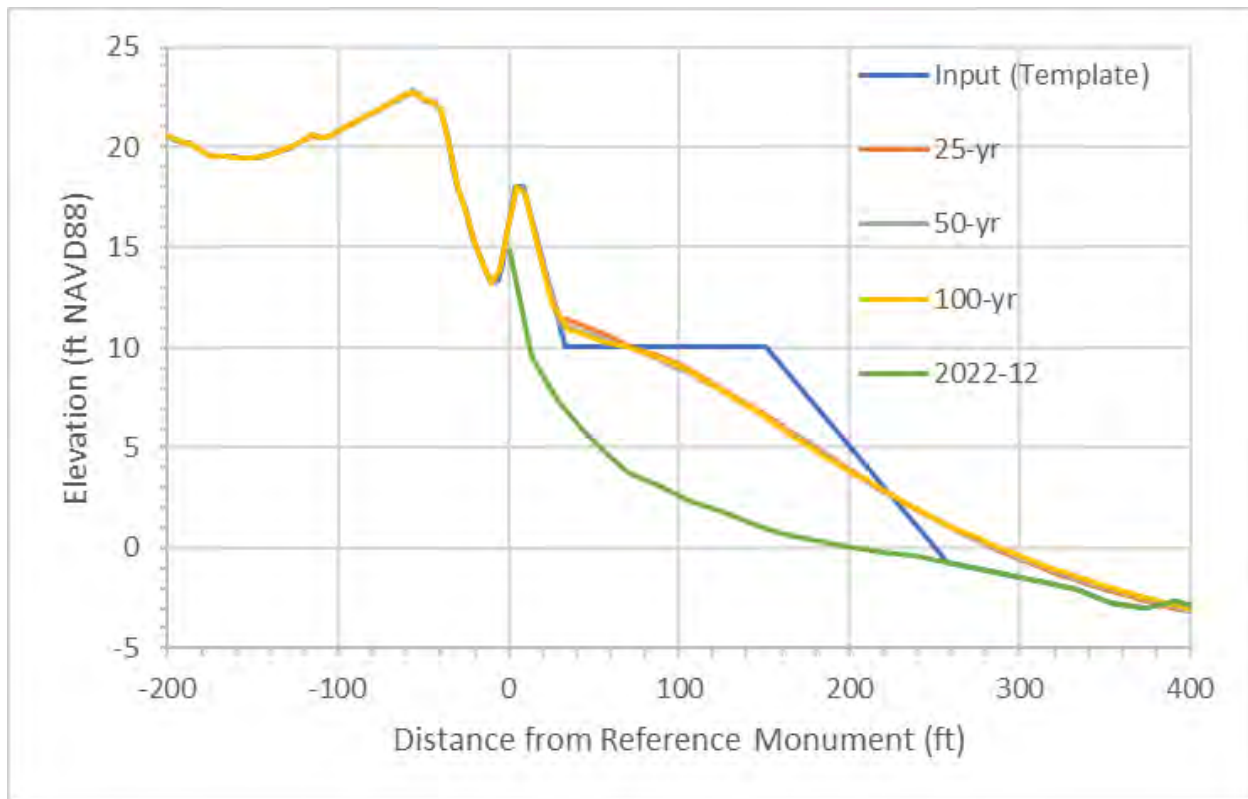
Figure 5.10 SBEACH Simulations for Beach and Dune Nourishment Alternative

An engineering analysis performed with USACE's SBEACH cross-shore erosion model helped assess the adequacy of the beach and dune template to future, synthetic storms. Appendix B presents more details regarding model setup, calibration, and future storm simulations. Briefly, model setup included specifying a pre-storm profile, storm parameters, and sediment transport parameters. This study calibrated the model to Hurricane Matthew (2016) conditions given the availability of pre- and post-storm profiles and storm information.

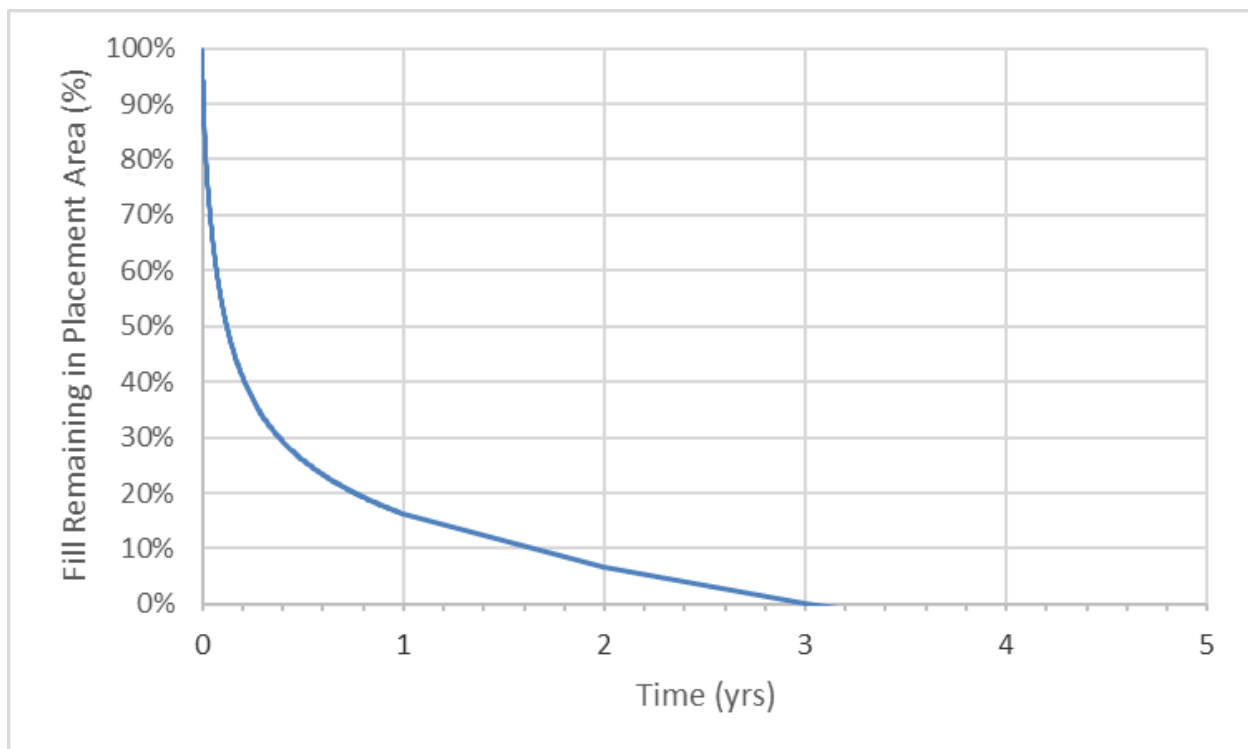
Figure 5.11 Prediction of Sand Remaining over Time

Based on site-specific parameters, including a representative background shoreline erosion rate of -1.5 ft/yr, **Figure 5.11** presents the predicted amount of the beach fill remaining over time for the concept project. The figure shows that no fill remains after approximately three years. This short fill life primarily relates to the very short length of the project.

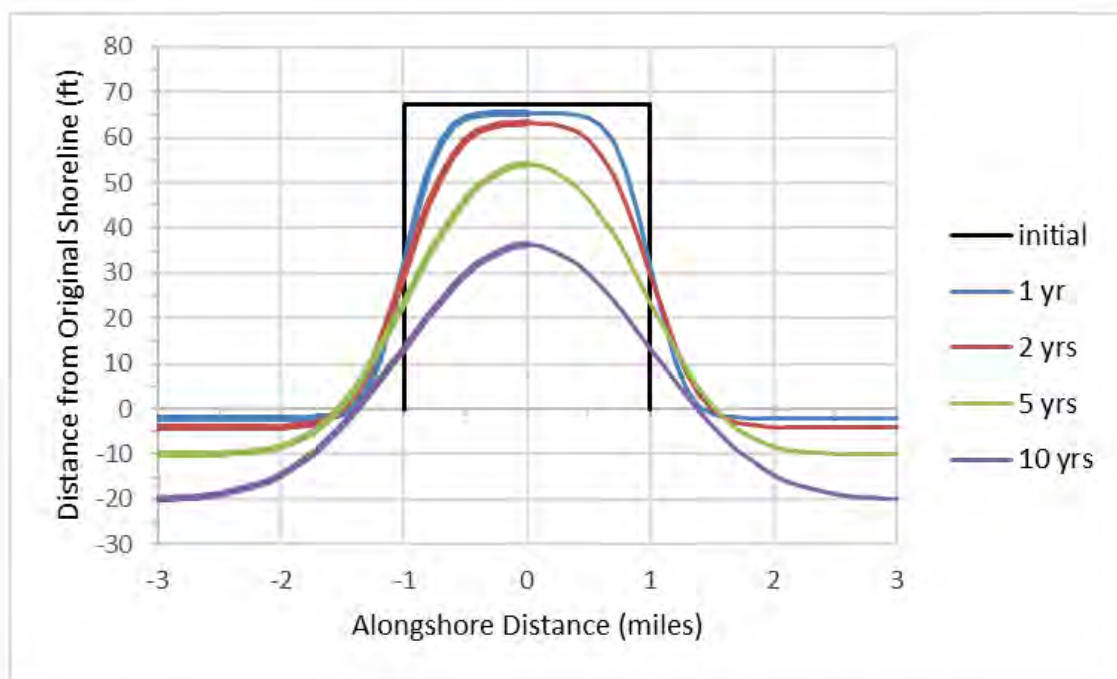
Figure 5.12 Example of Beach Fill Alongshore Dispersion

$L = 2$  miles,  $V = 1.5$  mcy,  $H = 2$  ft,  $T_p = 7$  sec,  $G = 0.09$  ft<sup>2</sup>/s,  $d_c = 30$  ft,  $h^* = 8$  ft,  $D_{50} = 0.35$  mm, Uniform background erosion rate = 2 ft/yr
