FINAL REPORT

# Study of Summerhouse and Surrounding Areas

St. Johns County, Florida

Prepared by: **INTERA - GEC**  
A joint venture of INTERA and G.E.C.

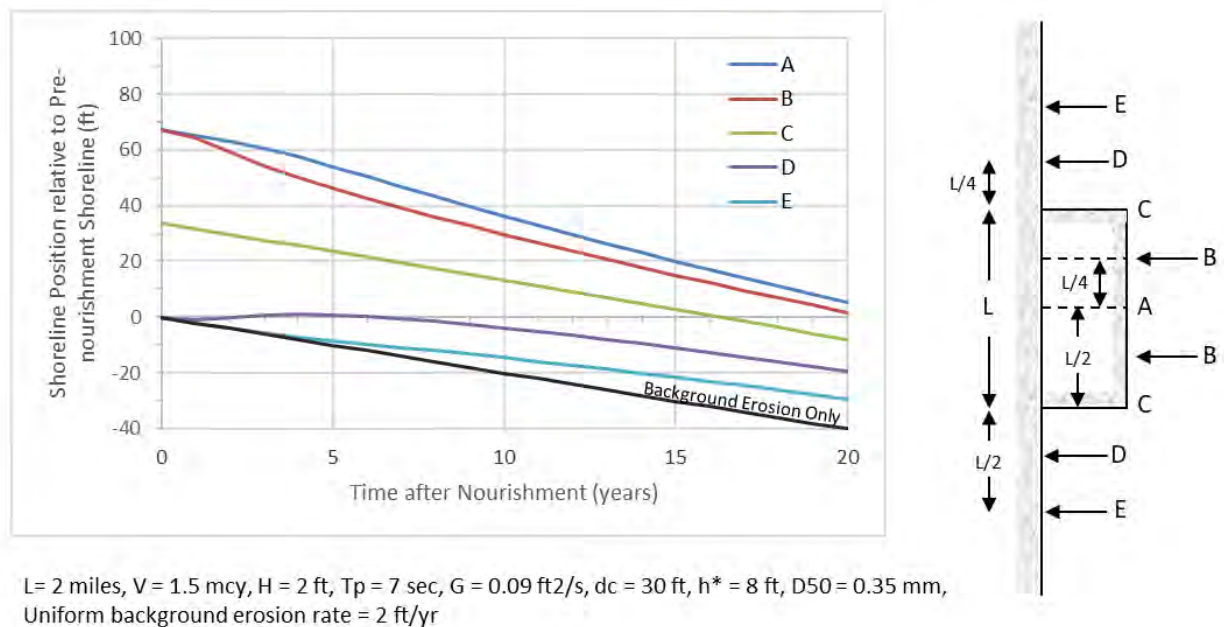
Figure 5.13 Example of Shoreline Advance with Time and Shoreline Location

its original placement area (denoted as “initial”) to the benefit of neighboring shorelines. To see this effect better, **Figure 5.13** shows how the shoreline in the example varies with time and different locations along the shoreline. The example suggests that shorelines within one mile of the initial project fill limits receive some benefit in the form of reducing the background erosion normally present.

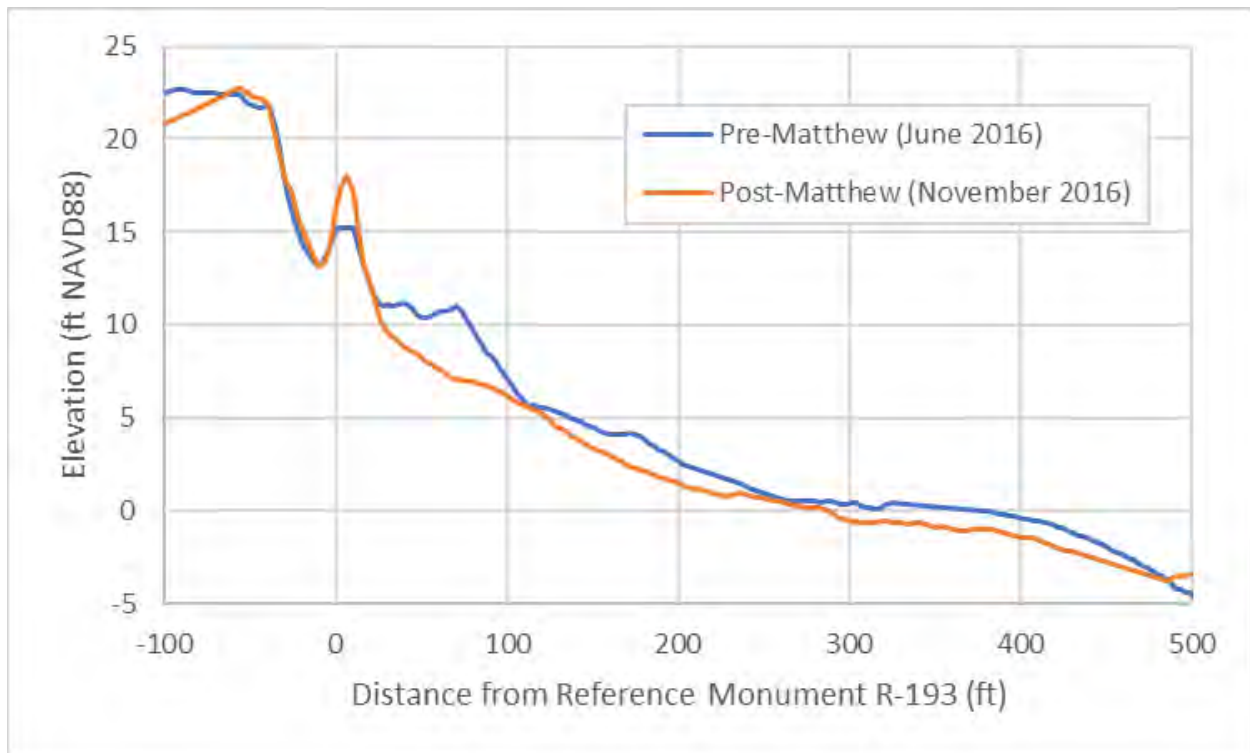
Figure 1 Pre- and Post-Storm Profiles at R-193 for Hurricane Matthew

To calibrate the model, this study assessed pre- and post-Hurricane Matthew (2016) profiles at R-193 near Summerhouse Beach & Racquet Club on the north side of Matanzas Inlet. Hurricane Matthew produced measurable beach profile changes captured by the June and November 2016 beach profiles (Figure 1). The figure shows some placement of sand at the secondary dune near elevation +15 ft NAVD88 that SBEACH excludes. Wave and water level conditions originate from INTERA's SWAN+ADCIRC hindcast of Hurricane Matthew completed for multiple Florida clients. Figure 2 shows the wave heights and periods offshore the study area and the water levels during Hurricane Matthew.

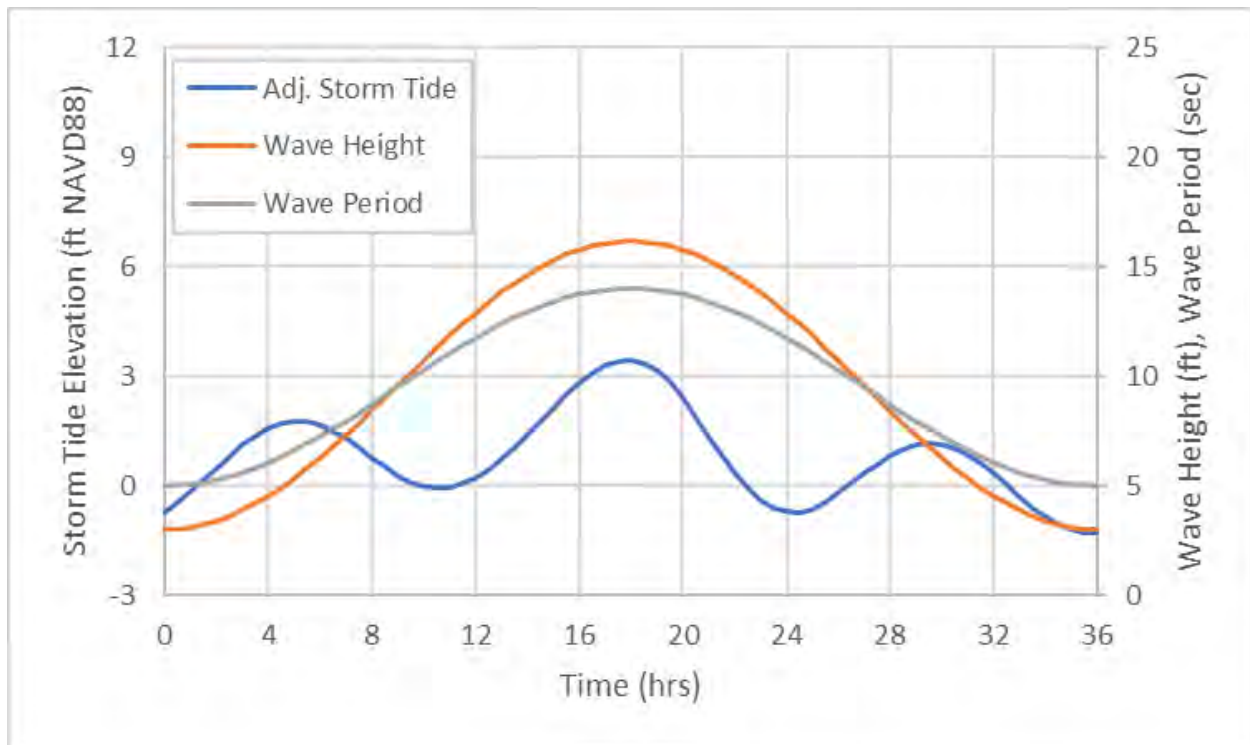
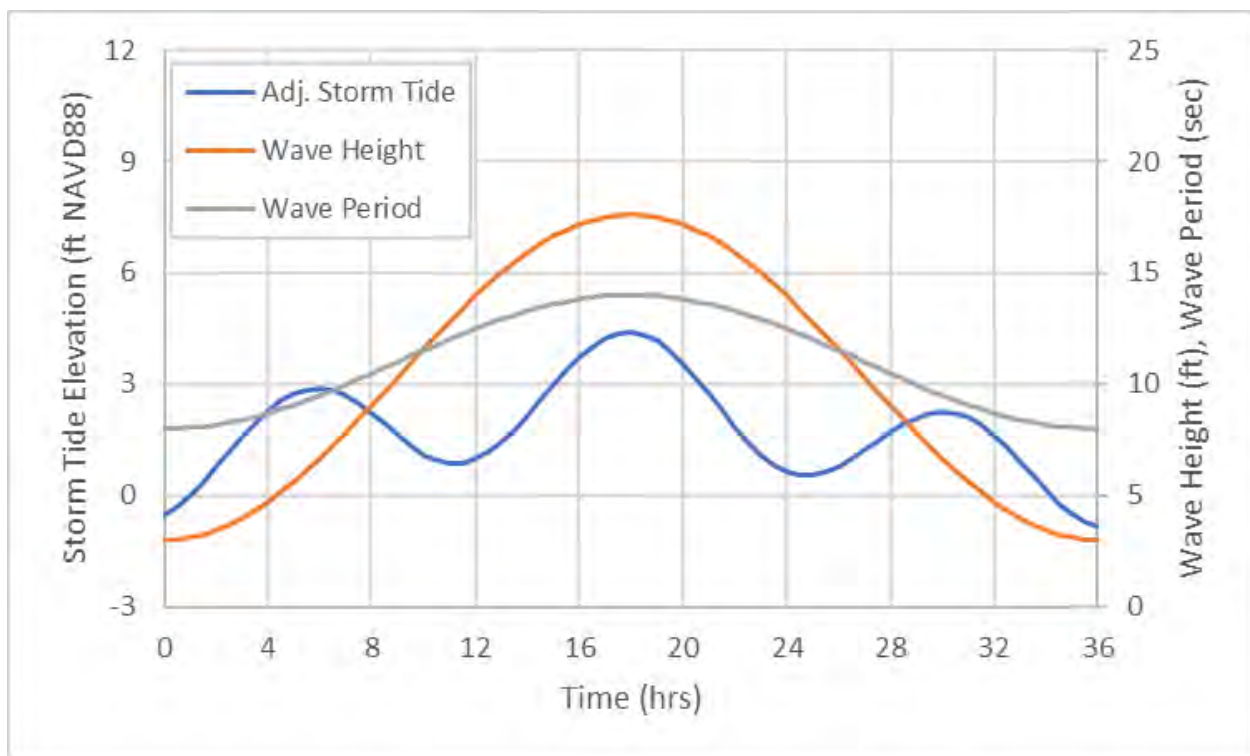
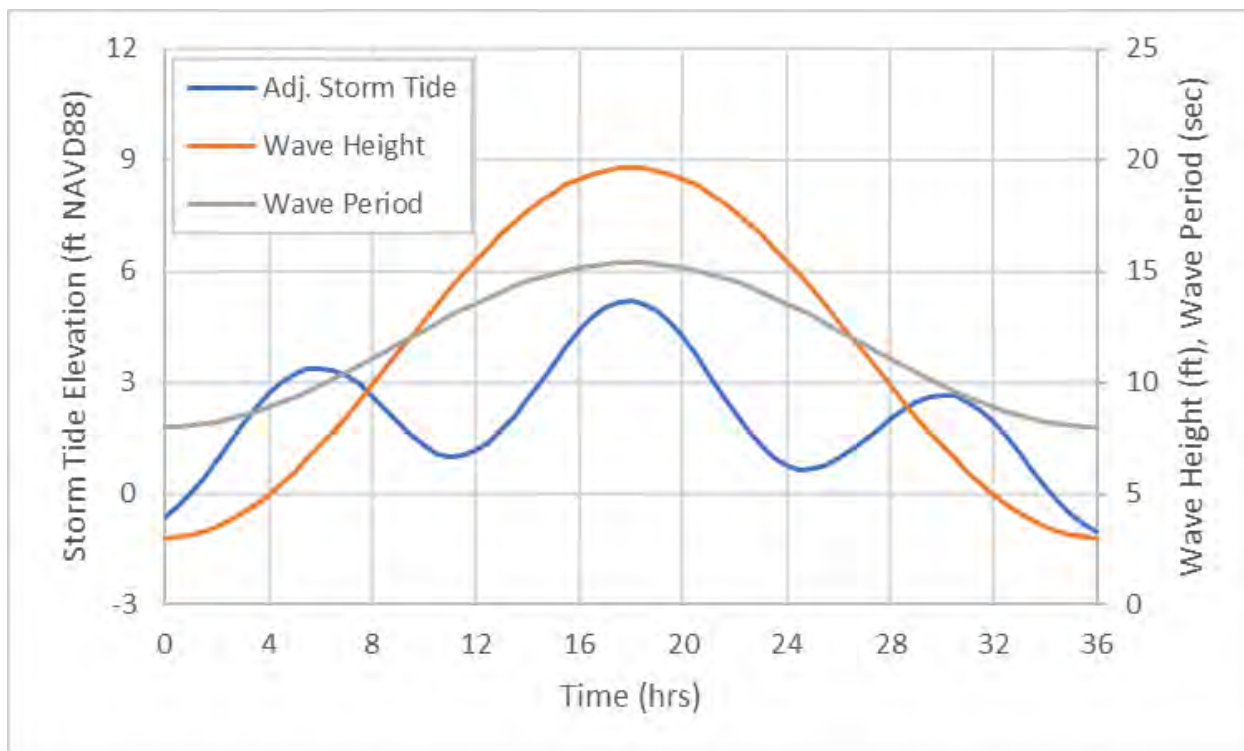
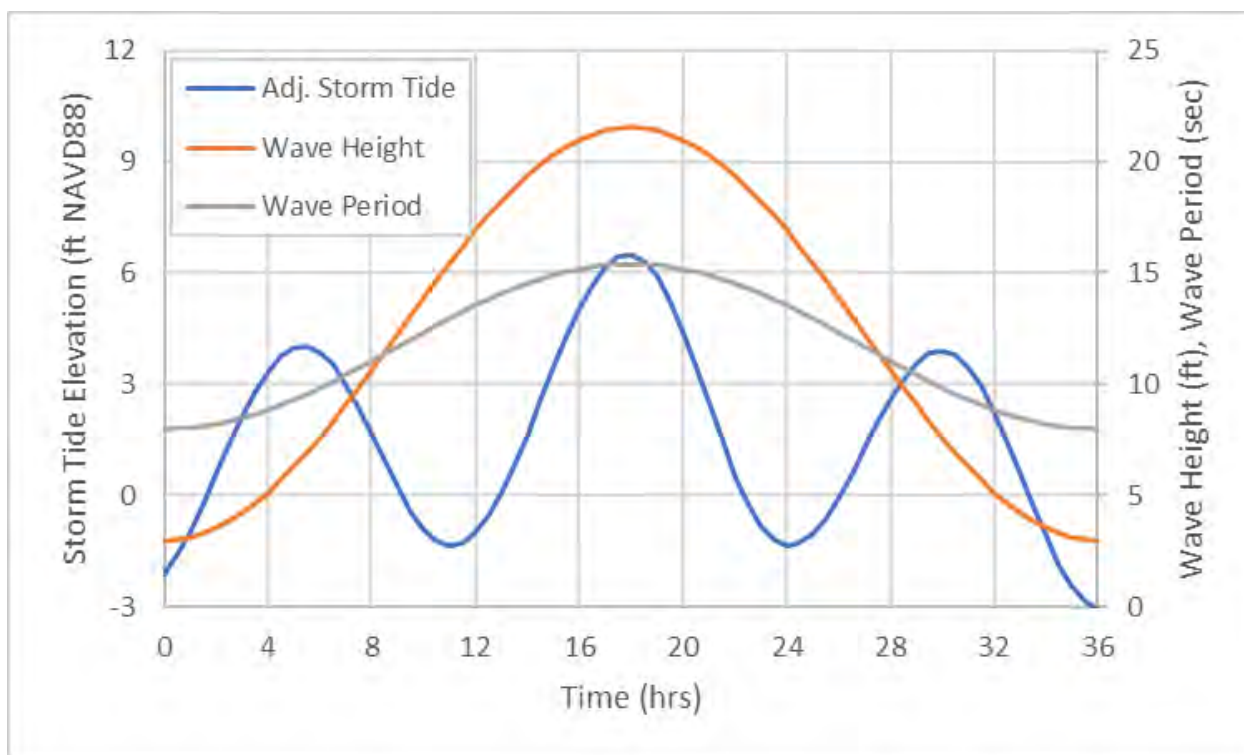
Figures 5-8 show the 15-, 25-, 50-, and 100-yr adjusted storm tide, wave height, and wave period hydrographs applied in SBEACH. The SBEACH model did not apply wave height randomization. This study applied a one-minute time step and variable grid spacing from 5 to 20 ft.

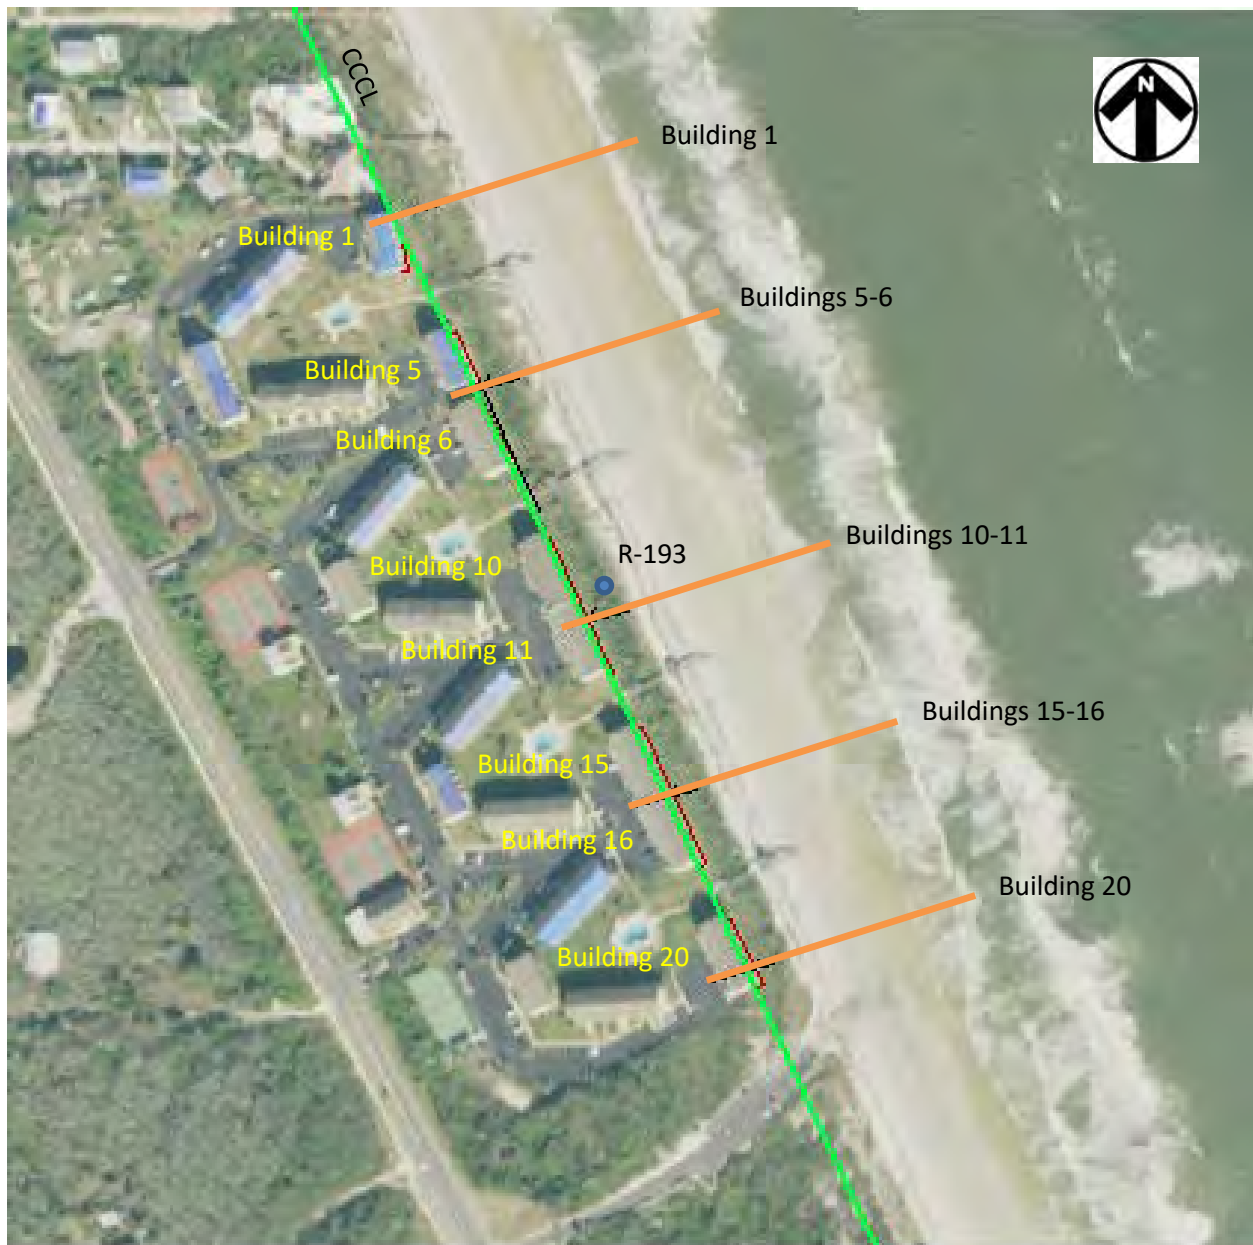
Figure 9 Pre-Storm Input Profiles (Based on December 2022 Survey)

To determine the lateral extents of any seawall, this study followed FDEP's rules for determining eligible structure vulnerability. These rules specifically include inputting certain SBEACH parameters (Table 2, fourth column), storm tide hydrograph, and constant wave height (10 ft) and period (10 seconds) for a 15-yr event. The storm tide hydrograph originated from FDEP (2009) with an adjustment of the peak elevation to account for the fact SBEACH and the unadjusted hydrograph both account for wave setup. Figure 9 shows the locations of the input pre-storm profiles. Figure 10 shows the adjusted hydrograph.

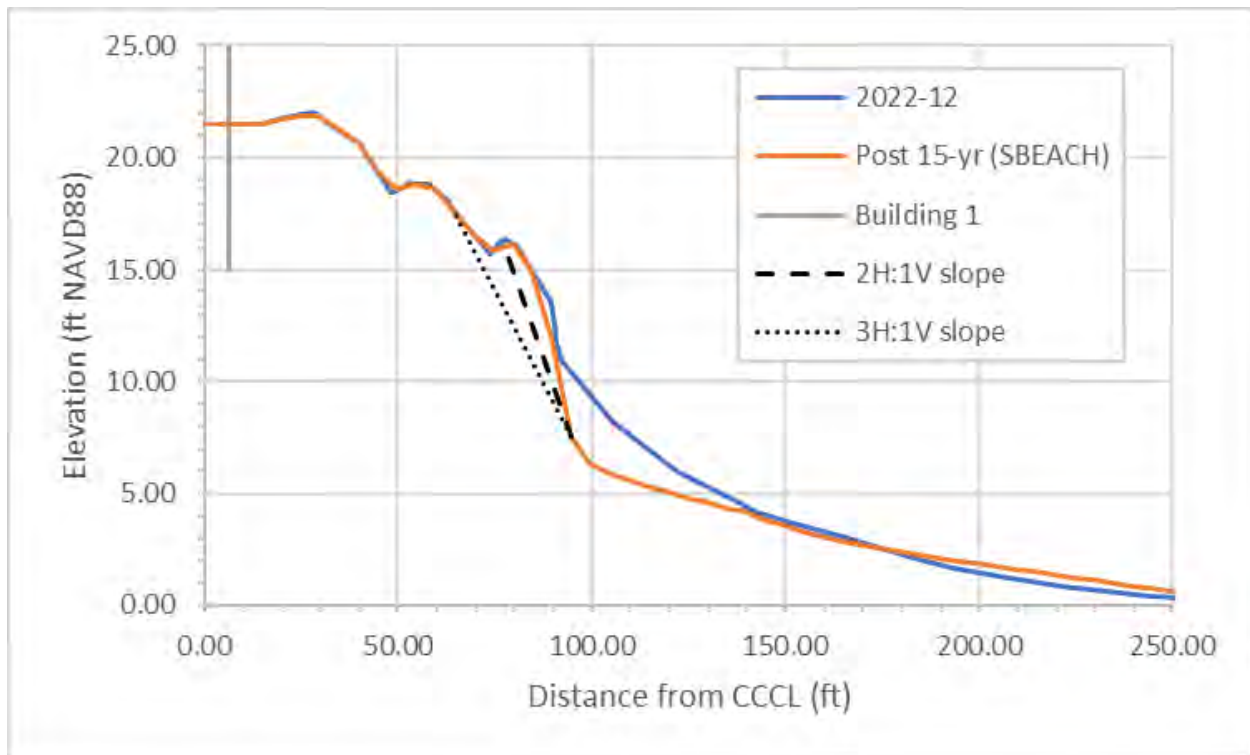
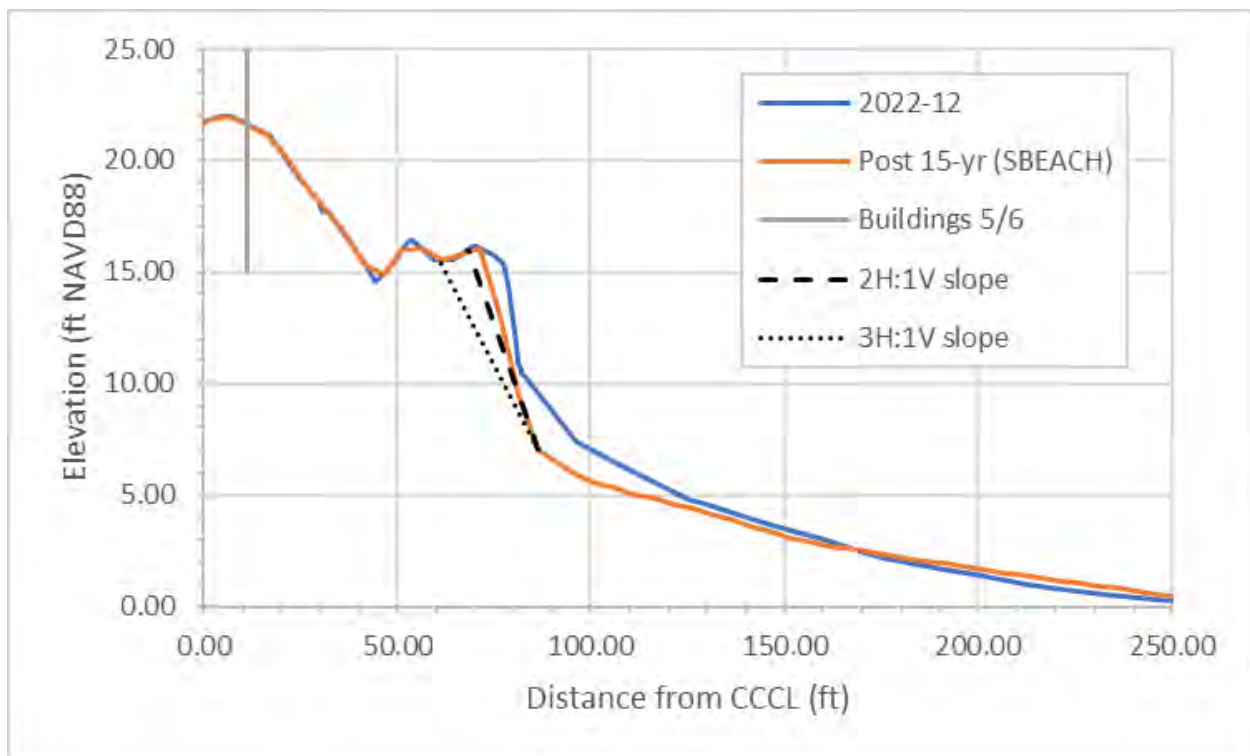
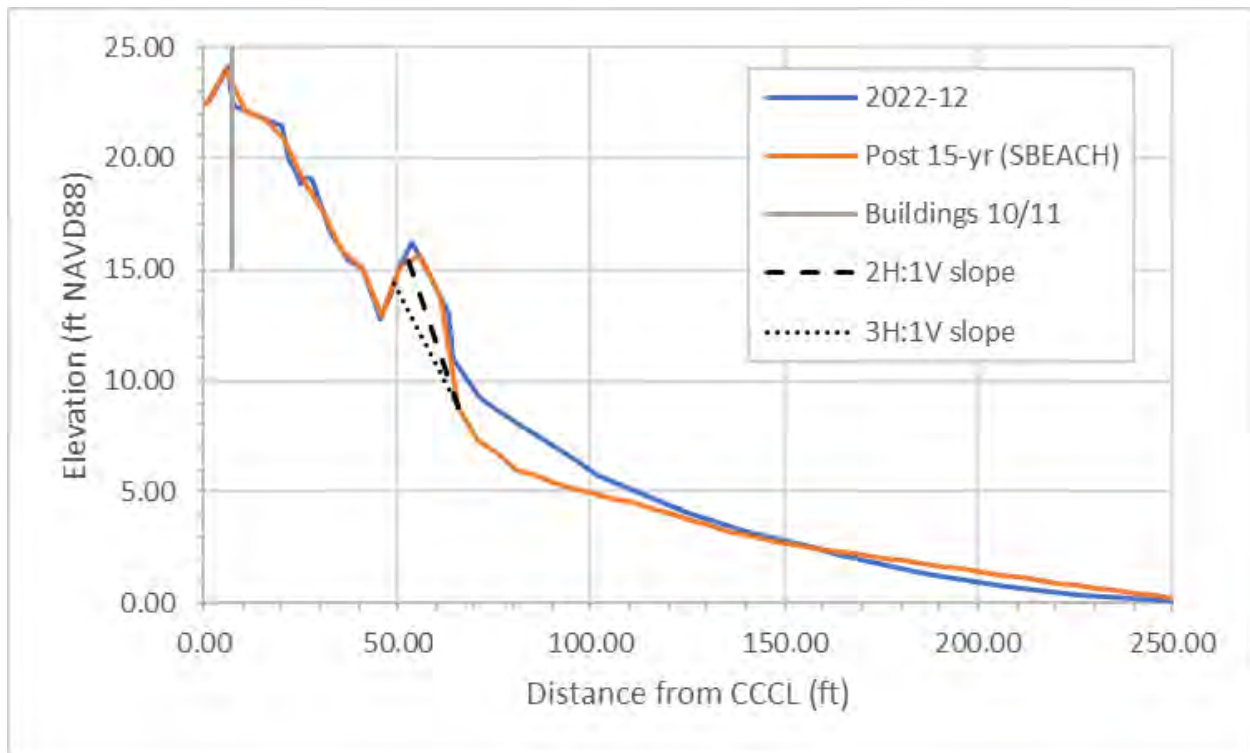
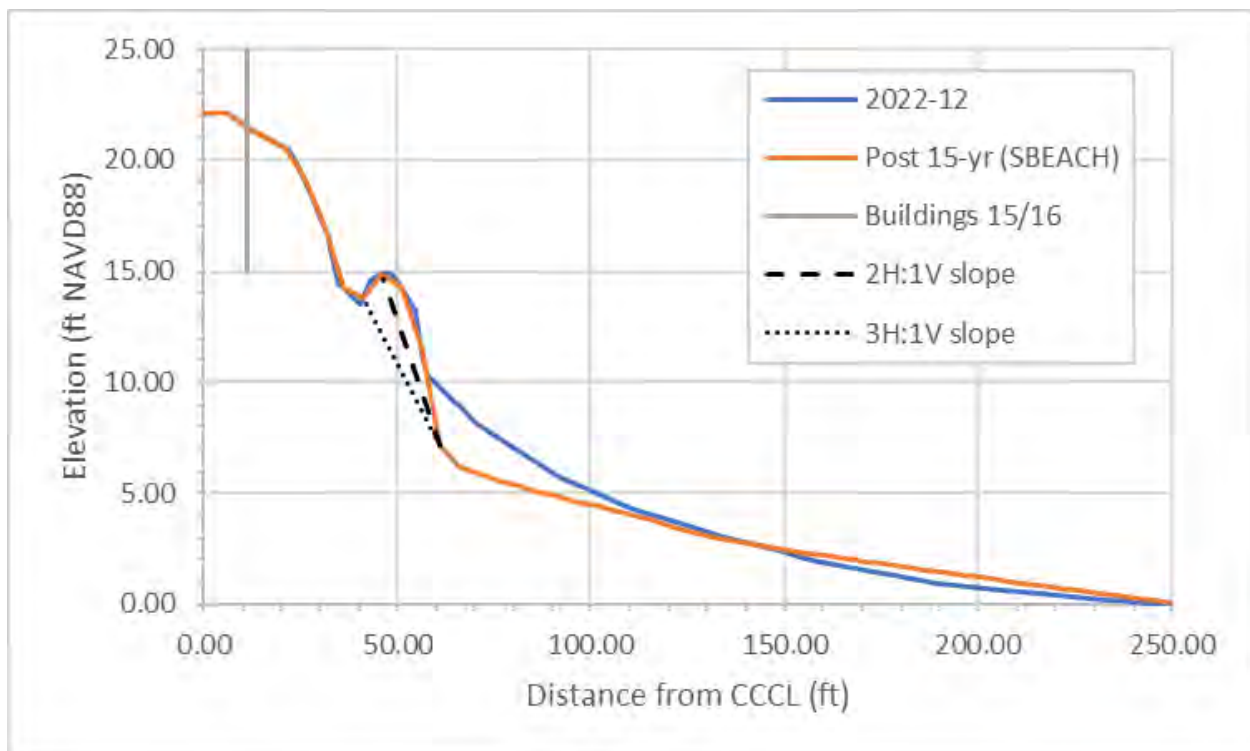
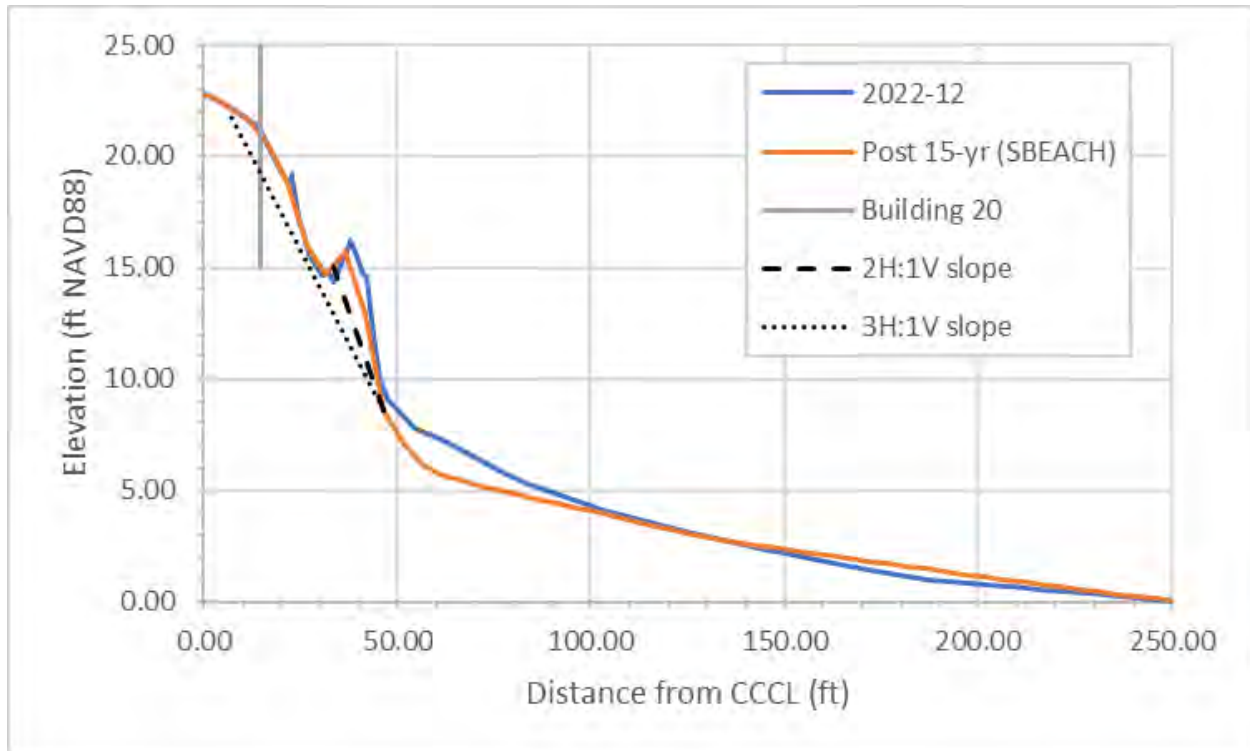
Figures 11-15 show the post-storm profiles relative to the seaward edge of the buildings. Because the storm-induced erosion falls landward of the existing dune escarpment and seaward of the buildings, the figures also show 2H:1V and 3H:1V slopes to approximate stable slopes from the dune toes of the 15-yr storm eroded profile. They indicate that only building 20 may need a seawall.

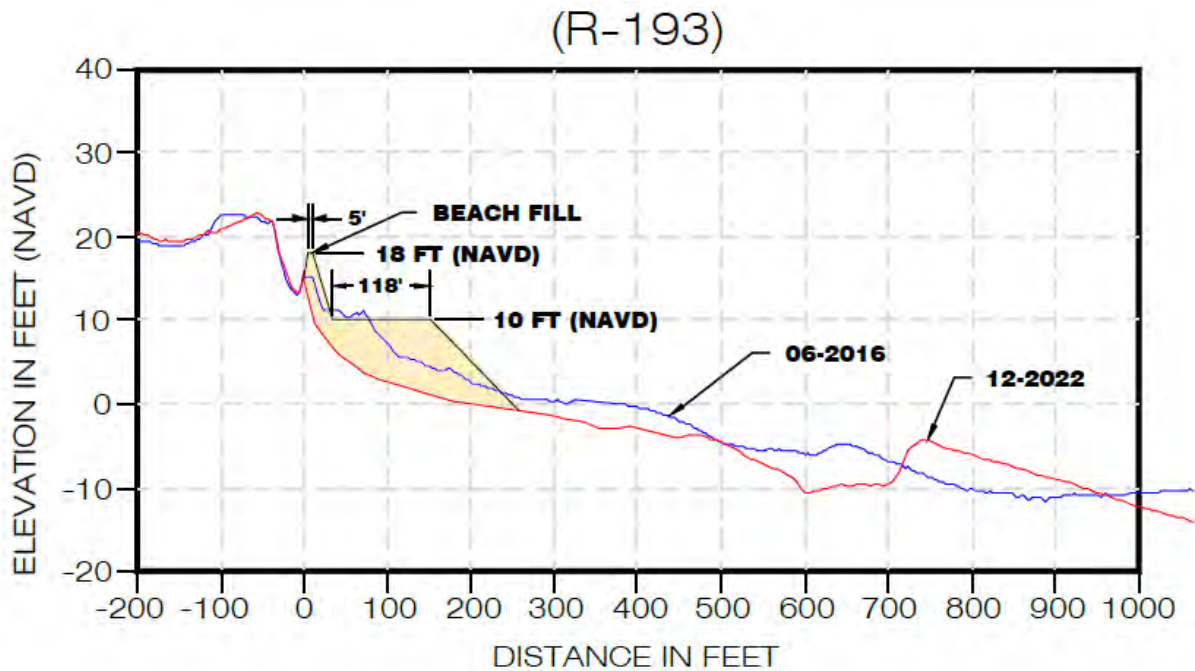
Figure 16 Dune and Beach Nourishment Concept

This alternative consists of restoring a portion of the secondary dune and completely restoring the seaward tertiary dune that were eroded during Hurricane Matthew. The secondary dune crest reaches an elevation of +18 ft NAVD88 and the tertiary dune crest reaches +10 ft NAVD88 to match the peak historical dune conditions. The beach consists of a 118-ft wide beach crest at elevation +10 ft NAVD88 with a 10H:1V seaward slope until matching existing grade (Figure 16). This study investigated use of median sand size of 0.23 mm that matches the native beach.

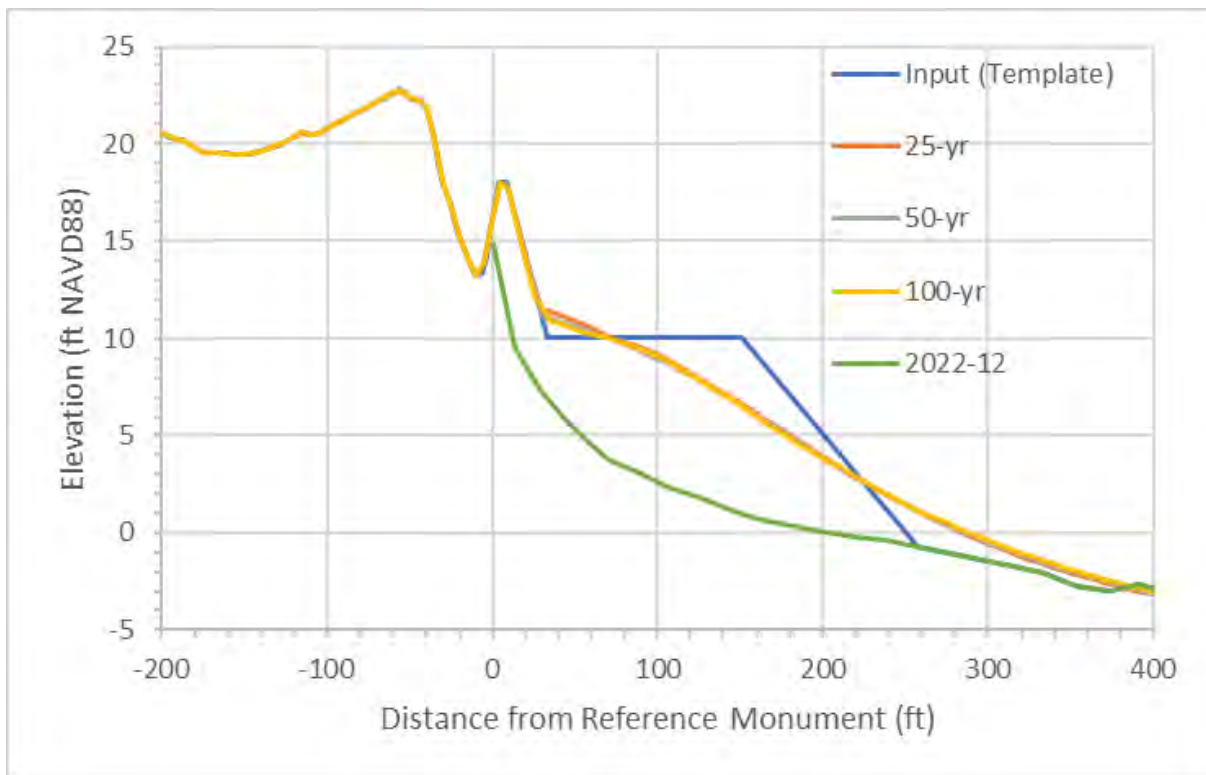
Figure 17 SBEACH Results – Dune and Beach Nourishment

Figure 17 shows the erosion resulting from 25-, 50-, and 100-yr events for the dune and beach concept at R-193. Erosion caused from the 25- and 50-yr events confines itself to the historical tertiary dune. The 100-yr event's erosion minimally extends into the secondary dune.

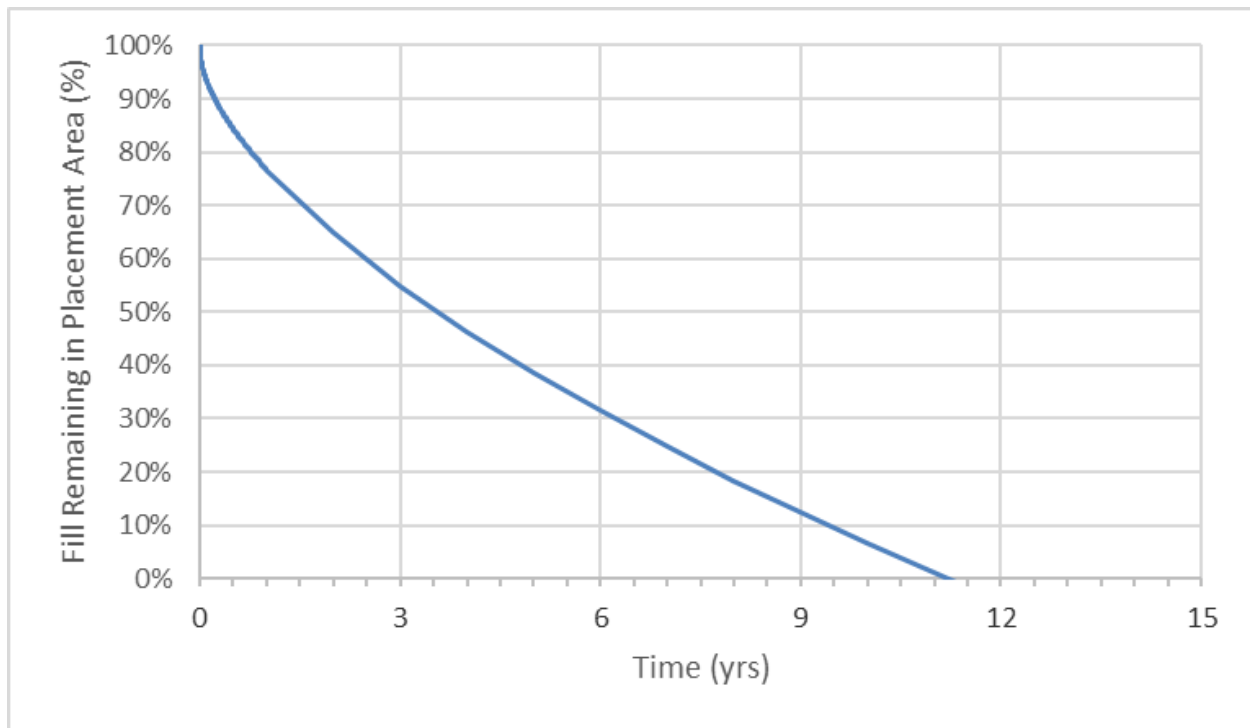
Figure 2 Prediction of Sand Remaining for Two-mile-long Project

Note that a longer project significantly improves project longevity as shown in Figure 2 for a project with the same fill density (54 cy/ft) and a length of eight times the original project length (approximately two-mile-long project).
