St. Johns County State Route A1A

Historic Resources Survey Report St. Johns County, Florida

GAI Project Number: R210889.00

July 2022

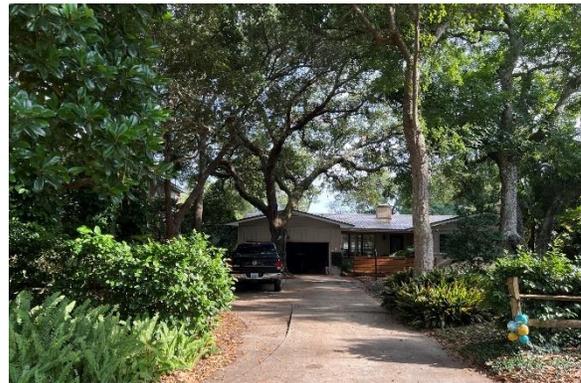
Photograph 18. SJ03765, 38 Ponte Vedra Circle.

The resource is a partially obscured, one-story, 1955 frame vernacular dwelling (Photograph 18). The foundation material is not visible from the public right of way. The dwelling is clad in board and batten siding, and capped by a side-gable roof covered in standing-seam metal. An interior, brick chimney interrupts the roof surface. A one-bay addition, capped by a gable roof, is appended to the north elevation. A one-car garage, capped by a gable roof, is appended to the north elevation. The primary single entrance, atop a two-bay porch and sheltered beneath the eaves, is located on the north elevation. Fenestration includes one-over-one, double-hung, vinyl-sash windows.

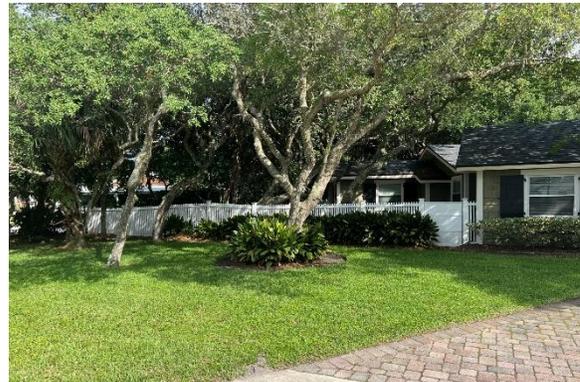
Photograph 20. SJ03768, 15 Ponte Vedra Circle.

The resource is a one-story, mostly obscured, 1950 Ranch dwelling (Photograph 20). The foundation material is not visible from the public right of way. The dwelling is clad in wood shingle siding, and capped by a front-gable roof covered in asphalt shingle. An exterior, brick chimney interrupts the roof surface on the north elevation. Two one-car garages, are appended to the north elevation at 45 degree angles. The primary double entrance is located on the north elevation. Fenestration includes one-over-one, double-hung, vinyl-sash windows.

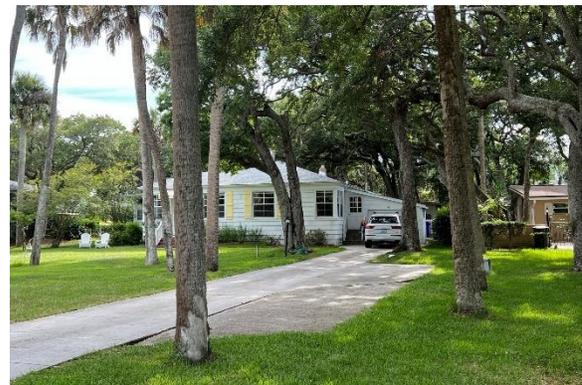
Photograph 22. SJ03770, 54 San Juan Drive.

The resource is a one-story, 1940 frame vernacular dwelling (Photograph 22). The dwelling rests on a parged foundation, is clad in asbestos shingle, and capped by a hipped roof covered in asphalt shingle. Two interior, brick chimneys interrupt the roof surface. A one-car garage, capped by a shed roof, is appended to the north elevation. The primary single entrance, atop a one bay porch and sheltered beneath a metal awning, is located on the east elevation. Fenestration includes four-over-four, double-hung, wood-sash windows.

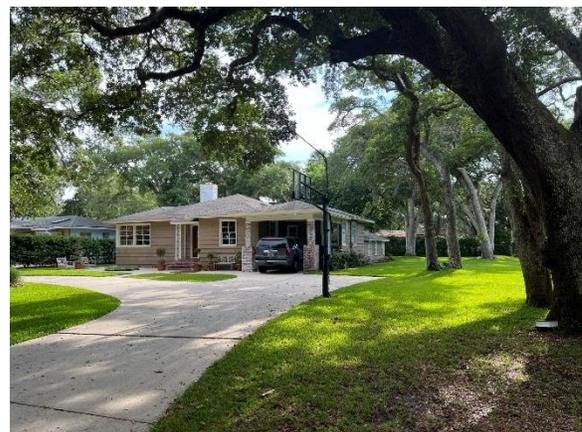
Photograph 23. SJ03771, 58 San Juan Drive.

The resource is a one-story, 1932 frame vernacular dwelling (Photograph 23). The dwelling rests on a parged foundation, is clad in wood shingle, and capped by a hipped roof covered in asphalt shingle. An interior, brick chimney interrupts the roof surface. The primary single entrance, atop a stoop and sheltered beneath an extended roof supported by metal posts, is located on the east elevation. A secondary single entrance,

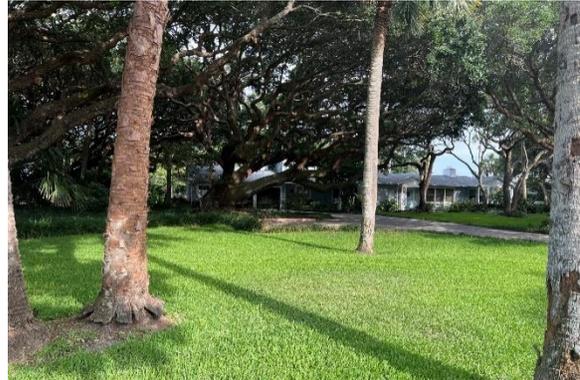
Photograph 24. SJ03773, 55 San Juan Drive.

The resource is a partially obscured one-and-a-half-story, 1950 frame vernacular dwelling (Photograph 23). The foundation material is not visible from the public right of way. The dwelling is clad in wood shingle, and capped by irregular roof covered in asphalt shingle. A three-car garage, capped by a gable roof, is appended to the north elevation. Several obscured one-story additions are appended to the rear elevation. The primary single entrance, atop a one-bay porch and sheltered beneath a gable roof supported by wood posts, is located on the west elevation. A secondary single entrance is located on the west elevation. Visible fenestration includes one-over-one, double-hung, vinyl-sash windows.

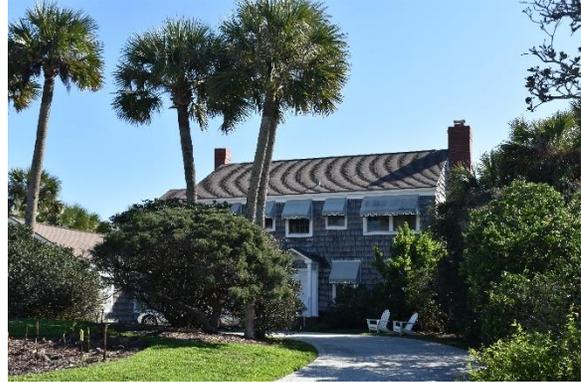
Photograph 26. SJ03776, 131 Ponte Vedra Boulevard.

The resource is a two-story, 1940 Georgian Revival dwelling (Photograph 26). The foundation material is not visible from the public right of way. The dwelling is clad in wood shingle siding and capped with a side-gable roof covered in asphalt shingle. A one-story, two-bay garage, capped by a gable roof, is appended to the north elevation. Two exterior brick chimneys are located on the north and south elevations. The primary single entrance with a fanlight is located on the west elevation, atop a stoop and sheltered beneath a gable roof supported by wood posts. Fenestration includes eight-over-eight, double-hung, wood-sash windows.

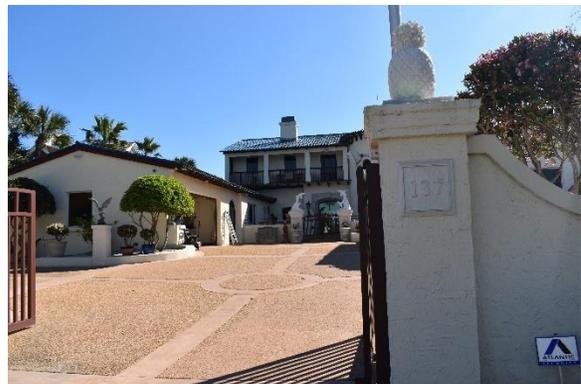
Photograph 27. SJ03777, 137 Ponte Vedra Boulevard.

The resource consists of a two-story, 1952, Mediterranean Revival dwelling standing five bays wide (Photograph 27). The dwelling has a concrete foundation, is clad in stucco, and capped by a low-pitched side-gable roof covered with standing seam metal. An internal chimney is located within the roof surface. A single-story addition is appended to the south corner of the west elevation and a single-story, two-car garage is appended to the north corner of the west elevation. The primary entrance is located on the west elevation, beneath a recessed balcony. A privacy wall surrounds the property.

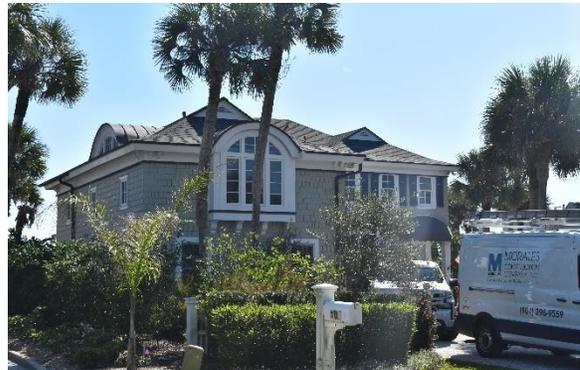
Photograph 30. SJ03796, 307 Ponte Vedra Boulevard.

The resource is a two-story, 1940 dwelling with Georgian Revival style elements (Photograph 30). The foundation material is not visible from the public right of way. The dwelling is clad in wood shingles and

capped with hipped roof covered in asphalt shingles. An exterior brick chimney is located on the south elevation. A central arch in the roofline is located on the east elevation and another arch on the north end of the west elevation. Corbels are located within the cornice at the corners and sides of the arches. The primary entrance is located at the southwest corner of the dwelling, recessed beneath the second story and flanked by sidelights. The recessed porch as an arch supported by a pillar and pilasters. A secondary entrance is located on the north end of the west elevation beneath a shed roof supported by a column. The primary porch is located on the east elevation overlooking the beach. Double doors open onto the porch. The porch is capped by a flat roof supported by columns. A balustrade is located atop the porch roof. Fenestration includes four-over-four, double-hung, wood-sash windows and hexagonal windows. A two-story, two-car garage is appended to the west elevation.

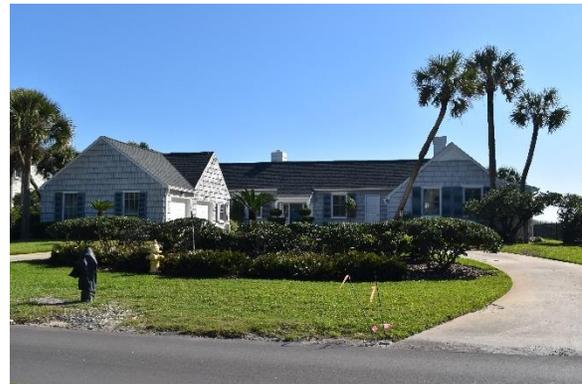
Photograph 31. SJ03797, 309 Ponte Vedra Boulevard.

The resource consists of a 1940, one-story Frame Vernacular dwelling (Photograph 31). The foundation material is not visible from the public right of way. The dwelling is clad in wood shingles and capped with cross-gable roof covered in asphalt shingles. Two interior brick chimneys are located within the roof slope. The primary entrance is located on the east elevation beneath a shed-roof hood supported by small pillars and flanked by sidelights. Fenestration includes six-over-six, double-hung, wood-sash windows. A two-car garage is appended to the west elevation.

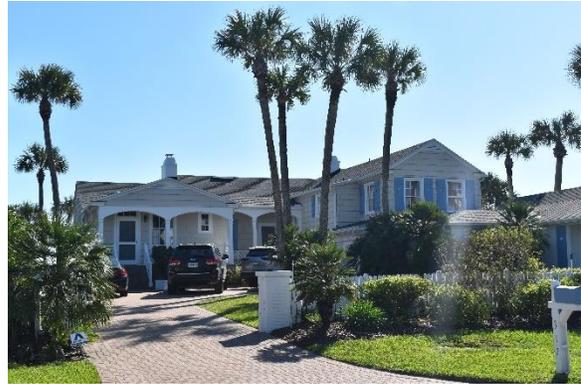
Photograph 33. SJ03801, 317 Ponte Vedra Boulevard.

The resource consists of a 1935, one-story, Frame Vernacular dwelling (Photograph 33). The foundation material is not visible from the public right of way. The dwelling is clad with wood shingles and capped with cross-gable roof covered in asphalt shingles. An external brick chimney is located on the north elevation and an internal brick chimney is located within the roof's surface. The primary entrance is located on the west elevation within the porch, capped by a gable roof supported by pillars. Fenestration includes six-over-six, double-hung, wood-sash windows, and wood-sash casement windows. A two-car, two-story garage is appended to the south end of the west elevation. A single-story, brick-clad apartment is appended to the garage.

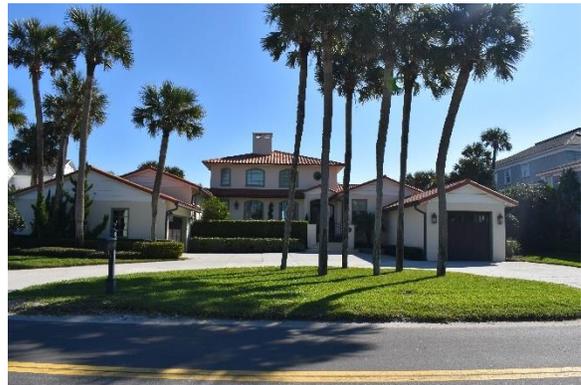
Photograph 34. SJ03802, 319 Ponte Vedra Boulevard.

The resource consists of a 1940, two-story, Mediterranean Revival dwelling (Photograph 34). The foundation material is not visible from the public right of way. The dwelling is clad with stucco siding and capped with a cross-gable roof covered with tiles. An internal brick chimney is located within the roof's surface. Single-story additions capped with front-gable roofs are appended to the north and south corner of the west elevation. The northern addition has a two-car garage, and the southern addition has a one-car garage. The primary entrance is recessed on the west elevation within a gabled entry. Fenestration includes simulated, multi-pane, fixed windows. Windows on the main portion of the dwelling are arched.

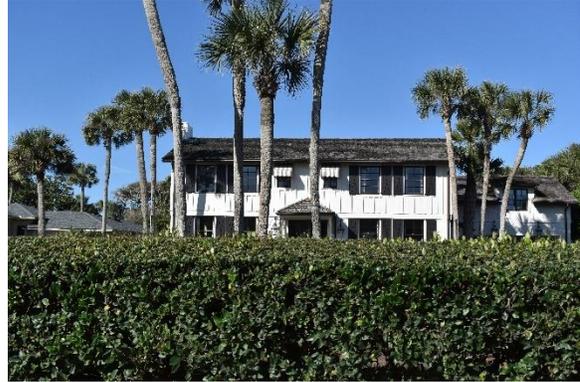
Photograph 35. SJ03806, 328 Ponte Vedra Boulevard.

The resource consists of a two-story 1940 side-gabled Colonial Revival residence standing six bays wide (Photograph 35). A two-story, two-bay garage dating to circa 2020 is appended to and recessed back from the north elevation and has a central shed-roofed dormer on the east elevation. The foundation material is not visible from the public right of way. Exterior walls on the first story are clad with a painted brick veneer, while the upper story is clad in board and batten wood siding. The roof is sheathed with wood or wood-look shingles. The primary entrance door, flanked by sidelights, is centered on the east elevation and sheltered beneath a bracketed hipped-roof overhang. A painted brick exterior chimney is located on the south elevation. Fenestration consists of four-over-four double-hung wood sash windows throughout.

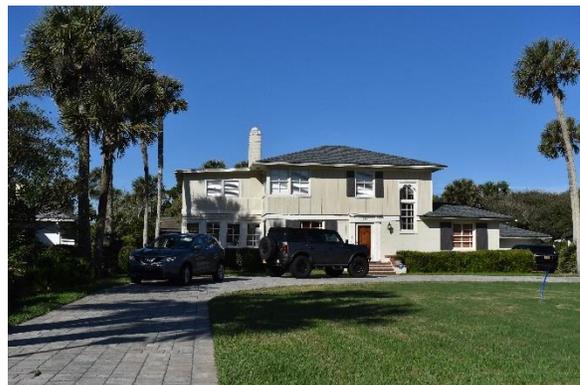
Photograph 36. SJ03808, 330 Ponte Vedra Boulevard.

The resource consists of a two-story 1940 Colonial Revival residence with a low-sloped hipped roof sheathed in asphalt shingles (Photograph 36). Wide overhanging eaves define the roofline. A single-story, two-bay garage is recessed back from the north elevation, while a two-story shed-roofed addition with a first-level

sunroom represents a later addition to the south. The foundation material is not visible from the public right of way. Exterior walls on the first story are clad with a painted brick veneer, while the upper story is clad in wide vertical wood board siding. The primary entrance door, set within a decorative pilaster surround, is centered on the east elevation and accessed via a set of brick steps. A painted brick interior chimney is located between the two-story southern addition and the original south elevation. Fenestration consists of eight-over-eight, four-over-four, and one-over-one double-hung wood sash windows, with a four-light transom window with clipped upper corners appearing over a stairwell window on the east elevation.

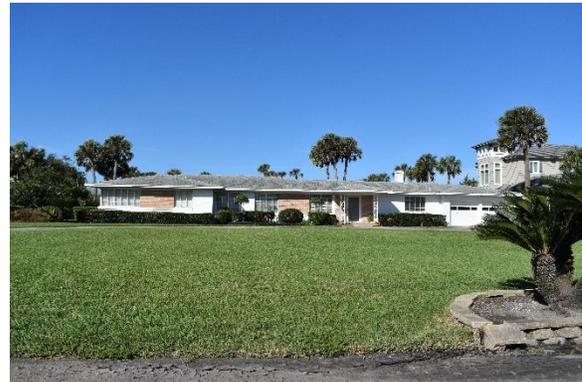
Photograph 37. SJ03811, 336 Ponte Vedra Boulevard.

The resource consists of a one-story 1953 Ranch residence with a low-sloped hipped roof sheathed in asphalt shingles set over wide eaves (Photograph 37). The dwelling has a roughly rectangular footprint which parallels the road, and an attached two-bay garage is situated at the northern extent of the resource. The foundation material is not visible from the public right of way. Exterior walls are clad in painted brick veneer, with variegated rusticated stacked stone veneer accenting walls surrounding the entry door and between windows on the east elevation. The primary entrance door is set beneath a small hipped-roof entry porch on paired, painted wrought iron posts flanking geometric ornamental ironwork. Fenestration consists of eight- and twelve-light metal casement windows, some of which are set beneath two-light fixed metal transoms. An internal painted brick chimney punctuates the roof ridge near the northern garage wing.

The resource is recommended eligible for the NRHP under Criterion C for its retention of original architectural character of a mid-twentieth dwelling.

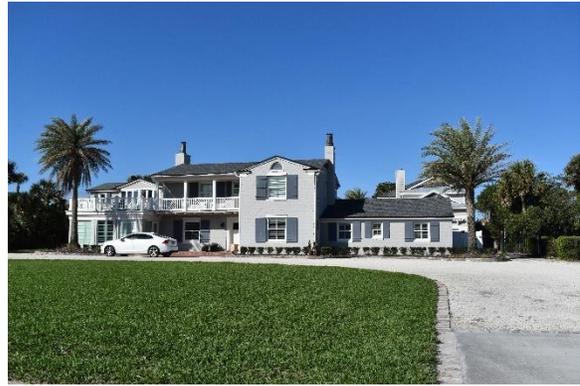
Photograph 38. SJ03812, 340 Ponte Vedra Boulevard.

The resource consists of a two-story, 1950 masonry Colonial Revival residence with sprawling one- and two-story additions to the north, west, and south (Photograph 38). The original portion of the resource has a low-sloped, cross-gabled roof with eave returns sheathed in asphalt shingles. While this roof type is replicated throughout the southernmost additions, a combination of hipped and cross-gabled roofs with a higher pitch are used for the northern additions and sheathed in both asphalt shingles and standing seam metal. The foundation material is not visible from the public right of way. Exterior walls throughout the oldest portion of the residence are painted brick, with stucco and wide horizontal weatherboard appearing on additions. The primary entrance door is roughly centered on the east elevation and recessed beneath a full-width second-story covered porch which extends to an uncovered deck over the easternmost portion of the southern addition. Fenestration consists of two-over-two double-hung and large single-pane fixed vinyl windows. External painted brick chimneys are centered on the north and south elevations of the original portion of the residence.

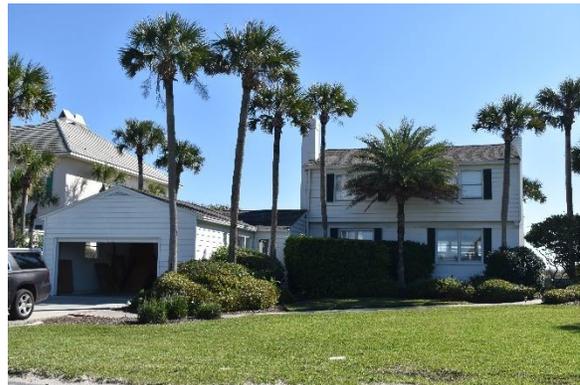
Photograph 39. SJ03813, 343 Ponte Vedra Boulevard.

The resource is a two-story, 1940 Georgian Revival dwelling (Photograph 39). The foundation material is not visible from the public right of way. The dwelling is clad in brick and aluminum siding and capped with a side-gable roof covered in asphalt shingle. A one-story addition and one-bay garage, capped by a gable roof, are appended to the north elevation. Two exterior brick chimneys are located on the north and south elevations. The primary entrance is not visible from the public right of way due to vegetation obstruction, but is located on the west elevation. Fenestration includes one-over-one, double-hung, wood-sash windows.

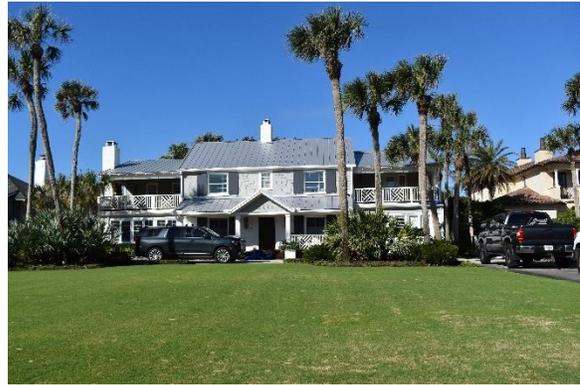
Photograph 40. SJ03814, 350 Ponte Vedra Boulevard.

The resource consists of a two-story, 1938 Colonial Revival side-gabled residence with two-story additions dating to circa 2012 with covered second-level porches flanking the original portion of the resource (Photograph 40). A shed-roofed, full-width entry porch with a central cross gable spans the east elevation of the central wing. Asphalt shingle roofing sheaths the primary and porch roofs on the original resource, while standing seam metal sheaths the roofs on the two-story additions to the north and south. The foundation material is not visible from the public right of way. First-level exterior walls are clad in a painted brick veneer while second-level walls are clad in composite shingles. A painted brick interior chimney punctuates the roof ridge at the center of the original dwelling. Fenestration consists of vinyl one-over-one, six-over-six and eight-over-eight double-hung and eight-light casement windows.

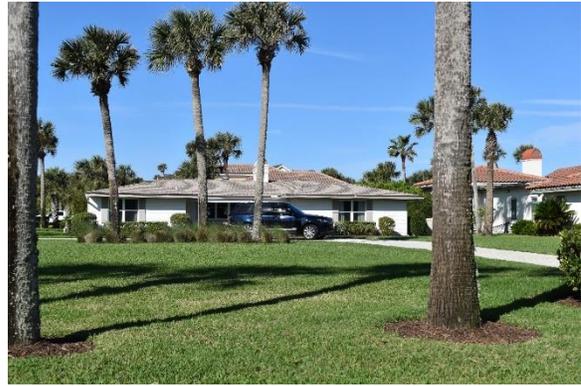
Photograph 41. SJ03818, 422 Ponte Vedra Boulevard.

The resource consists of a one-story, 1950 Ranch residence with low-slope hipped roof sheathed in asphalt shingles (Photograph 41). The foundation material is not visible from the public right of way; however, exterior brick veneer walls are painted. The primary entrance door is roughly centered and recessed beneath the main roof form, with board and batten wooden siding on the surrounding wall. Fenestration consists of vinyl one-over-one double-hung and single-pane casement windows throughout. A painted brick interior chimney punctuates the roof ridge and has an arched hood. A two-bay garage is accessed from the west elevation adjacent to a single-story hipped-roof addition.

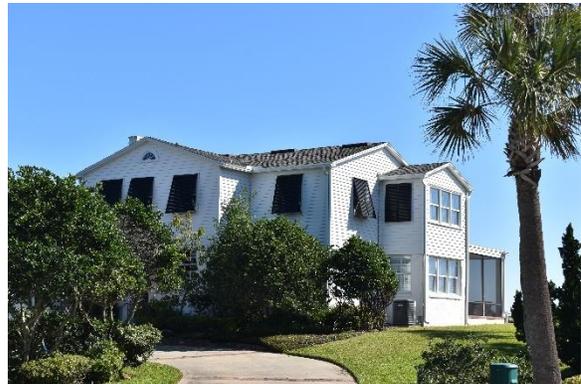
Photograph 42. SJ03821, 405 Ponte Vedra Boulevard.

The resource is a two-story, 1937 frame vernacular dwelling (Photograph 42). The dwelling rests on a concrete foundation, is clad in brick and weatherboard siding and capped with a side-gable roof covered in asphalt shingle. Two-story additions, capped by gable roofs, are appended to the east and west elevations. A two-story addition is appended to the south elevation. A one-story enclosed sunporch is appended to the east elevation. A one-car garage is appended to the north elevation. Two exterior brick chimneys are located on the north elevation. The primary single

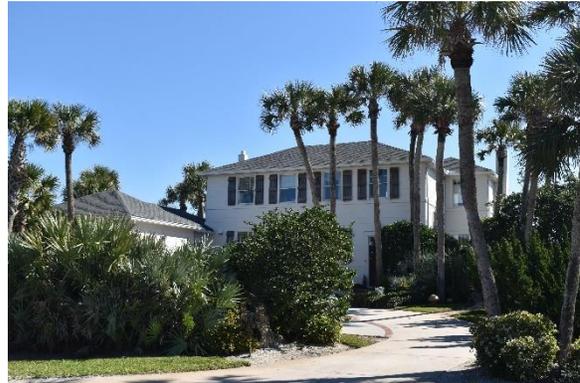
Photograph 43. SJ03822, 407 Ponte Vedra Boulevard.

The resource is a two-story, 1937 Georgian Revival dwelling (Photograph 43). The dwelling rests on a concrete foundation, is clad in weatherboard siding and capped with a hipped roof covered in asphalt shingle. A two-story, hipped roof addition is appended to the east elevation. An obscured one-story hipped roof addition is appended to the east elevation. A one-car garage capped by a hipped roof is appended to the north elevation. Two exterior brick chimneys are located on the north and south elevations. The primary single entrance with a transom is located on the west elevation, atop a stoop. Fenestration includes eight-over-one, double-hung, vinyl-sash windows.

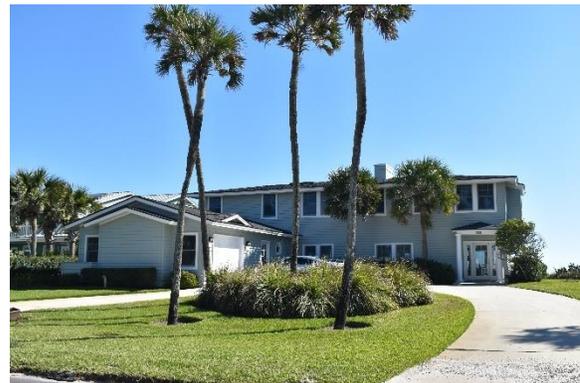
Photograph 44. SJ03823, 411 Ponte Vedra Boulevard.

The resource is a two-story, 1937 frame vernacular dwelling (Photograph 44). The dwelling rests on a concrete foundation, is clad in weatherboard siding and capped with a hipped roof covered in asphalt shingle. An obscured one-story hipped roof addition is appended to the east elevation. A one-car garage capped by a gable roof is appended to the north elevation. An interior brick chimney interrupts the roof surface. The primary single entrance with sidelights, sheltered beneath a hipped roof supported by Doric columns, is located on the south end of the west elevation. Fenestration includes six-over-one, and one-over-one double-hung, vinyl-sash and an octagon window.

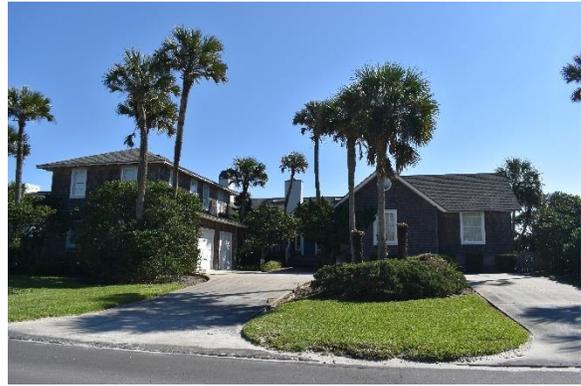
Photograph 45. SJ03824, 413 Ponte Vedra Boulevard.

The resource is a one-story, 1935 U-shaped frame vernacular dwelling (Photograph 45). The dwelling rests on a concrete foundation, is clad in wood shingle and capped with a cross-gable roof covered in asphalt shingle. A two-story addition, capped by a hipped roof with exposed rafters, is appended to the west elevation. Two single-car garages are located on the south elevation of the addition. Two interior brick chimneys interrupt the roof surface. The primary single entrance with sidelights, atop a two-bay porch and sheltered beneath a gable roof supported by wood posts, is located on the west elevation. Fenestration includes six-over-six, and twelve-over-twelve double-hung, wood-sash windows.

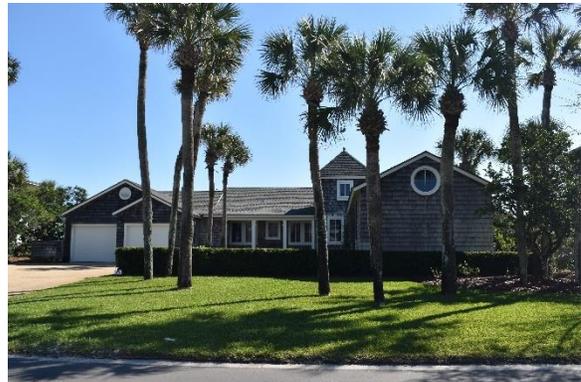
Photograph 46. SJ03825, 415 Ponte Vedra Boulevard.

The resource is a one-story, 1935, L-shaped, frame vernacular dwelling (Photograph 46). The dwelling rests on a concrete foundation, is clad in wood shingle and capped with a side-gable roof covered in asphalt shingle. Two obscured gable roof dormers are located on the east elevation. A one-story addition, capped by a gable roof is appended to the west elevation. An intersecting gable addition with two single-car garages, is appended to the west elevation. A two-story tower, capped by a pyramidal roof, is appended to the west elevation. The primary single entrance, atop a three-bay porch and sheltered beneath a shed roof supported by wood posts, is located on the west elevation. Fenestration includes four-pane casement windows and a porthole window.

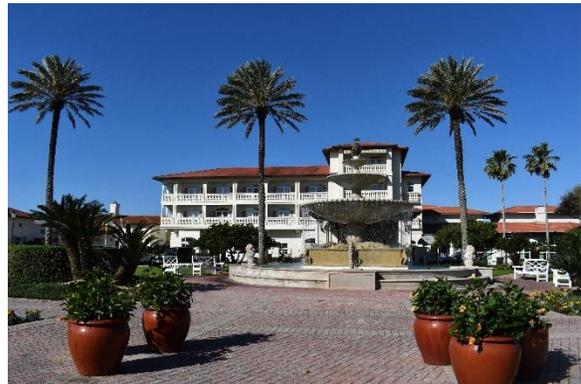
Photograph 48. SJ03829, 200 Ponte Vedra Boulevard.

The resource consists of a sprawling series of resort buildings constructed in the Spanish Colonial Revival style ranging from one to three stories in height (Photograph 48). Most buildings throughout the property have exterior walls clad in stucco and low-pitched hipped roofs sheathed in clay tile. Fenestration throughout consists of multi-pane fixed windows, many of which are set beneath fabric awnings or flanked by louvered shutters. Although initially developed during the 1930s, the resource has undergone significant expansions and alterations since its original construction and no longer retains visible remnants of its historic appearance.

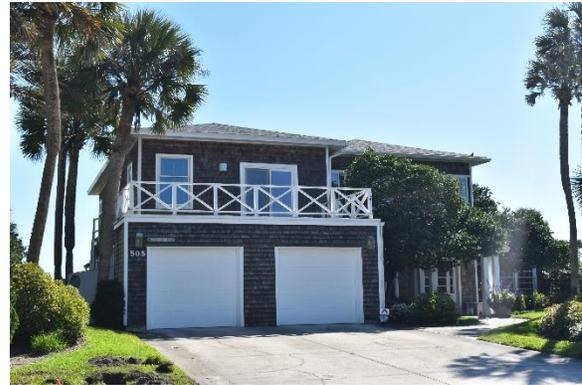
Photograph 49. SJ03833, 505 Ponte Vedra Boulevard.

The resource is a two-story, 1935 frame vernacular dwelling (Photograph 49). The dwelling rests on a concrete foundation, is clad in wood shingle and capped with an irregular roof covered in asphalt shingle. A one-story addition, capped with a second-story wraparound deck includes two single-car garages. An interior brick chimney interrupts the roof surface. An obscured second-story porch is located on the south elevation. The primary single entrance with sidelights sheltered beneath a gable roof with an arch and supported by wood posts is located on the west elevation. A sliding glass door is located above the garage addition. Fenestration includes one-over-six, double-hung, wood-sash and vinyl fixed frame windows.

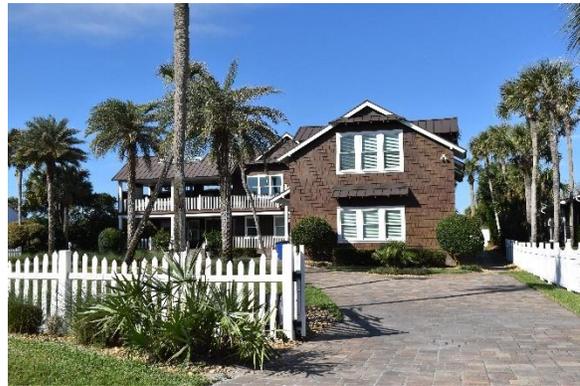
Photograph 51. SJ03839, 514 Ponte Vedra Boulevard.

The resource consists of a two-story, 1939 residence with major alterations dating to circa 2012 (Photograph 51). The residence includes a two-story front-gabled section which intersects with a side-gabled second-level covered porch situated over first-level enclosed living space. A gabled one-and-one-half-story two-bay garage addition to the east elevation has two garage doors facing south beneath front-gabled wall dormers. Pent roof overhangs with exposed rafter tails top first-level windows and doors on the garage addition and select second-level windows on the primary portion of the residence. Roofs are sheathed in standing seam metal. The foundation material is not visible from the public right of way; however, exterior walls are sheathed in dark stained wood shingles. Two-leaf primary entrance doors are accessed from a full-width entry porch set directly beneath the second-level full-width covered porch. Fenestration consists of vinyl one-over-one double-hung windows.

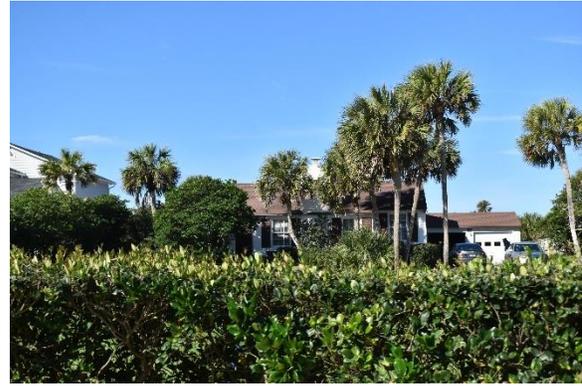
Photograph 52. SJ03840, 516 Ponte Vedra Boulevard.

The resource consists of a one-story, side-gabled, 1938, brick masonry Minimal Traditional dwelling with a side-gabled two-bay garage addition recessed from the east elevation at the northern elevation (Photograph 52). A wide exterior painted brick chimney is centered on the east elevation. The roof has minimal eave overhangs and is sheathed with asphalt shingles. A single-leaf offset primary entrance door is accessed via a set of brick steps. Fenestration consists of six-over-six double-hung vinyl windows, most of which are outfitted with louvered shutters.

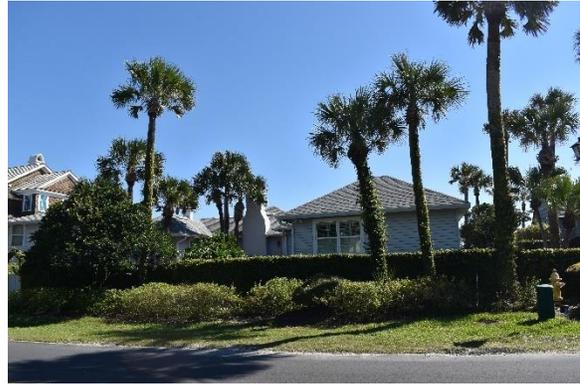
Photograph 53. SJ03847, 531 Ponte Vedra Boulevard.

The resource consists of a two-story, 1935 frame vernacular residence (Photograph 53). The dwelling foundation is not visible from the public right of way, but is clad with vinyl siding, and capped with a hipped roof covered with asphalt shingles. A two-story, two-car garage addition is appended to the north end of the west elevation. The primary entrance is located on the west elevation but is largely obscured from the public right of way due to the vine-covered fencing. An external brick chimney is located on the west elevation, and an internal chimney is located within the roofline. Fenestration consists of six-over-six, double-hung, wood- and vinyl-sash windows.

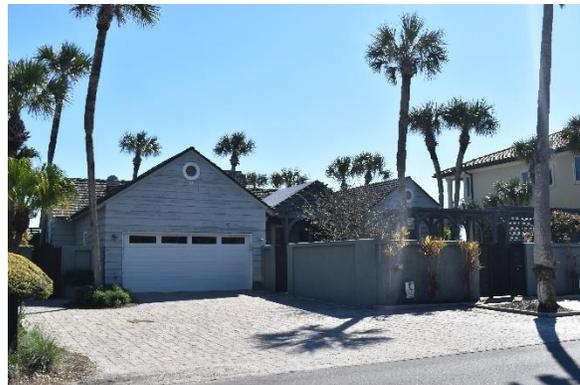
Photograph 54. SJ03848, 533 Ponte Vedra Boulevard.

The resource consists of a 1940, one-story, frame vernacular dwelling standing five bays wide (Photograph 54). The dwelling has a parged foundation, is clad with wood weatherboard siding, and capped with a cross-gabled roof covered in wood shingles. The resource has a roughly U-shaped footprint with a built-in, two-car garage located within the northernmost wing. An internal brick chimney with a corbeled top is located near the roof ridge. The primary entrance door is offset and recessed beneath the main roof form, and a detached, open entry porch with exposed rafter tails is centered on the primary elevation. Fenestration includes twelve-light vinyl-sash casement windows beneath four-light transoms and six-over-six double-hung windows.

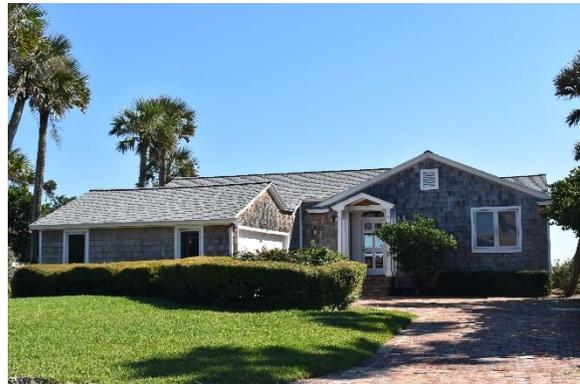
Photograph 56. SJ03853, 547 Ponte Vedra Boulevard.

The resource consists of a 1941, one-story, Frame Vernacular dwelling standing four bays wide (Photograph 56). While the foundation material is not visible from the right of way, exterior walls are clad with wood shingle siding. The low-sloped, cross-gable roof covered in asphalt shingles has shallow overhanging eaves. A two-car garage addition is appended to the north side of the west elevation. The primary entrance is located on the west elevation beneath a gable hood supported by columns. Fenestration includes vinyl casement windows.

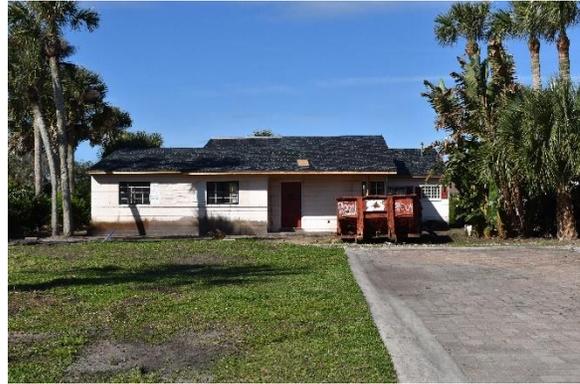
Photograph 57. SJ03856, 554 Ponte Vedra Boulevard.

The resource consists of a one-story, side-gabled 1952 masonry Ranch residence with a central entry door recessed beneath an overhang of the main roof form (Photograph 57). While the foundation material is not visible from the right of way, exterior walls are a combination of painted concrete masonry units with rounded corners and painted brick veneer. Roofs are sheathed in asphalt shingles. Fenestration consists of glass block, vinyl eight-over-eight double-hung, and six-light metal awning windows.

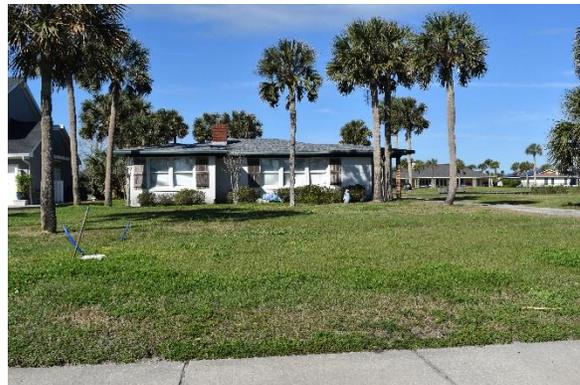
Photograph 58. SJ03857, 562 Ponte Vedra Boulevard.

The resource consists of a one-story, low-sloped hipped-roof 1948 Ranch residence with a roughly rectangular footprint (Photograph 58). The primary entrance door is recessed beneath the overhang of the main roof and faces north, somewhat obscured from the road. While the foundation material is not visible from the right of way, exterior walls are largely sheathed in stucco, with some variegated brick masonry appearing at the northeast corner of the resource. The roof, which has wide, overhanging boxed eaves, is sheathed in asphalt shingles and is punctuated with an unpainted interior brick chimney. Fenestration consists of one-over-one double-hung vinyl windows.

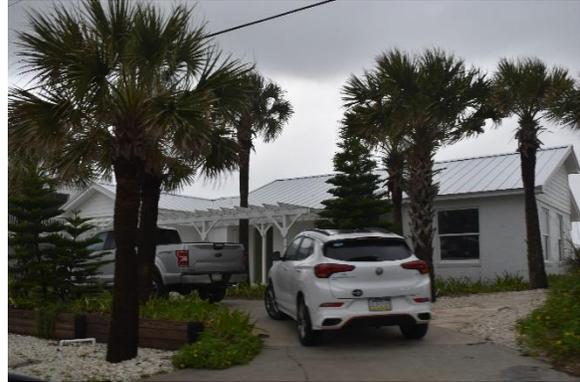
Photograph 59. SJ03884, 2659 Ponte Vedra Boulevard.

The resource is a partially obscured one-story, 1955 masonry vernacular dwelling (Photograph 59). The foundation material is not visible from the public right of way. The dwelling is clad in batten and concrete block and capped with a side-gable roof covered in standing-seam metal. A one-bay addition is appended to the west elevation, capped by a gable roof. An interior concrete chimney interrupts the roof surface. The primary entrance is located on the west elevation. Fenestration includes one-over-one, double-hung, wood-sash and fixed-frame windows. Large vegetation partially obscures the dwelling.

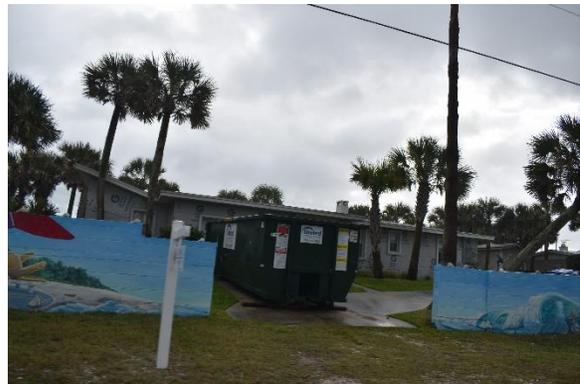
Photograph 60. SJ03885, 2513 Ponte Vedra Boulevard.

The resource is a partially obscured one-story, 1950 Ranch dwelling (Photograph 60). The concrete block dwelling rests atop a concrete block foundation and capped with a hipped roof covered in asphalt shingle. A one-car garage, capped by a flat roof, is appended to the north elevation. An obscured addition is located on the east elevation. An interior brick chimney interrupts the roof surface. The primary single entrance is located on the west elevation, sheltered beneath the eaves. Fenestration includes one-over-one, double-hung, wood-sash windows. A privacy wall partially obscures the property. The dwelling is currently being renovated.

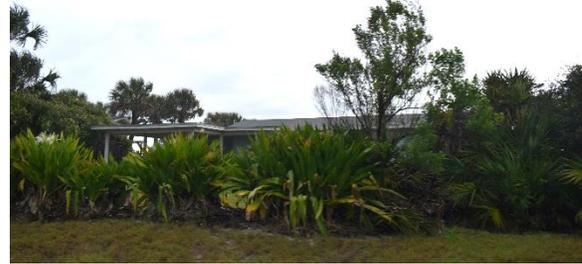
Photograph 61. SJ03886, 2493 Ponte Vedra Boulevard.

The resource is a one-story, 1954 Ranch dwelling (Photograph 61). The concrete block dwelling rests atop a concrete foundation and capped with a side-gable roof covered in asphalt shingle. A one-bay addition and carport, capped by a flat roof, is appended to the north elevation. The primary single entrance is located on the west elevation, sheltered beneath a shed roof supported by wood posts. Fenestration includes four-over-one, double-hung, vinyl-sash and vinyl horizontal slider windows.

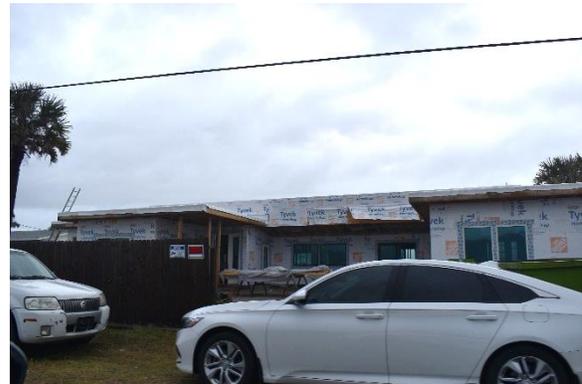
Photograph 62. SJ03887, 2495 Ponte Vedra Boulevard.

The resource is a partially obscured one-story, 1954 masonry-vernacular dwelling (Photograph 62). The concrete block dwelling rests atop a concrete foundation and capped with a side-gable roof covered in asphalt shingle. A one-bay addition, capped by a flat roof, is appended to the north elevation. The primary single entrance is located on the west elevation, atop a one-bay porch and sheltered beneath an extended roof supported by a wood post. Fenestration has been removed. A privacy fence partially obscures the property. The dwelling is currently under extensive renovations.

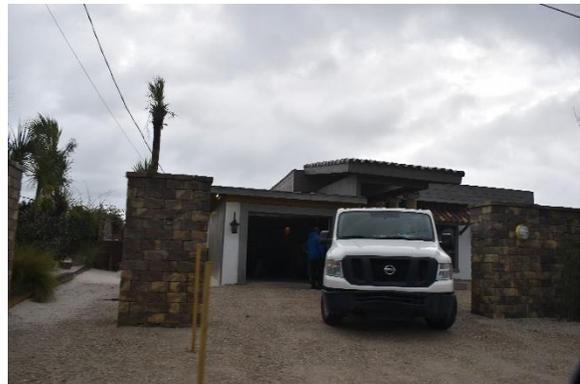
Photograph 64. SJ03889, 2505 Ponte Vedra Boulevard.

The resource is a mostly obscured one-story, 1952 masonry-vernacular dwelling (Photograph 64). The concrete block dwelling rests atop a concrete block foundation and capped with a flat roof covered in asphalt. A one-car garage, capped by a flat roof, is appended to the north elevation. An obscured addition is located on the south elevation. The primary single entrance is located on the west elevation, sheltered beneath a shed roof covered in tile and supported by Ionic columns. Fenestration is not visible from the public right of way. A privacy wall mostly obscures the property.

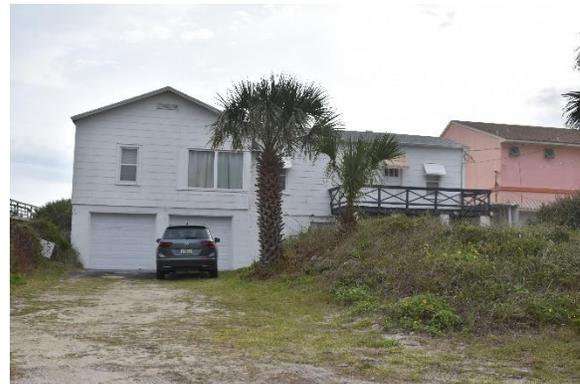
Photograph 66. SJ03898 / SJ05454, 3148 Coastal Highway.

The resource consists of a two-story, 1948 cross-gabled masonry and frame residence with a two-car garage situated on the first level on the west elevation (Photograph 66). The primary entrance door is situated on the second story of the west elevation and accessed from an uncovered, partial-width deck. Exterior concrete block walls on the first level are painted, while the upper story is clad in asbestos shingles. The roof, which has little to no eave overhang, is sheathed in asphalt shingles. Fenestration consists of fixed and one-over-one double-hung vinyl windows, some of which are set beneath awnings.

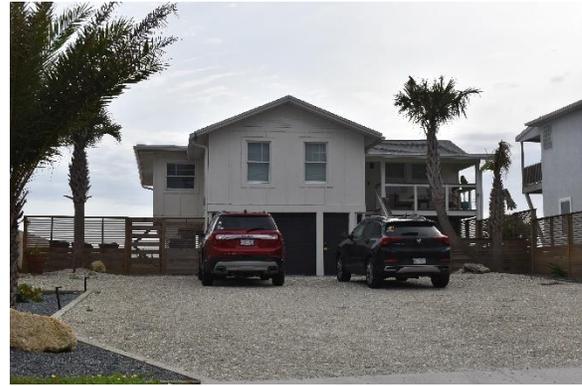
Photograph 67. SJ03899, 3156 Coastal Highway.

The resource consists of a two-story, 1948 cross-gabled residence with a built-in one-car garage on the first level of the west elevation (Photograph 67). The primary entrance door is situated beneath a partial-width, shed-roofed entry porch on the second level of the west elevation. Exterior walls are clad in stucco on the first level and board and batten siding on the upper level, while the roof is sheathed in asphalt shingles. Fenestration consists of six-over-one double-hung vinyl windows.

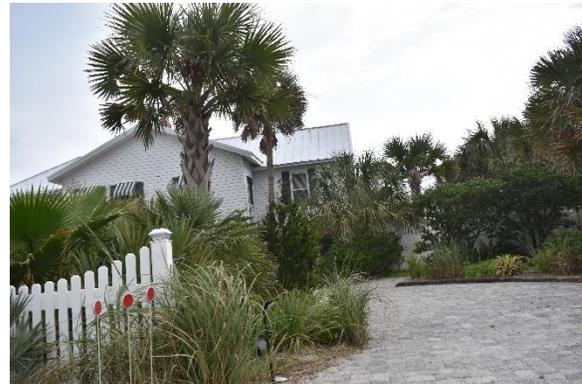
Photograph 68. SJ03900, 3200 Coastal Highway.

The resource consists of a two-story, 1957 cross-gabled residence with a built-in three-car garage on the first level (Photograph 68). The dwelling is largely obscured by vegetation. The primary entrance door is situated on the west elevation with no associated entry porch or overhang. Exterior walls are clad in horizontal weatherboard siding on the first level and composite shingles on the upper level, while the roof is sheathed in standing seam metal. Fenestration consists of one-over-one double-hung vinyl windows flanked by louvered shutters.

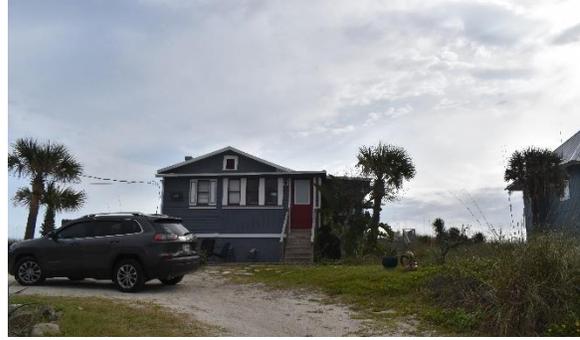
Photograph 69. SJ03901, 3216 Coastal Highway.

The resource consists of a one-story, 1935 front-gabled residence (Photograph 69). The primary entrance door is offset on an enclosed shed-roofed entry porch on the west elevation. Exterior walls are clad in horizontal weatherboard siding and vertical plank siding, while the roof is sheathed in asphalt shingles. An exterior painted brick chimney is centered on the north elevation. Fenestration consists of one-over-one double-hung wood windows flanked by paneled shutters.

The resource is recommended eligible for the NRHP under Criterion A for its association to the development of the North Beach area during the early twentieth century.

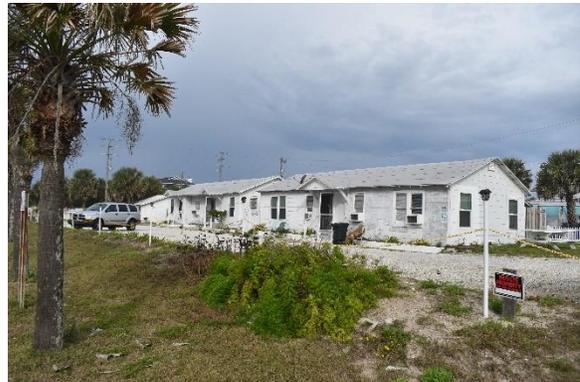
Photograph 70. SJ03904, 3080 Coastal Highway.

The resource consists of six one-story, 1948 and 1958 frame dwellings used as vacation rentals (Photograph 70). The easternmost four residences are side-gabled and clad in wide shingle siding. Roofs, with exposed rafter tails, are sheathed in tar paper.

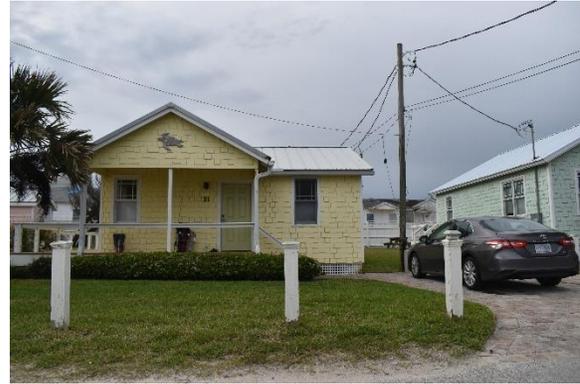
Photograph 71. SJ03905, 21 Surfside Avenue.

The resource consists of one-story, 1973 frame dwelling standing three bays wide (Photograph 71). The dwelling has a pier foundation, is clad with composite shingles, and is capped with a cross-gable roof covered in standing seam metal. The primary entrance is located on the north elevation within the front porch. The porch is capped with a gable roof supported by wood posts. Fenestration consists of vinyl fixed and one-over-one, double-hung, vinyl-sash windows with decorative mullions in the upper sash.

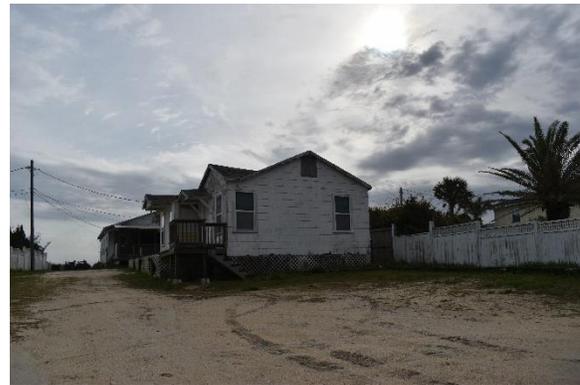
Photograph 72. SJ03907, 3056 Coastal Highway.

The resource consists of a one-story, 1930 gabled residence with flat-roofed and gabled additions to the east elevation (Photograph 72). The primary entrance is located on the north elevation atop a wooden deck. Exterior walls are clad in wide aluminum and asbestos siding, while the roof is sheathed in asphalt shingles. Fenestration consists of vinyl one-over-one windows.

The resource is recommended as a contributing resource to a potential historic district under Criterion A for the development of Vilano Beach from the early twentieth century through the mid-twentieth century.

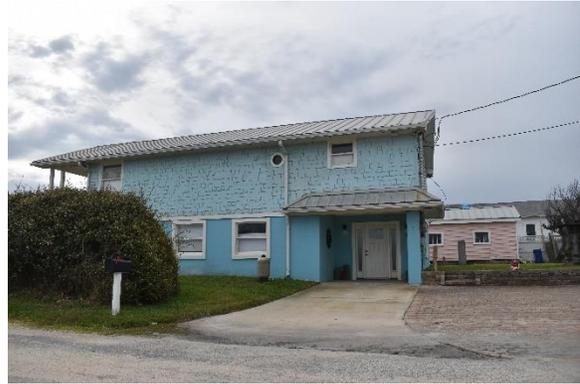
Photograph 73. SJ03908, 11 Surfside Avenue.

The resource consists of a two-story, 1973 side-gabled frame residence with a primary entrance door flanked by sidelights recessed beneath a partial-width, partially-inset entry porch at the northwest corner (Photograph 73). A small, hipped roof overhang extends from the entry porch. Exterior walls are clad in stucco at the first level and composite shingles at the second level, while the roof is sheathed in standing seam metal. Fenestration consists of vinyl fixed and one-over-one windows. A two-story, full-width open porch spans the eastern elevation. A one-story, front-gabled secondary residence clad in weatherboard siding is situated southwest of the primary residence.

The resource is recommended as a contributing resource to a potential historic district under Criterion A for the development of Vilano Beach from the early twentieth century through the mid-twentieth century.

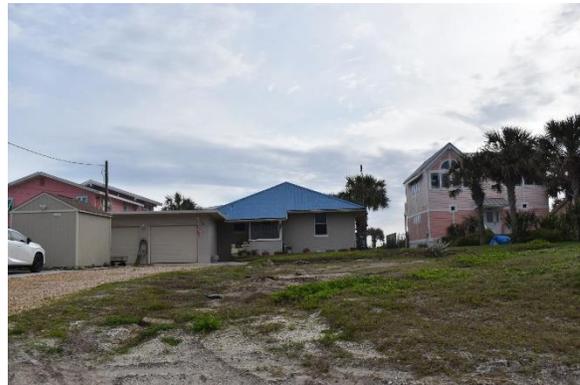
Photograph 74. SJ03909, 3024 Coastal Highway.

The resource consists of a one-story, 1950 hipped-roof, masonry vernacular residence with a flat-roofed, two-car garage addition to the west elevation (Photograph 74). The resource is clad with concrete blocks. The primary entrance door is offset on the west elevation beneath a partial-width entry porch which is partially enclosed with a patterned screen. Exterior concrete block walls are painted, while the roof is sheathed in standing seam metal. Fenestration consists of vinyl one-over-one double-hung windows. A front-gabled storage shed is located immediately west of the resource.

The resource is recommended as a contributing resource to a potential historic district under Criterion A for the development of Vilano Beach from the early twentieth century through the mid-twentieth century.

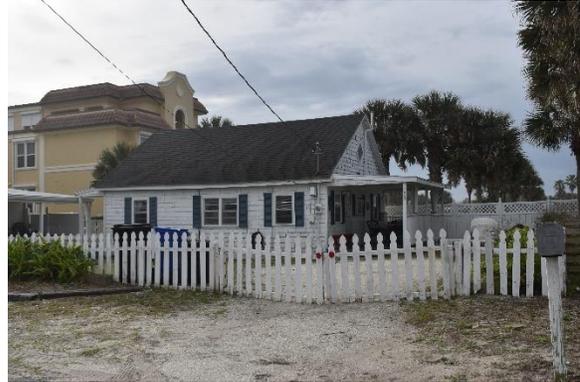
Photograph 75. SJ03911, 103 Palmetto Avenue.

The resource consists of a one-story, 1947 side-gabled frame vernacular residence with shed-roofed open porches spanning the east and west elevations (Photograph 75). The primary entrance door is situated on the west elevation beneath the full-width shed-roofed porch. Exterior walls are clad in painted wood shingles, while the roof is sheathed in asphalt shingles. Fenestration consists of wood two-over-two double-hung windows flanked with decorative shutters.

The resource is recommended as a contributing resource to a potential historic district under Criterion A for the development of Vilano Beach from the early twentieth century through the mid-twentieth century.

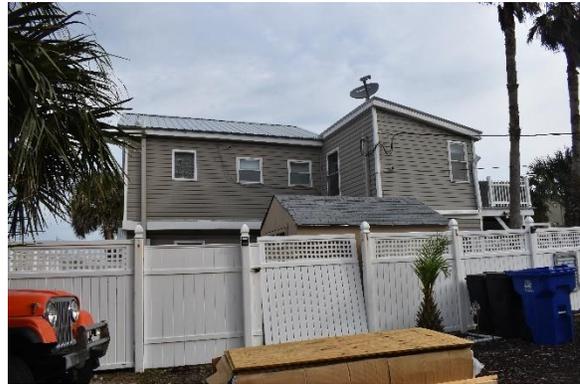
Photograph 76. SJ03912, 2930 Coastal Highway.

The resource consists of a two-story, 1935 frame vernacular residence with a combination front-gabled and shed roof (Photograph 76). The primary entrance door is situated on the second story of the north elevation beneath a shed-roofed, partial-width porch. Exterior walls are clad in horizontal vinyl siding, while the roof is sheathed in asphalt shingles. Fenestration consists of glass block and vinyl one-over-one double-hung windows. A one-story, front-gabled circa-2000 secondary residence with vinyl one-over-one double-hung windows is situated just north of the resource.

The resource is recommended as a contributing resource to a potential historic district under Criterion A for the development of Vilano Beach from the early twentieth century through the mid-twentieth century.

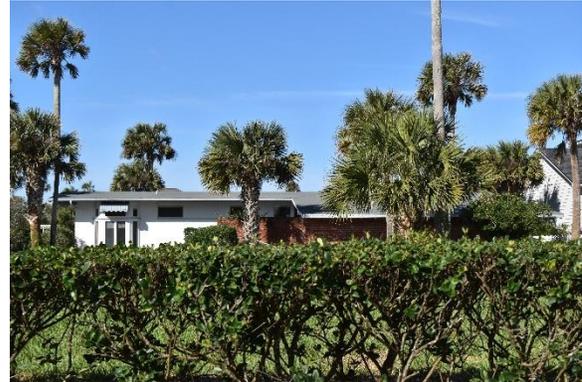
The resource consists of a one-story 1956 Mid-Century Modern residence with a low-slope side-gabled roof with wide overhanging eaves featuring exposed rafter tails (Photograph 111). The roof, sheathed in asphalt shingles, is partially cut away at the east elevation, creating a recessed south-facing entry. The foundation material is not visible from the public right of way. Exterior walls are primarily clad in wood board and batten siding, while the easternmost exterior wall is comprised of unpainted brick masonry. A double-leaf patio door with full-light glazing, sidelights, and a tripartite transom are situated beneath a fabric awning on the east elevation. Single-pane vinyl fixed clerestory windows are located on the east elevation, with other fenestration not visible from the public right of way.

Photograph 111. SJ08051, 520 Ponte Vedra Boulevard.

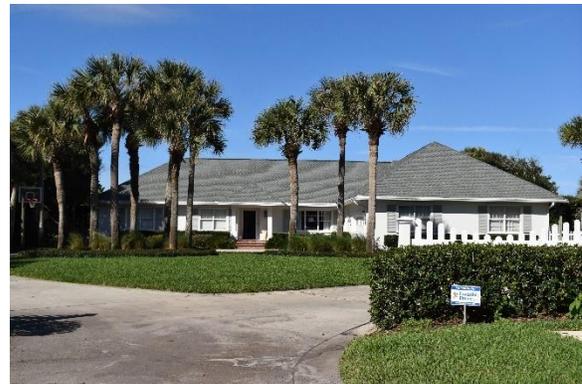
Photograph 112. SJ08052, 524 Ponte Vedra Boulevard.

The resource consists of a one-story, 1958 residence with a moderately-sloped hipped roof sheathed in asphalt shingles (Photograph 112). An attached two-bay garage with a south-facing garage door is located on the northern half of the east elevation. While the foundation material is not visible from the public right of way, exterior walls are clad in stucco. The central primary entrance door is situated beneath a small hipped-roof entry porch. A single interior chimney near the northern extent of the roof is clad in stucco. Fenestration consists of eight-over-one and eight-over-eight vinyl double-hung windows, most of which are flanked by decorative louvered shutters.

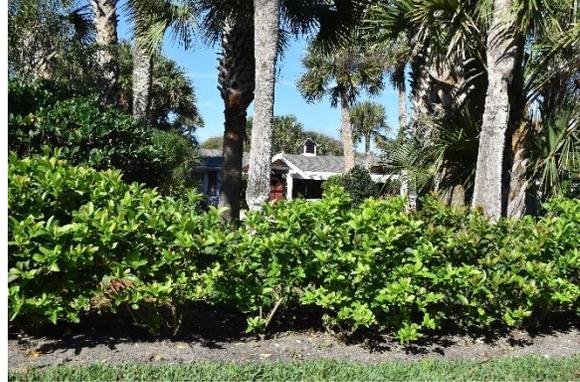
The resource consists of a one-story, 1959 Ranch residence with a low-sloped hipped roof sheathed in asphalt roofing (Photograph 113). An attached two-bay garage makes up the northernmost portion of the residence. While the foundation material is not visible from the public right of way, exterior walls are clad with horizontal weatherboard siding. The roughly centered primary entrance door is recessed beneath a front-gabled open-framed entry vestibule with exposed rafters and a gate. A pergola spans the east elevation between the entry vestibule and the garage. Fenestration consists of vinyl one-over-one double-hung windows flanked with operable louvered shutters. A square cupola with louvered vents and a hipped roof punctuates the roof ridge near the center of the residence.

Photograph 113. SJ08053, 532 Ponte Vedra Boulevard.
