St. Johns County State Route A1A

Historic Resources Survey Report St. Johns County, Florida

GAI Project Number: R210889.00

July 2022

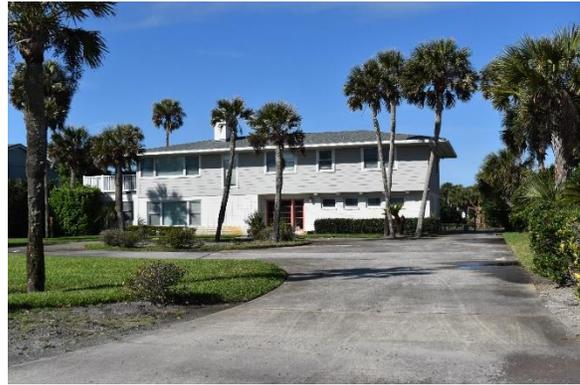
Photograph 114. SJ08054, 538 Ponte Vedra Boulevard.

The resource consists of a two-story, 1959 residence with a low-sloped hipped roof sheathed in asphalt shingles with wide overhanging boxed eaves (Photograph 114). A second-story uncovered porch with a square-cut baluster is situated over a sunroom addition at the southern extent of the residence. While the foundation material is not visible from the public right of way, exterior walls are clad in a combination of painted brick veneer and horizontal wood weatherboard siding. An accent wall of painted concrete masonry units set in a stacked bond is located immediately south of the central primary entrance door, which has full-light glazing divided horizontally into five panes and is flanked by five-pane sidelights. The painted brick wall upon which the door is situated is recessed slightly from the face of the east elevation, with rounded brackets appearing beneath the overhanging second-story portion of the façade. An interior painted brick chimney with cap is situated on the east-facing slope of the roof. Fenestration consists of vinyl one-over-one double-hung, single-pane awning, and fixed picture windows.

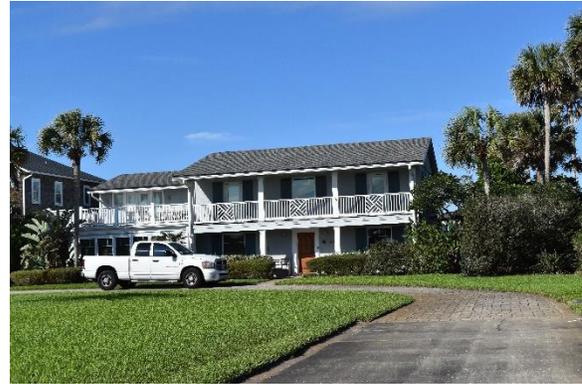
The resource consists of a two-story, 1973 side-gabled Colonial Revival residence with a two-story side-gabled southern addition (Photograph 115). While the foundation material is not visible from the public right of way, exterior walls on the original portion of the residence are clad in a painted brick veneer, with horizontal weatherboard siding cladding exterior walls of the addition. The primary entrance door, set in a decorative surround with fluted pilasters, is centered on the east elevation and set beneath a full-width two-story covered porch. At the second level, an uncovered portion of the porch extends over the southern addition. Fenestration consists of fixed single-pane vinyl windows with faux divided lights in the upper third.

Photograph 115. SJ08055, 540 Ponte Vedra Boulevard.

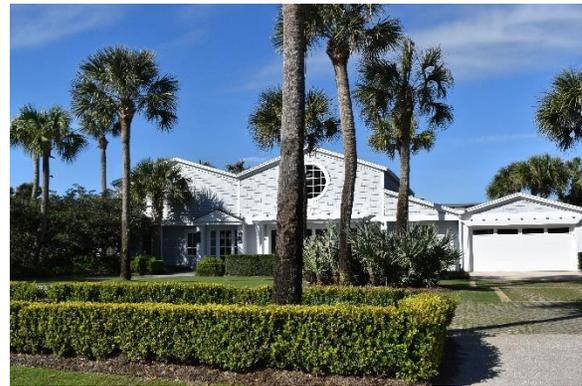
Photograph 116. SJ08056, 552 Ponte Vedra Boulevard.

The resource consists of a two-story, 1975 frame residence with paired, low-sloped front gables and a one-story front-gabled two-bay garage appended to the north side of the dwelling (Photograph 116). Roofs, punctuated with square skylights, are sheathed in asphalt shingles. While the foundation material is not visible from the public right of way, exterior walls on the first level are clad in horizontal weatherboard siding, with second-level walls clad in painted shingles. The primary entrance door has full-light, eight-pane glazing and is flanked by sidelights and a pedimented surround. A narrow pergola overhang supported by brackets is centered on the east elevation of the residence above a secondary double-leaf door with full-light glazing. A large round multi-light fixed window is situated above this door. Additional fenestration consists of six-light fixed and single-pane casement vinyl windows.

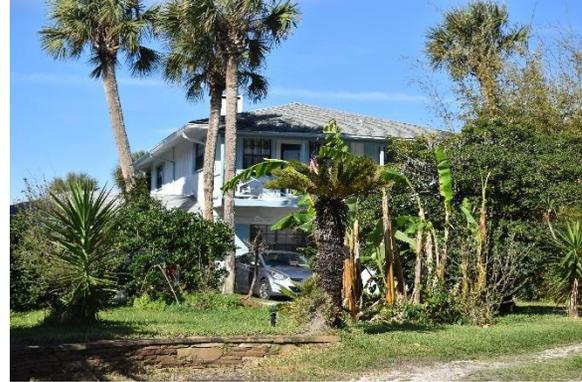
The resource consists of a two-story, 1954 hipped-roof frame residence with a single-story hipped-roof garage addition to the south (Photograph 117). The primary entrance door is situated within the northern half of the garage addition. While the foundation material is not visible from the right of way, exterior walls are clad in stucco at the first level and vertical wood siding at the second level. The hipped roofs have wide overhanging eaves and are sheathed in asphalt shingles. An interior rectangular painted brick chimney punctuates the southern slope of the hipped roof. A full-width second-story porch beneath a shed-roofed extension to the main roof form spans the upper level. Fenestration consists of six-over-six and eight-over-eight aluminum double-hung windows.

Photograph 117. SJ08057, 568 Ponte Vedra Boulevard.

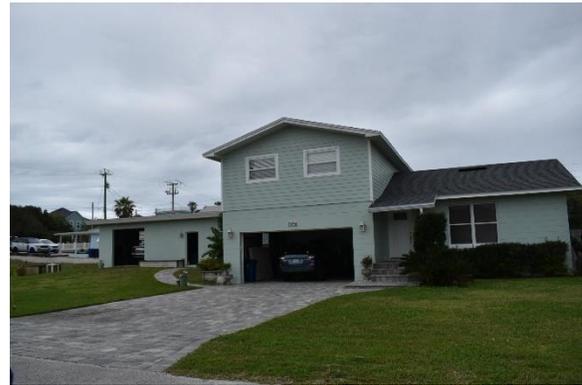
Photograph 118. SJ08058, 3870 Oak Street.

The resource consists of a two-story, 1964 Split Level residence with a built-in two-car garage and a partial-width, shed-roofed entry porch (Photograph 118). While the foundation material is not visible from the right of way, exterior walls are clad in composite horizontal siding. The front- and side-gabled roofs have wide overhanging eaves and are sheathed in asphalt shingles. Fenestration consists of one-over-one vinyl double-hung windows. A shed-roofed, one-car garage clad in stucco with aluminum jalousie windows is situated directly north of the residence.

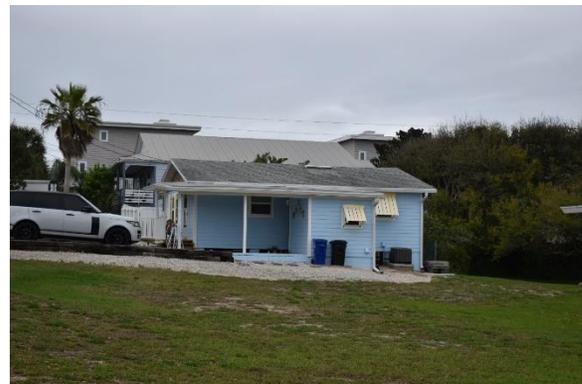
Photograph 119. SJ08059, 217 Boating Club Road.

The resource consists of a one-story, 1971 front-gabled frame residence with a partial-width, flat-roofed entry porch and a partially-

enclosed, shed-roofed carport addition to the west (Photograph 119). While the foundation material is not visible from the right of way, exterior walls are clad in horizontal wood siding with wood shingles in the gable ends. The roofs are sheathed in asphalt shingles. Fenestration consists of one-over-one vinyl double-hung windows.

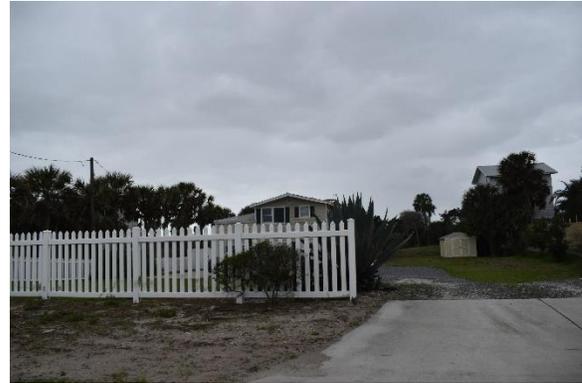
Photograph 120. SJ08060, 3245 Coastal Highway.

The resource consists of a two-story, 1975 front-gabled frame residence with a three-story uncovered deck on square wood posts situated on the north elevation (Photograph 120). The primary entrance door is centered on the second story of the north elevation and sheltered beneath a small roof overhang. While the foundation material is not visible from the right of way, exterior walls are clad in horizontal composite siding with corner boards. Roofs, including the hipped roof over a one-and-one-half story addition to the south elevation, are sheathed in standing seam metal. Fenestration consists of vinyl one-over-one and six-over-six double-hung windows. A front-gabled storage shed is situated north of the resource.

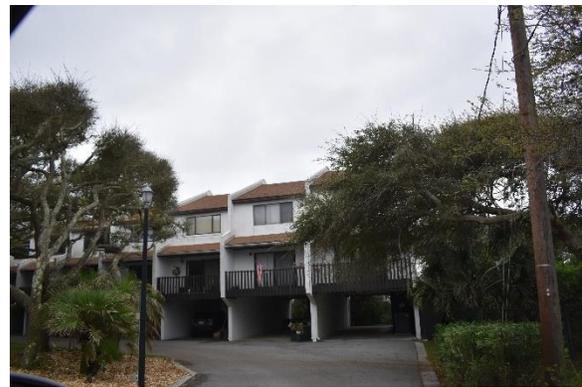
Photograph 121. SJ08061, 3145 Coastal Highway.

The resource consists of four individual three-story, 1975 condominium buildings. Each building contains eight side-gabled units with staggered setbacks and projecting party walls and parapets between units.

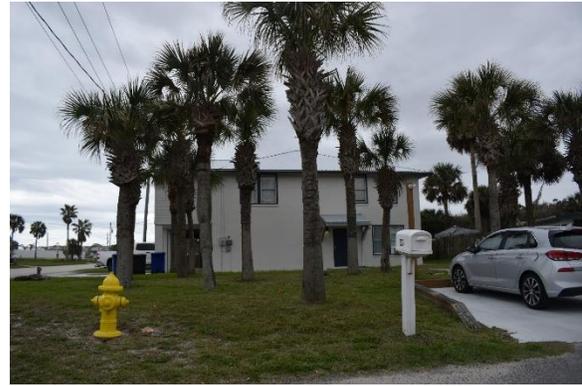
Photograph 122. SJ08062, 3125 Coastal Highway.

The resource consists of a two-story, circa-1955 frame residence with a combination hipped and front-gabled roof sheathed in standing seam metal (Photograph 122). The primary entrance door is adjacent to a built-in, partially-enclosed, one-car garage and recessed beneath a second-story, wraparound uncovered deck encircled with a wooden balustrade. Exterior walls are clad in a combination of stucco and wood weatherboard. Fenestration consists of glass block, vinyl picture, and vinyl one-over-one double-hung windows. A side-gabled, one-story duplex is located west of the primary dwelling, along with four manufactured dwellings.

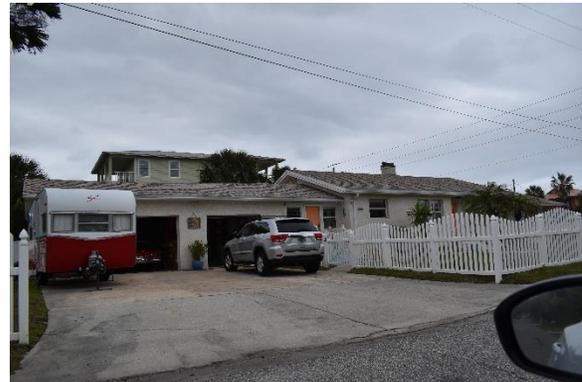
Photograph 123. SJ08063, 100 Meadow Avenue.

The resource consists of a one-story, 1950 Ranch residence with a side-gabled roof sheathed in asphalt shingles (Photograph 123). The central portion of the residence sits slightly above the two flanking wings, which are at ground level. The primary entrance door is situated on a small entry porch inset beneath the main roof form, and a secondary access door is adjacent to a built-in two-car garage. Foundation walls are not visible, but exterior walls are clad in heavily-textured stucco. An interior chimney clad in stucco punctuates the roof near the ridgeline. Fenestration consists of vinyl one-over-one double-hung windows.

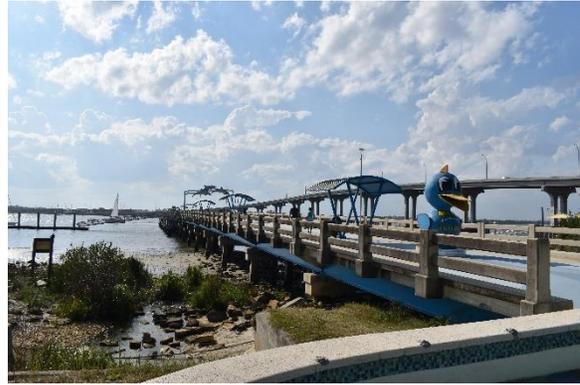
The resource consists of a 0.12-mile fishing pier with a concrete abutment, concrete supports, and concrete decking (Photograph 124). The pier was formerly part of a bridge carrying the A1A across the Tolomato River. The original wood bridge was built in the late 1920s, but damaged in hurricane. The bridge was rebuilt in 1938 with concrete and steel. This bridge, which also included a drawbridge for boats passing through the intracoastal waterway. In 1995, a larger bridge opened just north of this bridge to carry A1A traffic over the river without the need of a drawbridge. The older bridge was partially demolished, retaining this segment for use as a fishing pier.

Photograph 124. SJ08064, Vilano Road.

The resource is recommended as a contributing resource to a potential historic district under Criterion A for the development of Vilano Beach from the early twentieth century through the mid-twentieth century.

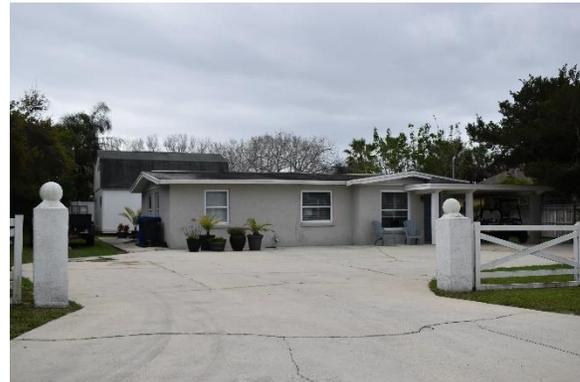
Photograph 125. SJ08065, 109 Morgan Avenue.

The resource consists of a one-story, 1955 Ranch residence with a cross-gabled, low-slope roof sheathed in rubber roofing with wide eave overhangs (Photograph 125). A flat-roofed combination entry porch and carport on large square piers wraps the north and west elevations. While foundation walls are not visible from the right-of-way, exterior walls are clad in stucco, with horizontal siding cladding the gable-ends. Fenestration consists of vinyl one-over-one double-hung windows. A one-and-one-half story outbuilding with a gambrel roof is situated south of the residence.

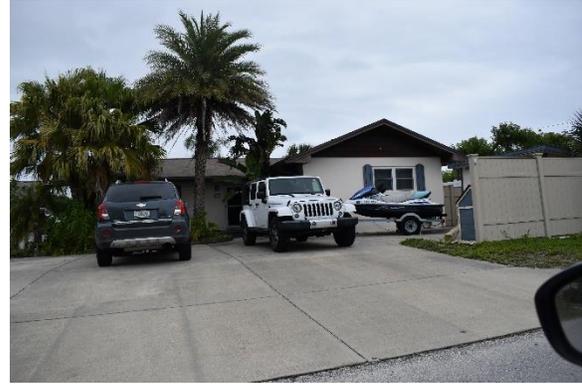
The resource consists of a one-story, 1955 Ranch residence with a cross-gabled roof sheathed in asphalt shingles and wide, boxed eave overhangs (Photograph 126). The primary entrance door is roughly centered on the primary (south) elevation and sheltered beneath the main roof form. While foundation walls are not visible from the right-of-way, exterior walls are clad in stucco, with wide horizontal siding cladding the gable-ends. Fenestration consists of vinyl one-over-one double-hung windows flanked by decorative wooden shutters. Northwest of the resource, a concrete block front-gabled garage with two infilled bays faces First Street. A shed-roofed storage building is situated south of the residence, near the front lot line.

Photograph 126. SJ08066, 112 Oak Avenue.

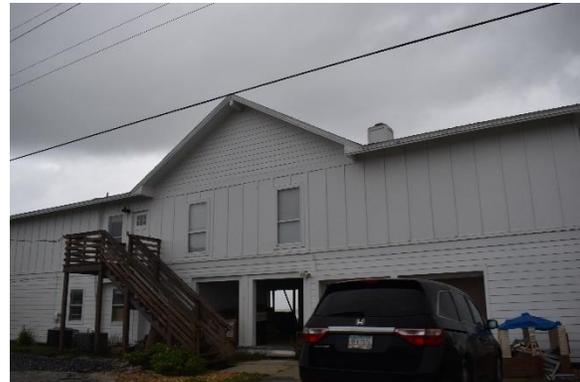
Photograph 214. SJ08154, 2643 Ponte Vedra Boulevard.

The resource is a two-story, 1976 frame vernacular dwelling (Photograph 214). The foundation material is not visible from the public right of way. The dwelling is clad in batten and weatherboard siding and capped with a cross-gable roof covered in asphalt shingle. An interior stucco-clad chimney interrupts the roof surface. Two one-car garages are located on the west elevation. The primary entrance, atop a second-story, one-bay porch, is located on the west elevation. Fenestration includes one-over-one, double-hung, wood-sash windows.

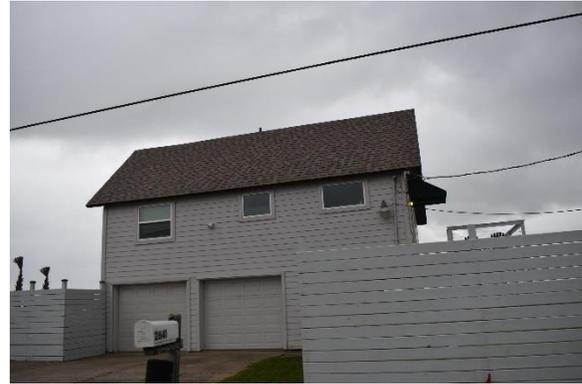
Photograph 215. SJ08155, 2641 Ponte Vedra Boulevard.

The resource is a two-story, 1969 frame vernacular dwelling (Photograph 215). The foundation material is not visible from the public right of way. The dwelling is clad in weatherboard siding and capped with a side-gable roof covered in asphalt shingle. Two one-car garages are located on the west elevation. The primary entrance is not visible from the public right of way. An obscured wraparound porch is located on the east and south elevations. Fenestration includes one-over-one, double-hung, vinyl-sash and fixed-frame windows.

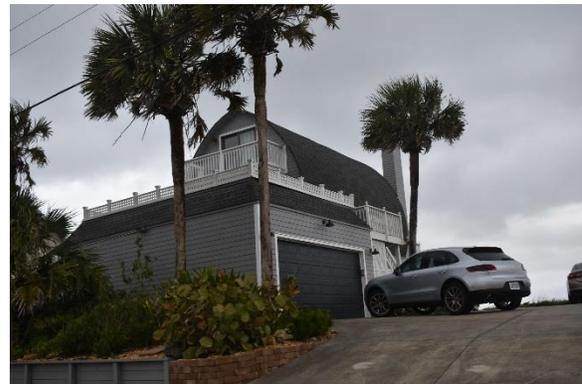
Photograph 216. SJ08156, 2619 Ponte Vedra Boulevard.

The resource is a partially obscured two-and-a-half-story, 1974 frame vernacular dwelling (Photograph 216). The foundation material is not visible from the public right of way. The dwelling is clad in weatherboard siding and capped with a bowed-arched roof covered in asphalt shingle. A shed roof dormer is located on the north elevation. A weatherboard-clad exterior chimney is located on the east elevation. A two-car garage, capped by a deck roof, is appended to the west elevation. The primary entrance is not visible from the public right of way. A mostly obscured wraparound porch is located on the west, east and south elevations. A one-bay balcony is located on the west elevation. Fenestration is not visible from the public right of way. Dense vegetation and a wood privacy fence mostly obscure the dwelling.

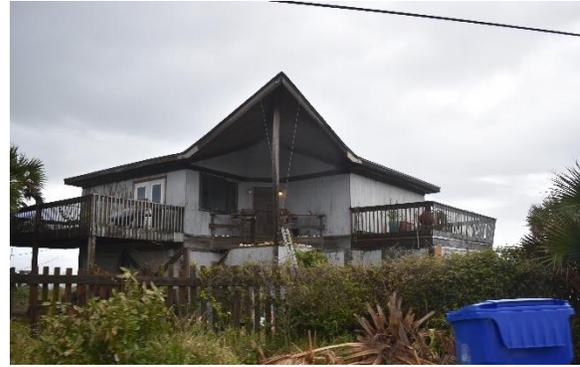
Photograph 217. SJ08157, 2595 Ponte Vedra Boulevard.

The resource is a partially obscured two-story, 1973 frame vernacular dwelling (Photograph 217). The foundation material is not visible from the public right of way. The dwelling is clad in vertical wood board siding and capped with an irregular roof covered in asphalt shingle. Two one-car garages are located on the west elevation. The primary entrance is not visible from the public right of way. A secondary double-entrance, located on a second-story wraparound porch is located on the southwest, southeast, northeast, and northwest elevations. A secondary single entrance, located on a balcony, atop a one-bay porch and sheltered beneath a gable roof supported by a wood post, is located on the west elevation. Fenestration includes a wood picture window. Dense vegetation and a wood privacy fence partially obscures the dwelling.

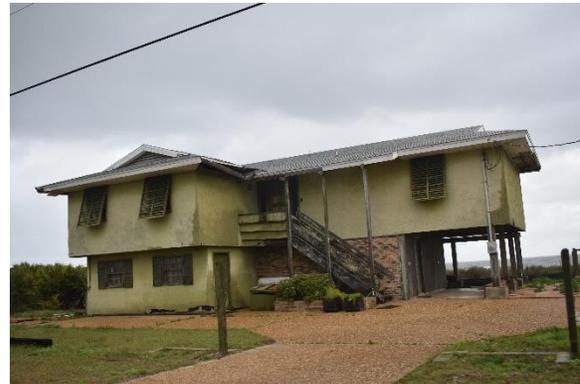
Photograph 218. SJ08158, 2593 Ponte Vedra Boulevard.

The resource is a two-story, 1975 frame vernacular dwelling (Photograph 218). The foundation material is not visible from the public right of way. The dwelling is clad in stucco siding and capped with a cross-hipped roof with gablets covered in asphalt shingle. A carport is located on the south elevation. The primary single entrance, atop a second-story, one-bay porch and sheltered beneath an extended roof supported by wood posts, is located on the west elevation. A secondary single entrance is located on the west elevation. A secondary single entry, sheltered beneath the dwelling, is located on the south elevation. An obscured porch is located on the east elevation. Fenestration includes six-over-six, double-hung, wood-sash windows. The dwelling is in a state of disrepair.

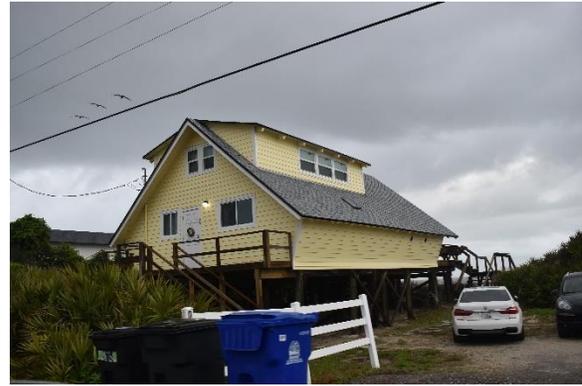
Photograph 219. SJ08159, 2591 Ponte Vedra Boulevard.

The resource is a two-and-a-half-story, 1973 frame vernacular with Craftsman elements dwelling (Photograph 219). The dwelling rests atop wood piers, is clad in weatherboard siding and capped with a front-gable roof with exposed rafters covered in asphalt shingle. The north and south elevation flair outward at the second-story. Two shed-roof dormers are located on the north and south elevations. The primary single entrance is located on the second-story of the west elevation, atop a three-bay porch and sheltered beneath the eaves. A second obscured porch is located on the east elevation. Fenestration includes one-over-one, double-hung, vinyl-sash, and horizontal slider windows.

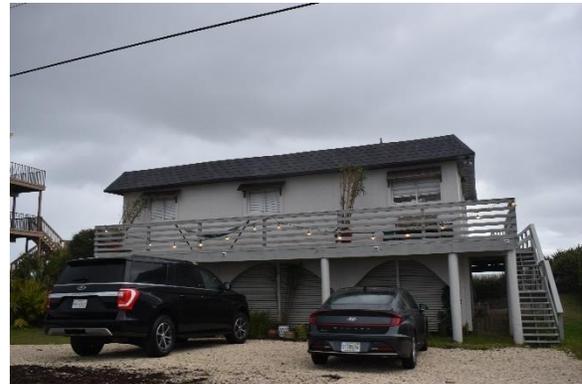
Photograph 220. SJ08160, 2589 Ponte Vedra Boulevard.

The resource is a two-story, 1973 frame-vernacular dwelling (Photograph 220). The foundation material is not visible from the public right of way. The dwelling is clad in stucco siding and capped with a deck roof covered in asphalt shingle. The west elevation includes arches lined with horizontal wood slats. The primary single entrance is not visible from the public right of way. A second-story wraparound porch is located on the west and south elevations. Fenestration includes two-over-two, double-hung, aluminum-sash and vinyl horizontal slider windows.

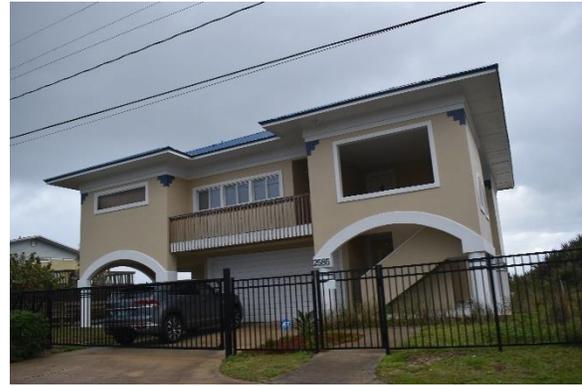
Photograph 221. SJ08161, 2585 Ponte Vedra Boulevard.

The resource consists of a two-story, 1973 frame vernacular dwelling standing three bays wide (Photograph 221). The H-shaped dwelling has a concrete foundation, is clad in stucco, and capped by a low-pitched hipped roof covered with standing seam metal. The first story is primarily open air, supported by columns. The primary entrance is located on the west elevation, recessed beneath the second story. An exterior staircase leads to a secondary entrance on the second floor. A garage door is centered on the west elevation. Fenestration consists of vinyl horizontal sliding windows and fixed-frame windows.

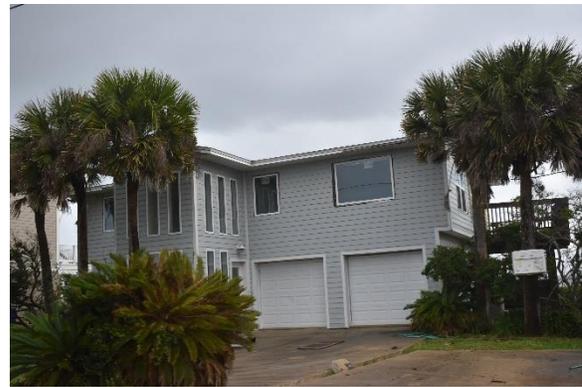
Photograph 222. SJ08162, 2583 Ponte Vedra Boulevard.

The resource consists of a two-story, 1973, frame vernacular dwelling standing four bays wide (Photograph 222). The dwelling has a concrete foundation, is clad with vinyl, and capped by a low-pitched side-gable roof covered with asphalt shingles. A front-facing gabled extension is located on the west elevation. The second story has slight overhangs on the north and south elevations. The primary entrance is located on the south elevation of the extension. Two garage doors are located in the southern bays on the west elevation. Fenestration consists of vinyl fixed-frame windows.

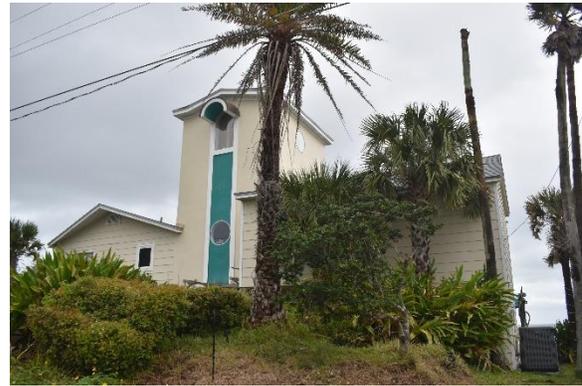
Photograph 223. SJ08163, 2579 Ponte Vedra Boulevard.

The resource consists of a two-and-a-half-story, 1973, frame vernacular dwelling standing three bays wide (Photograph 223). The dwelling has a concrete foundation, is clad with weatherboard siding, and capped by a gable roof covered with asphalt shingles. The center bay is a hipped roof tower with the additional half story. The primary entrance is located on the west elevation at the base of the tower. A garage door is located in the northern bay on the west elevation. Fenestration consists of aluminum horizontal sliding windows and fixed-frame windows. A privacy wall surrounds the property.

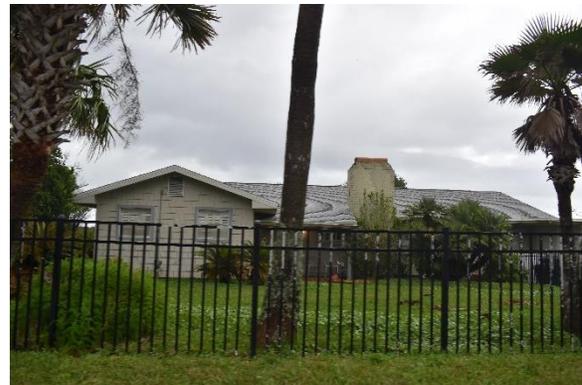
Photograph 224. SJ08164, 2577 Ponte Vedra Boulevard.

The resource consists of a one-story, 1975, Ranch dwelling standing seven bays wide (Photograph 224). The dwelling has a concrete foundation, is clad with composite shingles, and capped by a low-pitched side-gable roof covered with asphalt shingles. An exterior brick chimney is located on the west elevation. A front-gable ell extends from the west elevation, and a flat-roof attached garage is appended to the south elevation. An additional garage door is located adjacent to the addition. The primary entrance is located on the west elevation, sheltered beneath the overhanging eave. Fenestration consists of two-over-two, double-hung, aluminum-sash windows. A privacy fence surrounds the property.

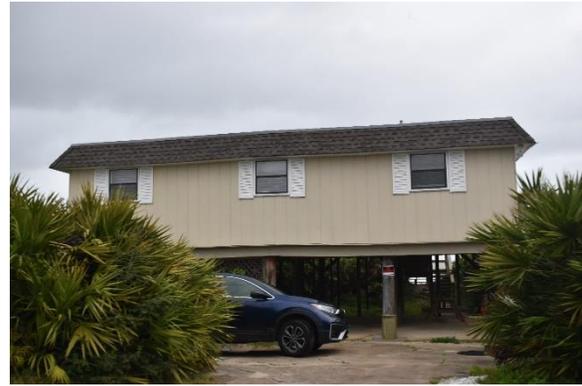
Photograph 225. SJ08165, 2575 Ponte Vedra Boulevard.

The resource consists of a one-story, 1973, frame vernacular dwelling on piers standing three bays wide (Photograph 225). The dwelling has a wood pier foundation, is clad in stucco, and capped by a flat roof with a pent roof overhand covered with asphalt shingles. An exterior staircase leads to the primary entrance on the east elevation on the elevated deck. Fenestration consists

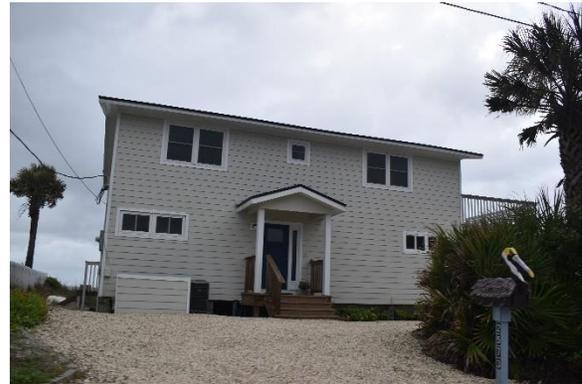
Photograph 226. SJ08166, 2573 Ponte Vedra Boulevard.

The resource consists of a two-story, 1977, frame vernacular dwelling standing three bays wide (Photograph 226). The dwelling has a pier foundation, is clad with vinyl siding, and capped by a side-gable roof covered with asphalt shingles. The primary entrance is located on the west elevation within the porch. The single-bay porch is capped with a gable roof supported by columns. A wooden balcony is appended to the south elevation. Fenestration consists of one-over-one, double-hung, vinyl-sash windows and vinyl horizontal sliding windows. A semicircular driveway is located in front of the dwelling.

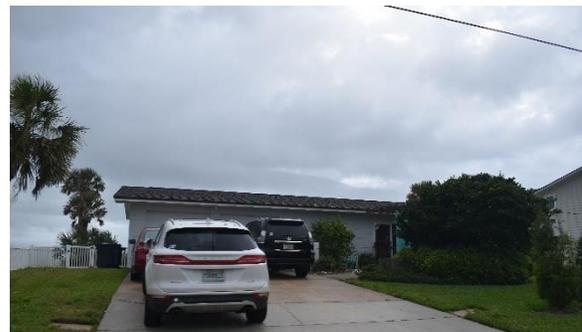
Photograph 227. SJ08167, 2571 Ponte Vedra Boulevard.

The resource consists of a one-story, 1964, Ranch dwelling standing five bays wide (Photograph 227). The dwelling has a concrete foundation, scored stucco siding, and capped by a side-gable roof covered

with asphalt shingles. Two garage doors are located in the northern bays on the west elevation. The primary entrance, a sliding glass door, is located on the west elevation sheltered beneath the roof eaves and a pergola supported by concrete block pillars. Fenestration consists of one-over-one, double-hung, vinyl-sash windows.

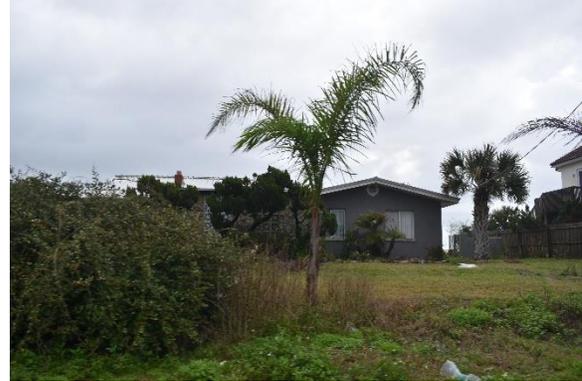
Photograph 228. SJ08168, 2561 Ponte Vedra Boulevard.

The resource consists of a one-story, 1962, Ranch dwelling standing four bays wide (Photograph 228). The dwelling has a concrete foundation, is clad in stucco and faux stone, and capped by a side gable roof covered with standing seam metal. A forward-facing gable ell is located on the south end of the west elevation. An internal brick chimney is located within the roof slope.

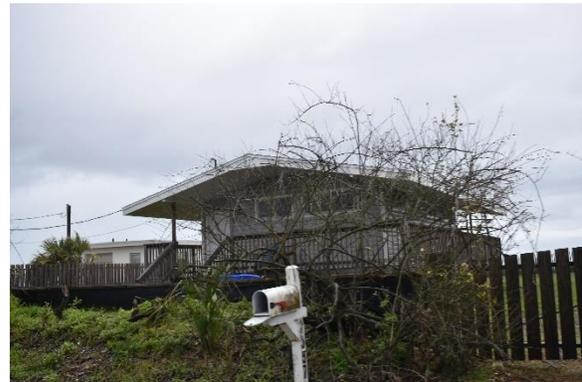
Photograph 229. SJ08169, 2557 Ponte Vedra Boulevard.

The resource consists of a one-story, 1962, frame dwelling standing three bays wide (Photograph 229). The dwelling has a pier foundation, is clad in vinyl siding, and capped by a gable roof covered in asphalt shingles. The eaves have a wide overhang, sheltering the wraparound deck. The primary entrance is located on the west elevation beneath the overhanging eaves. Fenestration includes vinyl horizontal sliding windows.

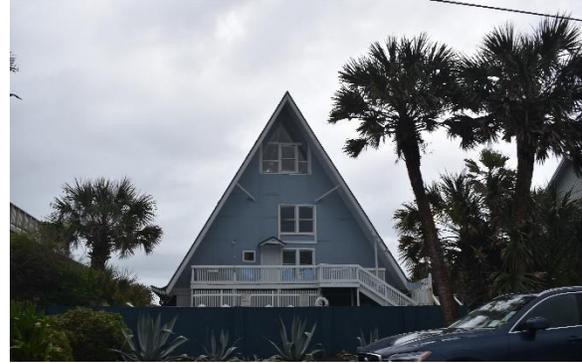
Photograph 230. SJ08170, 2541 Ponte Vedra Boulevard.

The resource consists of a one-and-a-half story, 1961, A-Frame dwelling standing a single bay wide with an exposed basement level (Photograph 230). The dwelling has a concrete block foundation, batten siding, and is capped by a steep gable roof covered with asphalt shingles. The primary entrance is located on the west elevation sheltered beneath a gable hood. Fenestration includes one-over-one, double-hung, vinyl-sash windows, fixed-frame windows.

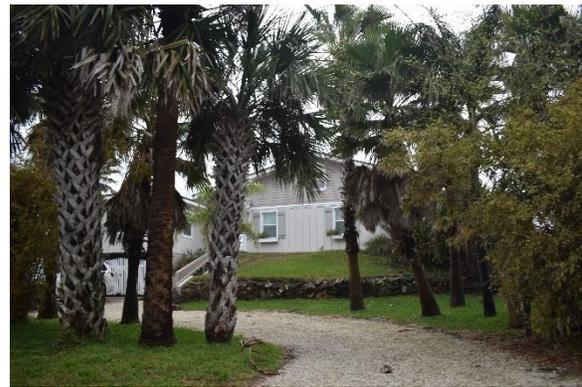
Photograph 231. SJ08171, 2539 Ponte Vedra Boulevard.

The resource consists of a one-and-a-half-story, 1959, frame vernacular dwelling standing five bays wide with an exposed basement level (Photograph 231). A garage door is located on the west elevation into the exposed basement. The dwelling has a concrete foundation, is clad with batten and vinyl siding, and capped by a gable roof covered with asphalt shingles. An internal chimney is located in the roof centerline. The primary entrance is located on the west elevation, sheltered by a flat-roof hood supported by knee braces. A balcony is located on top of the southern bay. Fenestration consists of one-over-one, double-hung, vinyl-sash windows and fixed-frame windows. A semicircular driveway is located in front of the dwelling.
