St. Johns County Andy King Reef

2022 Reef Observations and Report Authored by: Joe Kistel, Kistel Media LLC 6-27-22 Submitted to: 500 San Sebastian View St. Augustine, FL 32084 Contract #: 22-GAS-KIS-16164 U. S. Army Corps of Engineers permit: SAJ-2009-00237 (SP-BAL) [Bridge of Lions]

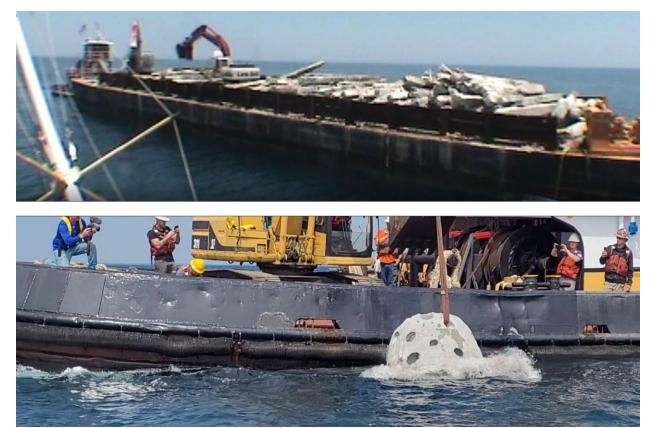
Figure 2 Andy King Reef Deployment Barge in 2010 And Reef Ball Deployment in 2021

The Andy King reef was deployed in the year 2010 utilizing concrete pilings from the dismantling of the temporary bridge that was in service during a Bridge of Lions rehabilitation project. The Andy King reef resides in SJC Bridge of Lions (BOL) artificial reef permit zone. The BOL permit site is a small deployment zone that is, at the time of this publication, SJC's only active artificial reef permit location. Since the deployment of the Andy King reef in 2010, additional reef materials have been placed in the BOL permit zone. The Honest Jim Blalock reef was created several years later just north of the Andy King reef, and in 2021 four reef balls were placed closer to the Andy King materials.

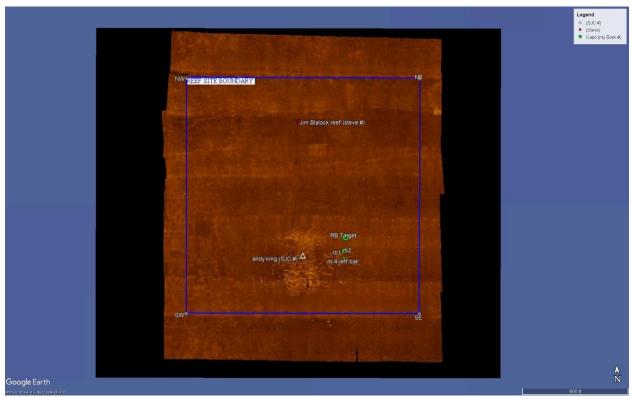
Figure 4: Zoomed in View with LAMP Sonar Survey Image Overlay Showing Underwater Structures of the Andy King Artificial Reef

The Andy King site resides in the more southwardly side of the permit boundary box. The image below demonstrates side scan imagery created by the Lighthouse Archaeological Maritime Program in 2010. This scan was generated shortly after the Andy King Reef was created but before other reef structures were added within the BOL permit boundaries. The image has been manipulated to scale appropriately with-in Google maps to provide a somewhat accurate idea of the Andy King location and boundaries within the BOL zone. Additional markings on the map image suggest where other structures have been deployed as well.
