St. Johns County Capo Reef (North and South)

2022 Reef Observations and Report

Authored by: Joe Kistel, Kistel Media LLC

8-4-2022

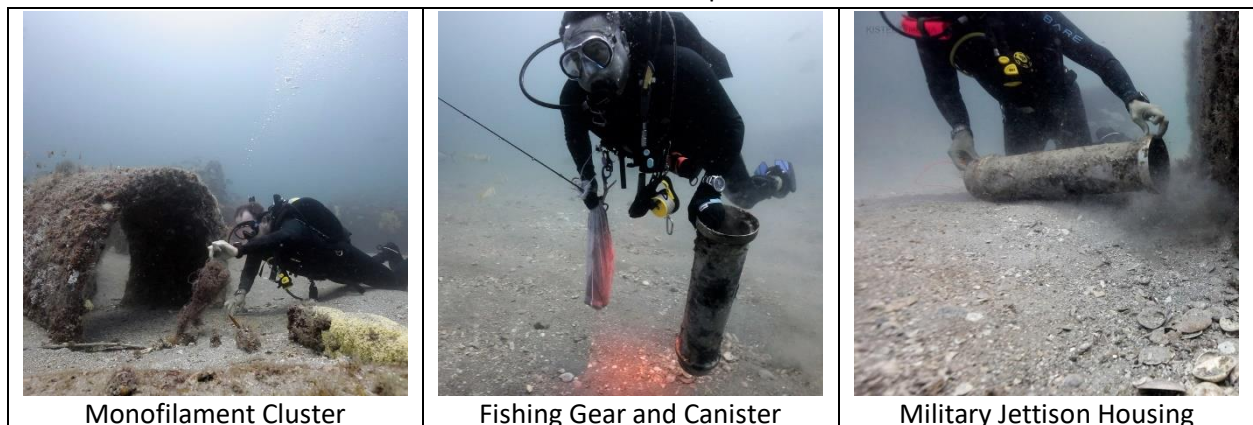
The Capo Reefs are located a further distance from the St. Augustine Inlet than the other reefs monitored during this project. Even so they have likely received moderate fishing use since the deployments in the year 2000. This was evident by items encountered down below. Fishing line was observed and some of the monofilament had attached fishing tackle including lead weights and hooks. Several sections of rope were found and recovered. A lost fishing pole and what is assumed to be a discarded military canister was retrieved.

Figure 6. Debris and Entanglement hazards Removed from Capo Reef North 6-1-22
