# St. Johns County State Route A1A

## Historic Resources Survey Report St. Johns County, Florida

GAI Project Number: R210889.00

July 2022

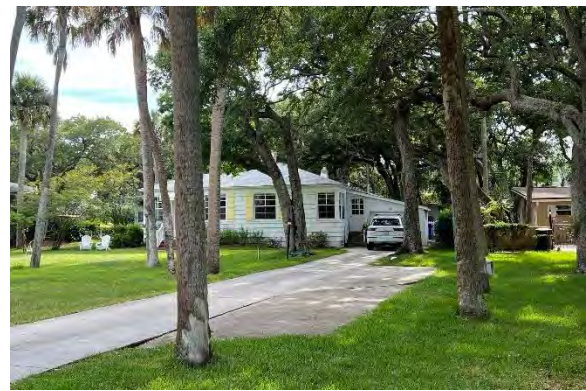
**Photograph 22. SJ03770, 54 San Juan Drive.**

The resource is a one-story, 1940 frame vernacular dwelling (Photograph 22). The dwelling rests on a parged foundation, is clad in asbestos shingle, and capped by a hipped roof covered in asphalt shingle. Two interior, brick chimneys interrupt the roof surface. A one-car garage, capped by a shed roof, is appended to the north elevation. The primary single entrance, atop a one bay porch and sheltered beneath a metal awning, is located on the east elevation. Fenestration includes four-over-four, double-hung, wood-sash windows.

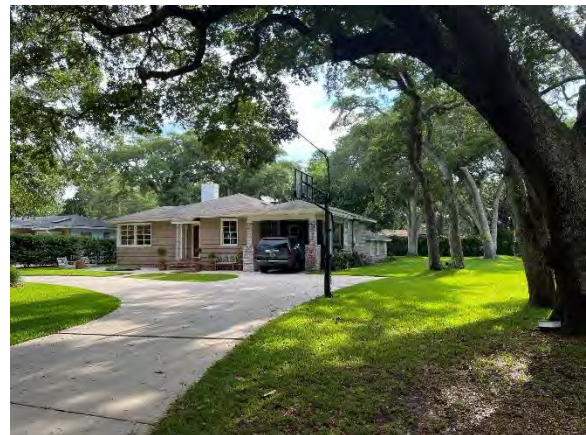
**Photograph 23. SJ03771, 58 San Juan Drive.**

The resource is a one-story, 1932 frame vernacular dwelling (Photograph 23). The dwelling rests on a parged foundation, is clad in wood shingle, and capped by a hipped roof covered in asphalt shingle. An interior, brick chimney interrupts the roof surface. The primary single entrance, atop a stoop and sheltered beneath an extended roof supported by metal posts, is located on the east elevation. A secondary single entrance,

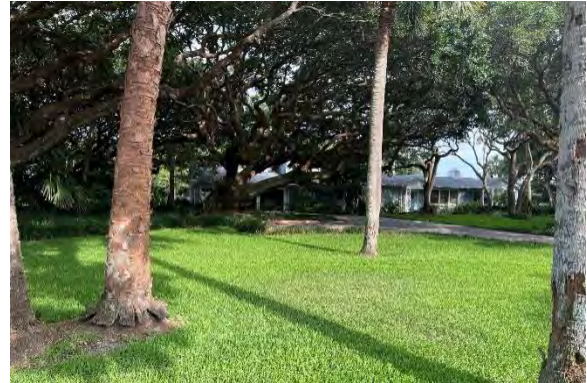
**Photograph 24. SJ03773, 55 San Juan Drive.**

The resource is a partially obscured one-and-a-half-story, 1950 frame vernacular dwelling (Photograph 23). The foundation material is not visible from the public right of way. The dwelling is clad in wood shingle, and capped by irregular roof covered in asphalt shingle. A three-car garage, capped by a gable roof, is appended to the north elevation. Several obscured one-story additions are appended to the rear elevation. The primary single entrance, atop a one-bay porch and sheltered beneath a gable roof supported by wood posts, is located on the west elevation. A secondary single entrance is located on the west elevation. Visible fenestration includes one-over-one, double-hung, vinyl-sash windows.

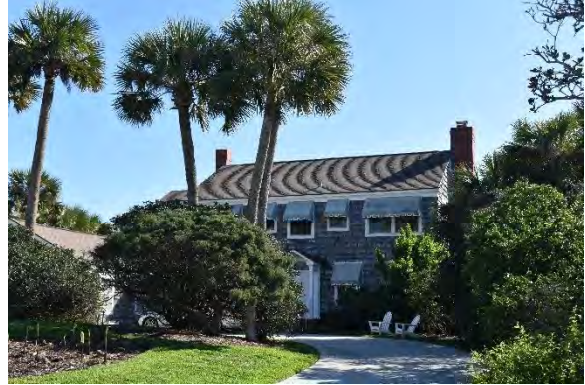
**Photograph 26. SJ03776, 131 Ponte Vedra Boulevard.**

The resource is a two-story, 1940 Georgian Revival dwelling (Photograph 26). The foundation material is not visible from the public right of way. The dwelling is clad in wood shingle siding and capped with a side-gable roof covered in asphalt shingle. A one-story, two-bay garage, capped by a gable roof, is appended to the north elevation. Two exterior brick chimneys are located on the north and south elevations. The primary single entrance with a fanlight is located on the west elevation, atop a stoop and sheltered beneath a gable roof supported by wood posts. Fenestration includes eight-over-eight, double-hung, wood-sash windows.

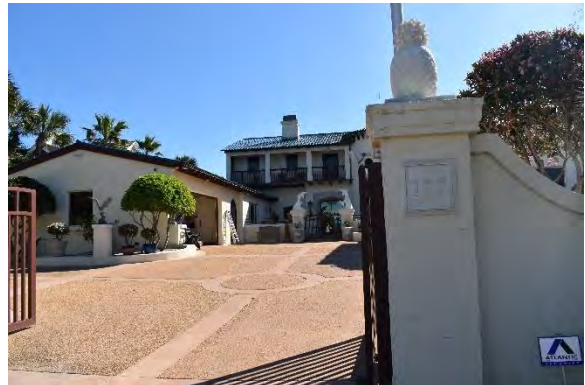
**Photograph 27. SJ03777, 137 Ponte Vedra Boulevard.**

The resource consists of a two-story, 1952, Mediterranean Revival dwelling standing five bays wide (Photograph 27). The dwelling has a concrete foundation, is clad in stucco, and capped by a low-pitched side-gable roof covered with standing seam metal. An internal chimney is located within the roof surface. A single-story addition is appended to the south corner of the west elevation and a single-story, two-car garage is appended to the north corner of the west elevation. The primary entrance is located on the west elevation, beneath a recessed balcony. A privacy wall surrounds the property.

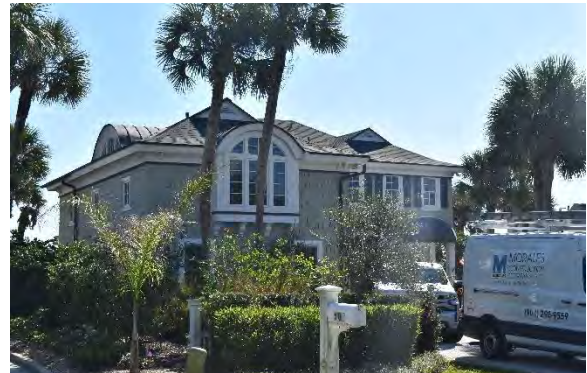
**Photograph 30. SJ03796, 307 Ponte Vedra Boulevard.**

The resource is a two-story, 1940 dwelling with Georgian Revival style elements (Photograph 30). The foundation material is not visible from the public right of way. The dwelling is clad in wood shingles and

capped with hipped roof covered in asphalt shingles. An exterior brick chimney is located on the south elevation. A central arch in the roofline is located on the east elevation and another arch on the north end of the west elevation. Corbels are located within the cornice at the corners and sides of the arches. The primary entrance is located at the southwest corner of the dwelling, recessed beneath the second story and flanked by sidelights. The recessed porch has an arch supported by a pillar and pilasters. A secondary entrance is located on the north end of the west elevation beneath a shed roof supported by a column. The primary porch is located on the east elevation overlooking the beach. Double doors open onto the porch. The porch is capped by a flat roof supported by columns. A balustrade is located atop the porch roof. Fenestration includes four-over-four, double-hung, wood-sash windows and hexagonal windows. A two-story, two-car garage is appended to the west elevation.

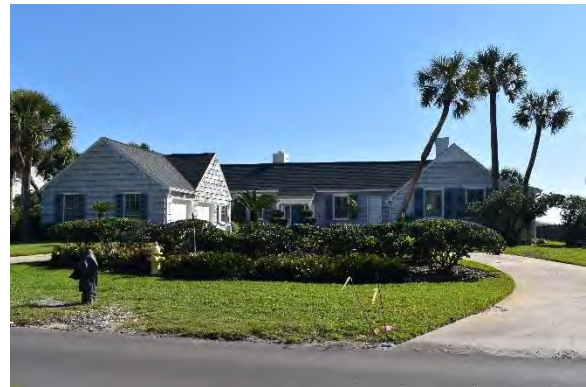
**Photograph 31. SJ03797, 309 Ponte Vedra Boulevard.**

The resource consists of a 1940, one-story Frame Vernacular dwelling (Photograph 31). The foundation material is not visible from the public right of way. The dwelling is clad in wood shingles and capped with cross-gable roof covered in asphalt shingles. Two interior brick chimneys are located within the roof slope. The primary entrance is located on the east elevation beneath a shed-roof hood supported by small pillars and flanked by sidelights. Fenestration includes six-over-six, double-hung, wood-sash windows. A two-car garage is appended to the west elevation.

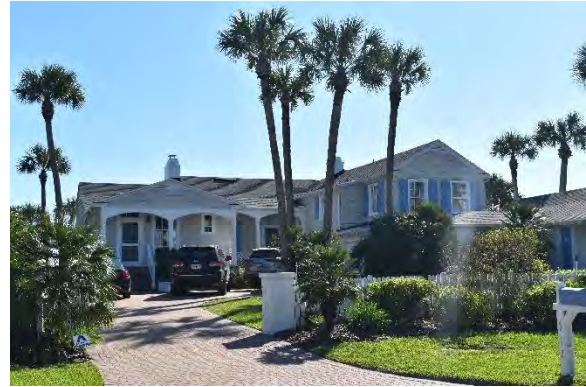
Photograph 33. SJ03801, 317 Ponte Vedra Boulevard.

The resource consists of a 1935, one-story, Frame Vernacular dwelling (Photograph 33). The foundation material is not visible from the public right of way. The dwelling is clad with wood shingles and capped with cross-gable roof covered in asphalt shingles. An external brick chimney is located on the north elevation and an internal brick chimney is located within the roof's surface. The primary entrance is located on the west elevation within the porch, capped by a gable roof supported by pillars. Fenestration includes six-over-six, double-hung, wood-sash windows, and wood-sash casement windows. A two-car, two-story garage is appended to the south end of the west elevation. A single-story, brick-clad apartment is appended to the garage.

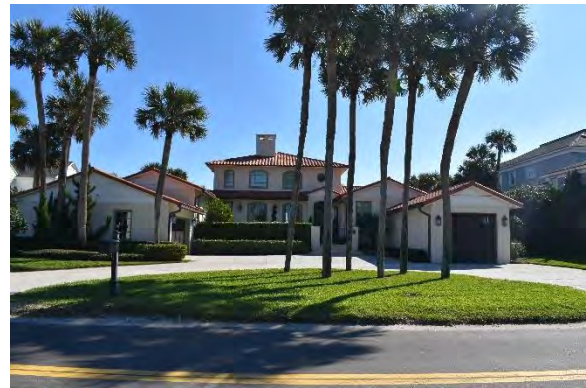
Photograph 34. SJ03802, 319 Ponte Vedra Boulevard.

The resource consists of a 1940, two-story, Mediterranean Revival dwelling (Photograph 34). The foundation material is not visible from the public right of way. The dwelling is clad with stucco siding and capped with a cross-gable roof covered with tiles. An internal brick chimney is located within the roof's surface. Single-story additions capped with front-gable roofs are appended to the north and south corner of the west elevation. The northern addition has a two-car garage, and the southern addition has a one-car garage. The primary entrance is recessed on the west elevation within a gabled entry. Fenestration includes simulated, multi-pane, fixed windows. Windows on the main portion of the dwelling are arched.

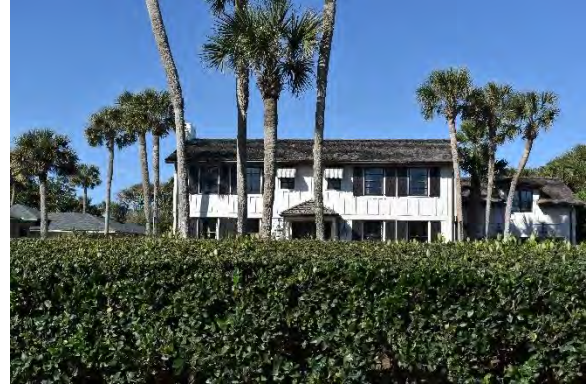
**Photograph 35. SJ03806, 328 Ponte Vedra Boulevard.**

The resource consists of a two-story 1940 side-gabled Colonial Revival residence standing six bays wide (Photograph 35). A two-story, two-bay garage dating to circa 2020 is appended to and recessed back from the north elevation and has a central shed-roofed dormer on the east elevation. The foundation material is not visible from the public right of way. Exterior walls on the first story are clad with a painted brick veneer, while the upper story is clad in board and batten wood siding. The roof is sheathed with wood or wood-look shingles. The primary entrance door, flanked by sidelights, is centered on the east elevation and sheltered beneath a bracketed hipped-roof overhang. A painted brick exterior chimney is located on the south elevation. Fenestration consists of four-over-four double-hung wood sash windows throughout.

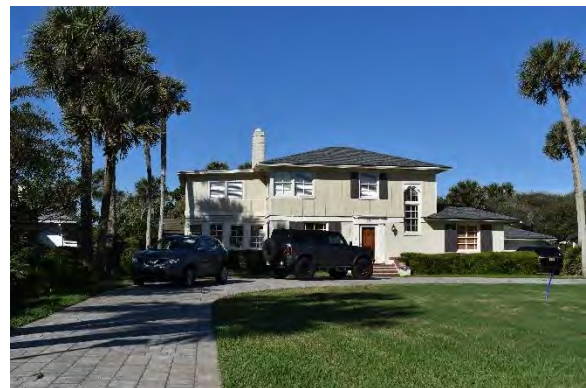
**Photograph 36. SJ03808, 330 Ponte Vedra Boulevard.**

The resource consists of a two-story 1940 Colonial Revival residence with a low-sloped hipped roof sheathed in asphalt shingles (Photograph 36). Wide overhanging eaves define the roofline. A single-story, two-bay garage is recessed back from the north elevation, while a two-story shed-roofed addition with a first-level

sunroom represents a later addition to the south. The foundation material is not visible from the public right of way. Exterior walls on the first story are clad with a painted brick veneer, while the upper story is clad in wide vertical wood board siding. The primary entrance door, set within a decorative pilaster surround, is centered on the east elevation and accessed via a set of brick steps. A painted brick interior chimney is located between the two-story southern addition and the original south elevation. Fenestration consists of eight-over-eight, four-over-four, and one-over-one double-hung wood sash windows, with a four-light transom window with clipped upper corners appearing over a stairwell window on the east elevation.

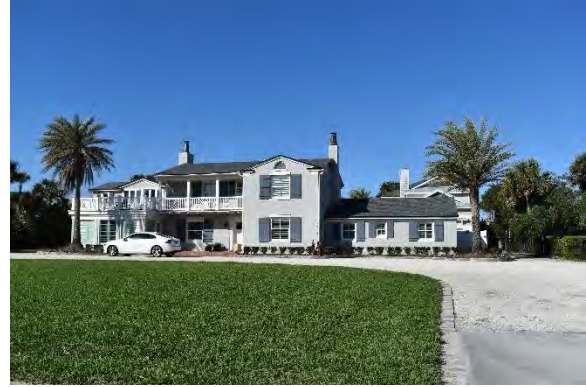
**Photograph 38. SJ03812, 340 Ponte Vedra Boulevard.**

The resource consists of a two-story, 1950 masonry Colonial Revival residence with sprawling one- and two-story additions to the north, west, and south (Photograph 38). The original portion of the resource has a low-sloped, cross-gabled roof with eave returns sheathed in asphalt shingles. While this roof type is replicated throughout the southernmost additions, a combination of hipped and cross-gabled roofs with a higher pitch are used for the northern additions and sheathed in both asphalt shingles and standing seam metal. The foundation material is not visible from the public right of way. Exterior walls throughout the oldest portion of the residence are painted brick, with stucco and wide horizontal weatherboard appearing on additions. The primary entrance door is roughly centered on the east elevation and recessed beneath a full-width second-story covered porch which extends to an uncovered deck over the easternmost portion of the southern addition. Fenestration consists of two-over-two double-hung and large single-pane fixed vinyl windows. External painted brick chimneys are centered on the north and south elevations of the original portion of the residence.

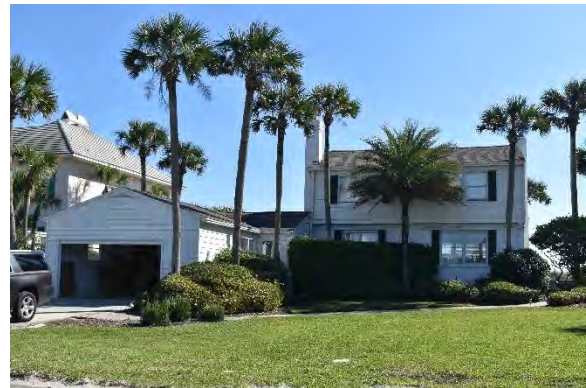
**Photograph 39. SJ03813, 343 Ponte Vedra Boulevard.**

The resource is a two-story, 1940 Georgian Revival dwelling (Photograph 39). The foundation material is not visible from the public right of way. The dwelling is clad in brick and aluminum siding and capped with a side-gable roof covered in asphalt shingle. A one-story addition and one-bay garage, capped by a gable roof, are appended to the north elevation. Two exterior brick chimneys are located on the north and south elevations. The primary entrance is not visible from the public right of way due to vegetation obstruction, but is located on the west elevation. Fenestration includes one-over-one, double-hung, wood-sash windows.

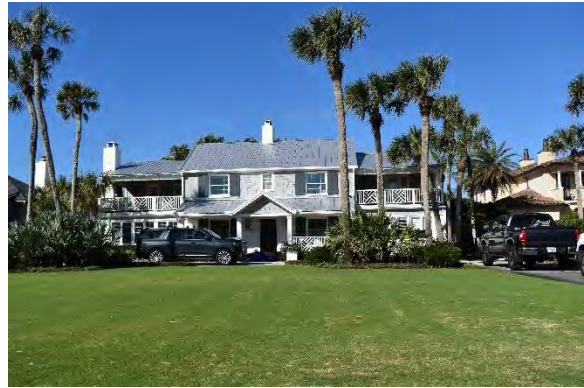
**Photograph 40. SJ03814, 350 Ponte Vedra Boulevard.**

The resource consists of a two-story, 1938 Colonial Revival side-gabled residence with two-story additions dating to circa 2012 with covered second-level porches flanking the original portion of the resource (Photograph 40). A shed-roofed, full-width entry porch with a central cross gable spans the east elevation of the central wing. Asphalt shingle roofing sheaths the primary and porch roofs on the original resource, while standing seam metal sheaths the roofs on the two-story additions to the north and south. The foundation material is not visible from the public right of way. First-level exterior walls are clad in a painted brick veneer while second-level walls are clad in composite shingles. A painted brick interior chimney punctuates the roof ridge at the center of the original dwelling. Fenestration consists of vinyl one-over-one, six-over-six and eight-over-eight double-hung and eight-light casement windows.

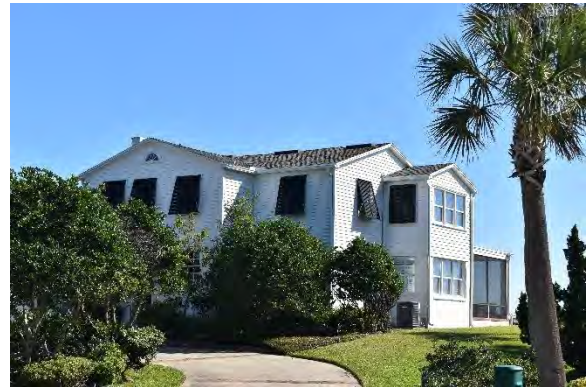
**Photograph 42. SJ03821, 405 Ponte Vedra Boulevard.**

The resource is a two-story, 1937 frame vernacular dwelling (Photograph 42). The dwelling rests on a concrete foundation, is clad in brick and weatherboard siding and capped with a side-gable roof covered in asphalt shingle. Two-story additions, capped by gable roofs, are appended to the east and west elevations. A two-story addition is appended to the south elevation. A one-story enclosed sunporch is appended to the east elevation. A one-car garage is appended to the north elevation. Two exterior brick chimneys are located on the north elevation. The primary single

entrance is located on the west elevation, atop a stoop. Fenestration includes one-over-one and six-over-six, double-hung, vinyl-sash windows and a fanlight.

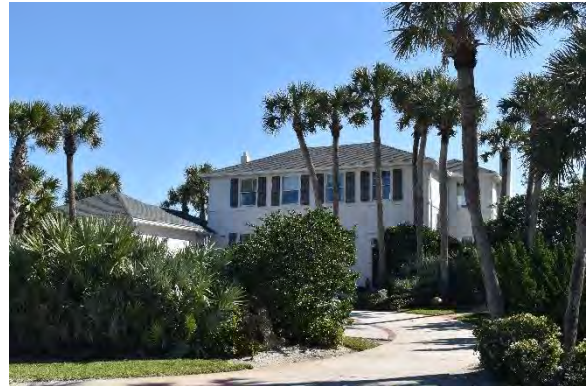
**Photograph 43. SJ03822, 407 Ponte Vedra Boulevard.**

The resource is a two-story, 1937 Georgian Revival dwelling (Photograph 43). The dwelling rests on a concrete foundation, is clad in weatherboard siding and capped with a hipped roof covered in asphalt shingle. A two-story, hipped roof addition is appended to the east elevation. An obscured one-story hipped roof addition is appended to the east elevation. A one-car garage capped by a hipped roof is appended to the north elevation. Two exterior brick chimneys are located on the north and south elevations. The primary single entrance with a transom is located on the west elevation, atop a stoop. Fenestration includes eight-over-one, double-hung, vinyl-sash windows.

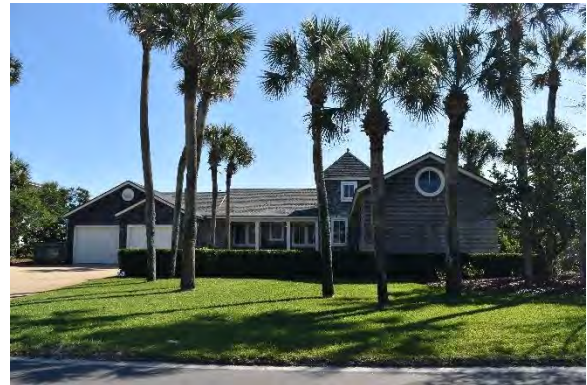
**Photograph 46. SJ03825, 415 Ponte Vedra Boulevard.**

The resource is a one-story, 1935, L-shaped, frame vernacular dwelling (Photograph 46). The dwelling rests on a concrete foundation, is clad in wood shingle and capped with a side-gable roof covered in asphalt shingle. Two obscured gable roof dormers are located on the east elevation. A one-story addition, capped by a gable roof is appended to the west elevation. An intersecting gable addition with two single-car garages, is appended to the west elevation. A two-story tower, capped by a pyramidal roof, is appended to the west elevation. The primary single entrance, atop a three-bay porch and sheltered beneath a shed roof supported by wood posts, is located on the west elevation. Fenestration includes four-pane casement windows and a porthole window.

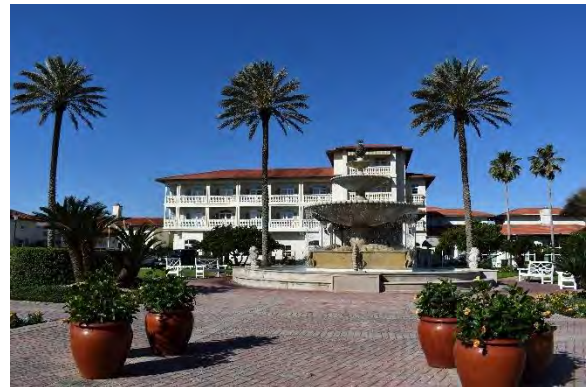
**Photograph 48. SJ03829, 200 Ponte Vedra Boulevard.**

The resource consists of a sprawling series of resort buildings constructed in the Spanish Colonial Revival style ranging from one to three stories in height (Photograph 48). Most buildings throughout the property have exterior walls clad in stucco and low-pitched hipped roofs sheathed in clay tile. Fenestration throughout consists of multi-pane fixed windows, many of which are set beneath fabric awnings or flanked by louvered shutters. Although initially developed during the 1930s, the resource has undergone significant expansions and alterations since its original construction and no longer retains visible remnants of its historic appearance.

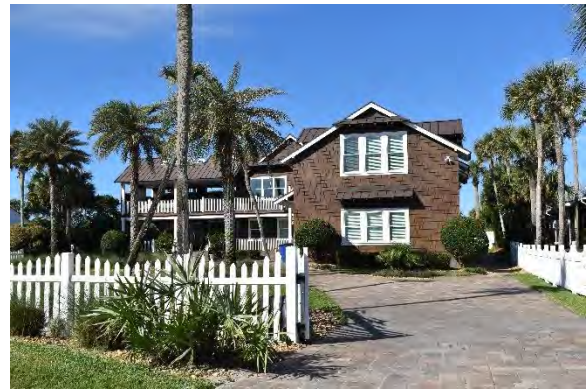
**Photograph 51. SJ03839, 514 Ponte Vedra Boulevard.**

The resource consists of a two-story, 1939 residence with major alterations dating to circa 2012 (Photograph 51). The residence includes a two-story front-gabled section which intersects with a side-gabled second-level covered porch situated over first-level enclosed living space. A gabled one-and-one-half-story two-bay garage addition to the east elevation has two garage doors facing south beneath front-gabled wall dormers. Pent roof overhangs with exposed rafter tails top first-level windows and doors on the garage addition and select second-level windows on the primary portion of the residence. Roofs are sheathed in standing seam metal. The foundation material is not visible from the public right of way; however, exterior walls are sheathed in dark stained wood shingles. Two-leaf primary entrance doors are accessed from a full-width entry porch set directly beneath the second-level full-width covered porch. Fenestration consists of vinyl one-over-one double-hung windows.

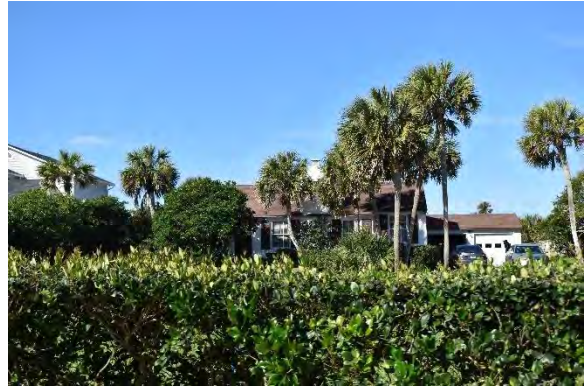
**Photograph 52. SJ03840, 516 Ponte Vedra Boulevard.**

The resource consists of a one-story, side-gabled, 1938, brick masonry Minimal Traditional dwelling with a side-gabled two-bay garage addition recessed from the east elevation at the northern elevation (Photograph 52). A wide exterior painted brick chimney is centered on the east elevation. The roof has minimal eave overhangs and is sheathed with asphalt shingles. A single-leaf offset primary entrance door is accessed via a set of brick steps. Fenestration consists of six-over-six double-hung vinyl windows, most of which are outfitted with louvered shutters.

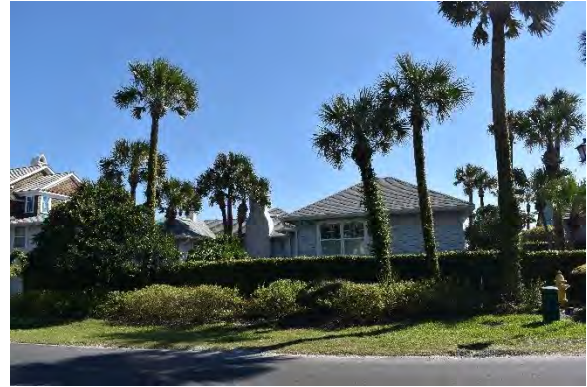
**Photograph 53. SJ03847, 531 Ponte Vedra Boulevard.**

The resource consists of a two-story, 1935 frame vernacular residence (Photograph 53). The dwelling foundation is not visible from the public right of way, but is clad with vinyl siding, and capped with a hipped roof covered with asphalt shingles. A two-story, two-car garage addition is appended to the north end of the west elevation. The primary entrance is located on the west elevation but is largely obscured from the public right of way due to the vine-covered fencing. An external brick chimney is located on the west elevation, and an internal chimney is located within the roofline. Fenestration consists of six-over-six, double-hung, wood- and vinyl-sash windows.

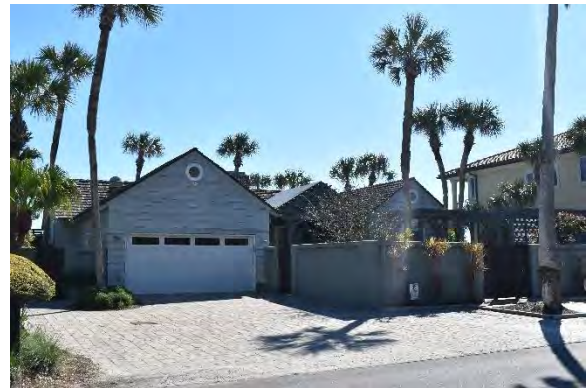
**Photograph 54. SJ03848, 533 Ponte Vedra Boulevard.**

The resource consists of a 1940, one-story, frame vernacular dwelling standing five bays wide (Photograph 54). The dwelling has a parged foundation, is clad with wood weatherboard siding, and capped with a cross-gabled roof covered in wood shingles. The resource has a roughly U-shaped footprint with a built-in, two-car garage located within the northernmost wing. An internal brick chimney with a corbeled top is located near the roof ridge. The primary entrance door is offset and recessed beneath the main roof form, and a detached, open entry porch with exposed rafter tails is centered on the primary elevation. Fenestration includes twelve-light vinyl-sash casement windows beneath four-light transoms and six-over-six double-hung windows.

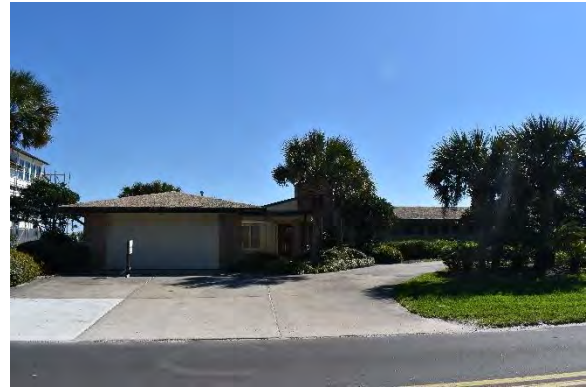
**Photograph 55. SJ03851, 545 Ponte Vedra Boulevard.**

The resource consists of a 1953, one-story, Ranch dwelling standing ten bays wide (Photograph 55). While the foundation material is not visible from the right of way, exterior walls are clad with a combination of wood board and batten siding and stacked stone veneer. The low-sloped, hipped roof, which has wide, overhanging eaves, is covered in built-up gravel roofing. The resource has an L-shaped footprint with a built-in, two-car garage located within the northernmost wing adjacent to a flat-roofed covered walkway supported by masonry piers clad in stone veneer. A prominent external chimney clad in stone veneer is situated on the primary elevation adjacent to the primary entrance door. Fenestration includes six- and four-light vinyl-sash casement windows and eight- and four-light vinyl-sash awning windows.

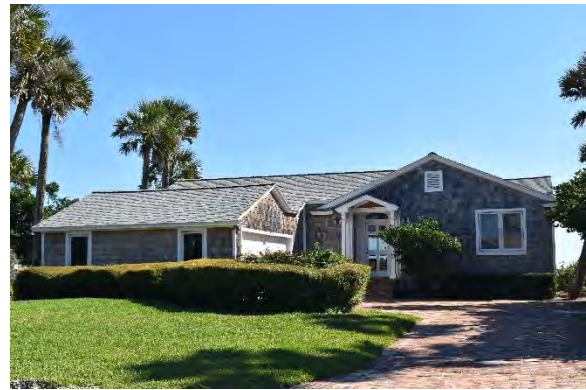
**Photograph 56. SJ03853, 547 Ponte Vedra Boulevard.**

The resource consists of a 1941, one-story, Frame Vernacular dwelling standing four bays wide (Photograph 56). While the foundation material is not visible from the right of way, exterior walls are clad with wood shingle siding. The low-sloped, cross-gable roof covered in asphalt shingles has shallow overhanging eaves. A two-car garage addition is appended to the north side of the west elevation. The primary entrance is located on the west elevation beneath a gable hood supported by columns. Fenestration includes vinyl casement windows.

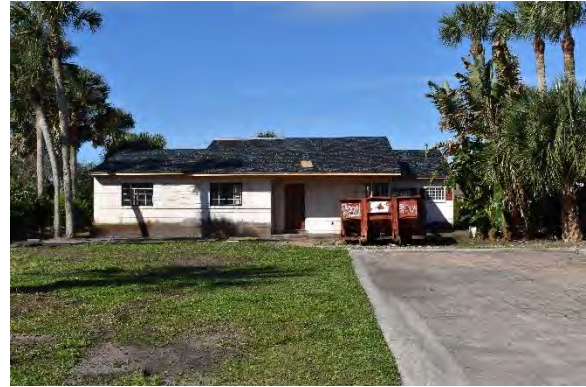
**Photograph 57. SJ03856, 554 Ponte Vedra Boulevard.**

The resource consists of a one-story, side-gabled 1952 masonry Ranch residence with a central entry door recessed beneath an overhang of the main roof form (Photograph 57). While the foundation material is not visible from the right of way, exterior walls are a combination of painted concrete masonry units with rounded corners and painted brick veneer. Roofs are sheathed in asphalt shingles. Fenestration consists of glass block, vinyl eight-over-eight double-hung, and six-light metal awning windows.

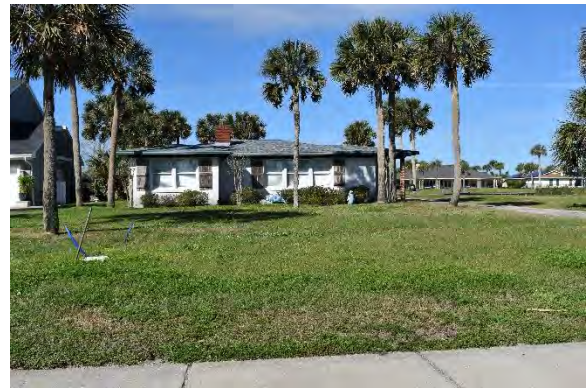
**Photograph 58. SJ03857, 562 Ponte Vedra Boulevard.**

The resource consists of a one-story, low-sloped hipped-roof 1948 Ranch residence with a roughly rectangular footprint (Photograph 58). The primary entrance door is recessed beneath the overhang of the main roof and faces north, somewhat obscured from the road. While the foundation material is not visible from the right of way, exterior walls are largely sheathed in stucco, with some variegated brick masonry appearing at the northeast corner of the resource. The roof, which has wide, overhanging boxed eaves, is sheathed in asphalt shingles and is punctuated with an unpainted interior brick chimney. Fenestration consists of one-over-one double-hung vinyl windows.

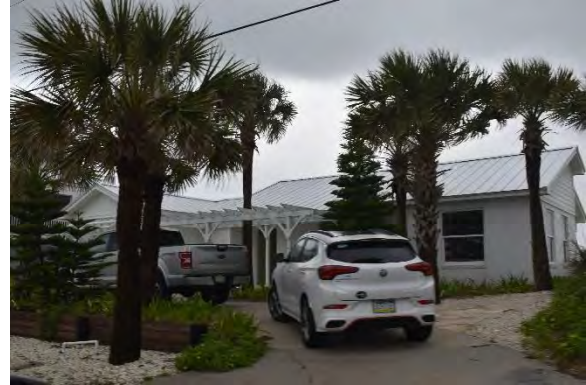
**Photograph 59. SJ03884, 2659 Ponte Vedra Boulevard.**

The resource is a partially obscured one-story, 1955 masonry vernacular dwelling (Photograph 59). The foundation material is not visible from the public right of way. The dwelling is clad in batten and concrete block and capped with a side-gable roof covered in standing-seam metal. A one-bay addition is appended to the west elevation, capped by a gable roof. An interior concrete chimney interrupts the roof surface. The primary entrance is located on the west elevation. Fenestration includes one-over-one, double-hung, wood-sash and fixed-frame windows. Large vegetation partially obscures the dwelling.

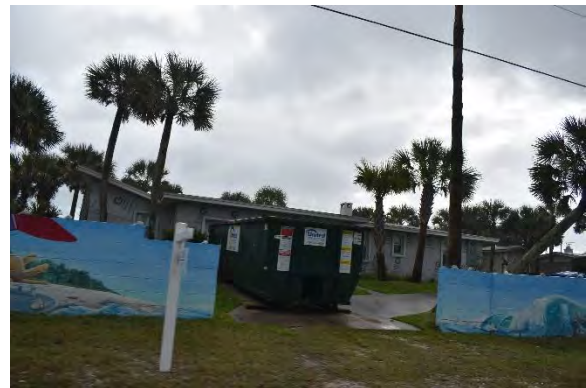
**Photograph 60. SJ03885, 2513 Ponte Vedra Boulevard.**

The resource is a partially obscured one-story, 1950 Ranch dwelling (Photograph 60). The concrete block dwelling rests atop a concrete block foundation and capped with a hipped roof covered in asphalt shingle. A one-car garage, capped by a flat roof, is appended to the north elevation. An obscured addition is located on the east elevation. An interior brick chimney interrupts the roof surface. The primary single entrance is located on the west elevation, sheltered beneath the eaves. Fenestration includes one-over-one, double-hung, wood-sash windows. A privacy wall partially obscures the property. The dwelling is currently being renovated.

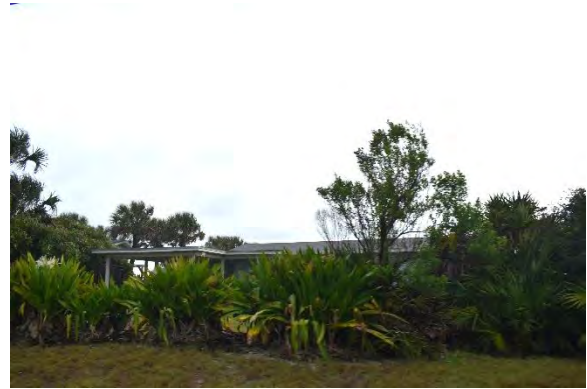
**Photograph 61. SJ03886, 2493 Ponte Vedra Boulevard.**

The resource is a one-story, 1954 Ranch dwelling (Photograph 61). The concrete block dwelling rests atop a concrete foundation and capped with a side-gable roof covered in asphalt shingle. A one-bay addition and carport, capped by a flat roof, is appended to the north elevation. The primary single entrance is located on the west elevation, sheltered beneath a shed roof supported by wood posts. Fenestration includes four-over-one, double-hung, vinyl-sash and vinyl horizontal slider windows.

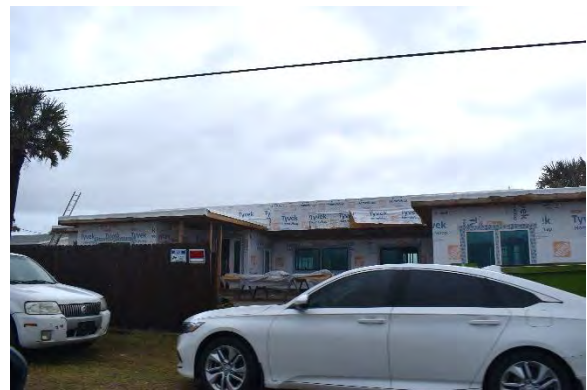
**Photograph 62. SJ03887, 2495 Ponte Vedra Boulevard.**

The resource is a partially obscured one-story, 1954 masonry-vernacular dwelling (Photograph 62). The concrete block dwelling rests atop a concrete foundation and capped with a side-gable roof covered in asphalt shingle. A one-bay addition, capped by a flat roof, is appended to the north elevation. The primary single entrance is located on the west elevation, atop a one-bay porch and sheltered beneath an extended roof supported by a wood post. Fenestration has been removed. A privacy fence partially obscures the property. The dwelling is currently under extensive renovations.

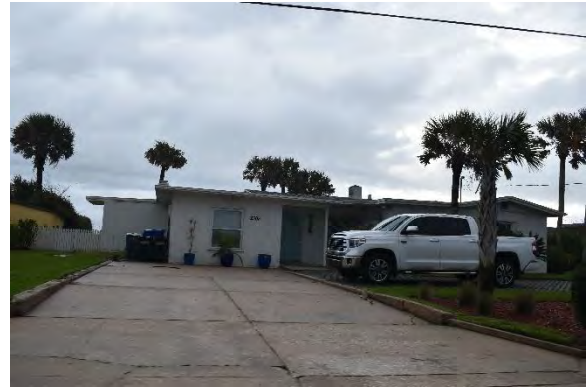
**Photograph 63. SJ03888, 2503 Ponte Vedra Boulevard.**

The resource is a one-story, 1949 Ranch dwelling (Photograph 63). The concrete block dwelling rests atop a concrete foundation and capped with a side-gable roof covered in asphalt shingle. A one-bay addition, capped by a gable roof, is appended to the west elevation. A wraparound addition, capped by a flat roof, is located on the west, north, and east elevations. An interior brick chimney interrupts the roof surface. The primary single entrance is located on the west elevation, atop a two-bay porch and sheltered beneath an extended roof supported by a wood post. Fenestration includes one-over-one, double-hung, vinyl-sash and six-over-six, double-hung, wood-sash windows.

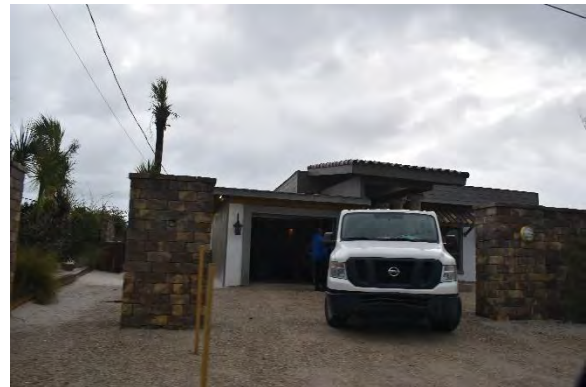
**Photograph 64. SJ03889, 2505 Ponte Vedra Boulevard.**

The resource is a mostly obscured one-story, 1952 masonry-vernacular dwelling (Photograph 64). The concrete block dwelling rests atop a concrete block foundation and capped with a flat roof covered in asphalt. A one-car garage, capped by a flat roof, is appended to the north elevation. An obscured addition is located on the south elevation. The primary single entrance is located on the west elevation, sheltered beneath a shed roof covered in tile and supported by Ionic columns. Fenestration is not visible from the public right of way. A privacy wall mostly obscures the property.

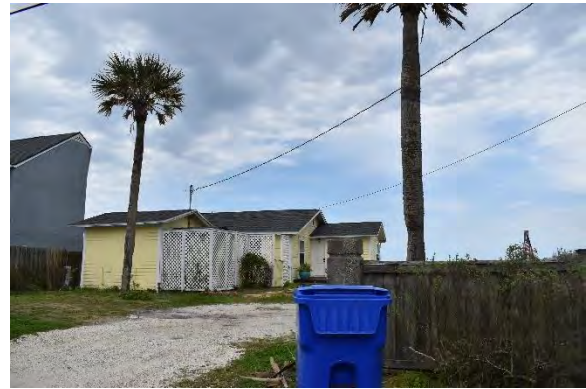
**Photograph 65. SJ03891, 2871 Ponte Vedra Boulevard.**

The resource is a one-story, 1947 frame vernacular dwelling (Photograph 65). The foundation material is not visible from the public right of way. The dwelling is clad in weatherboard siding and capped with a side-gable roof covered in asphalt shingle. A gable roof addition is appended to the west elevation, connected to the dwelling by a gable walkway. A gable roof addition is appended to the south elevation. The primary entrance is located on the south elevation addition, atop a one-bay porch and sheltered beneath the eaves. Fenestration includes three-over-one, double-hung, wood-sash windows. A wood latticework fence partially obscures the dwelling.

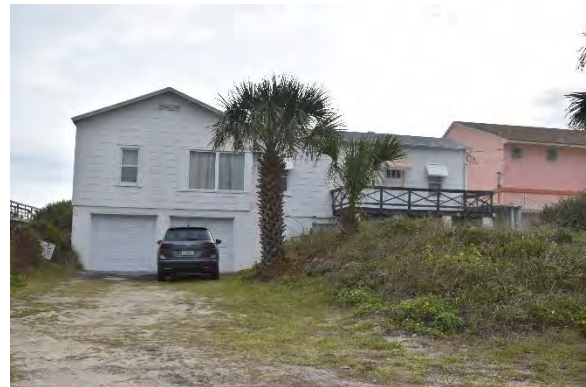
**Photograph 66. SJ03898 / SJ05454, 3148 Coastal Highway.**

The resource consists of a two-story, 1948 cross-gabled masonry and frame residence with a two-car garage situated on the first level on the west elevation (Photograph 66). The primary entrance door is situated on the second story of the west elevation and accessed from an uncovered, partial-width deck. Exterior concrete block walls on the first level are painted, while the upper story is clad in asbestos shingles. The roof, which has little to no eave overhang, is sheathed in asphalt shingles. Fenestration consists of fixed and one-over-one double-hung vinyl windows, some of which are set beneath awnings.

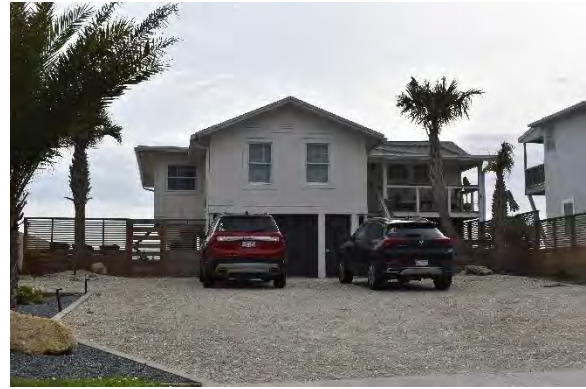
Photograph 67. SJ03899, 3156 Coastal Highway.

The resource consists of a two-story, 1948 cross-gabled residence with a built-in one-car garage on the first level of the west elevation (Photograph 67). The primary entrance door is situated beneath a partial-width, shed-roofed entry porch on the second level of the west elevation. Exterior walls are clad in stucco on the first level and board and batten siding on the upper level, while the roof is sheathed in asphalt shingles. Fenestration consists of six-over-one double-hung vinyl windows.

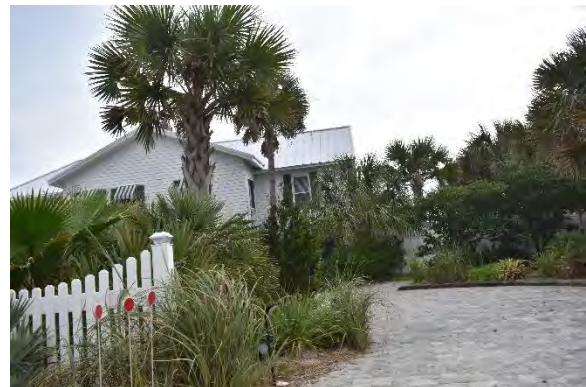
Photograph 68. SJ03900, 3200 Coastal Highway.

The resource consists of a two-story, 1957 cross-gabled residence with a built-in three-car garage on the first level (Photograph 68). The dwelling is largely obscured by vegetation. The primary entrance door is situated on the west elevation with no associated entry porch or overhang. Exterior walls are clad in horizontal weatherboard siding on the first level and composite shingles on the upper level, while the roof is sheathed in standing seam metal. Fenestration consists of one-over-one double-hung vinyl windows flanked by louvered shutters.

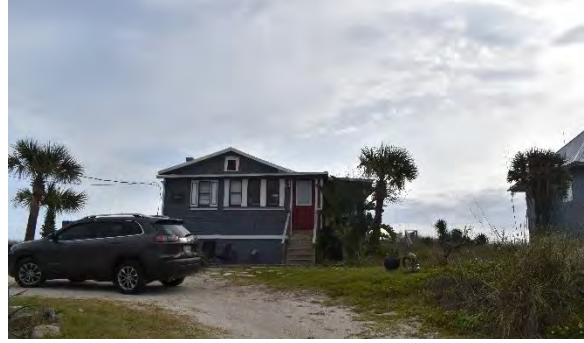
Photograph 69. SJ03901, 3216 Coastal Highway.

The resource consists of a one-story, 1935 front-gabled residence (Photograph 69). The primary entrance door is offset on an enclosed shed-roofed entry porch on the west elevation. Exterior walls are clad in horizontal weatherboard siding and vertical plank siding, while the roof is sheathed in asphalt shingles. An exterior painted brick chimney is centered on the north elevation. Fenestration consists of one-over-one double-hung wood windows flanked by paneled shutters.

The resource is recommended eligible for the NRHP under Criterion A for its association to the development of the North Beach area during the early twentieth century.

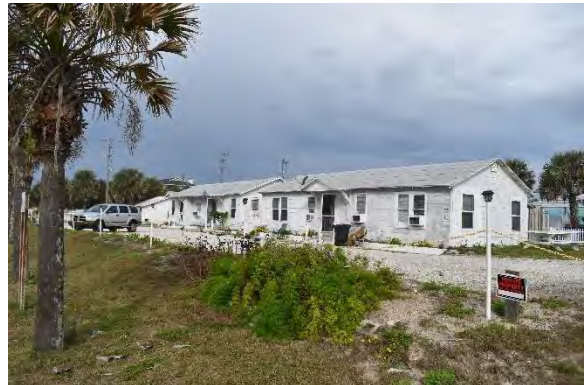
Photograph 70. SJ03904, 3080 Coastal Highway.

The resource consists of six one-story, 1948 and 1958 frame dwellings used as vacation rentals (Photograph 70). The easternmost four residences are side-gabled and clad in wide shingle siding. Roofs, with exposed rafter tails, are sheathed in tar paper.

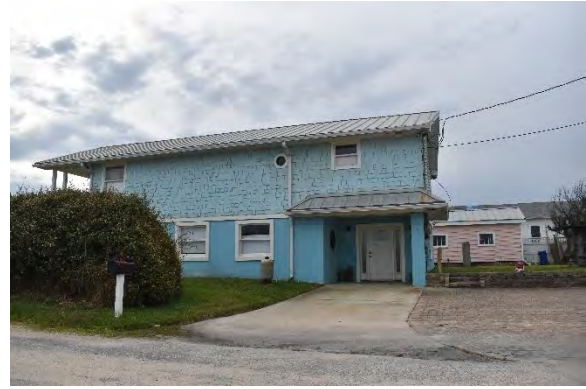
Photograph 73. SJ03908, 11 Surfside Avenue.

The resource consists of a two-story, 1973 side-gabled frame residence with a primary entrance door flanked by sidelights recessed beneath a partial-width, partially-inset entry porch at the northwest corner (Photograph 73). A small, hipped roof overhang extends from the entry porch. Exterior walls are clad in stucco at the first level and composite shingles at the second level, while the roof is sheathed in standing seam metal. Fenestration consists of vinyl fixed and one-over-one windows. A two-story, full-width open porch spans the eastern elevation. A one-story, front-gabled secondary residence clad in weatherboard siding is situated southwest of the primary residence.

The resource is recommended as a contributing resource to a potential historic district under Criterion A for the development of Vilano Beach from the early twentieth century through the mid-twentieth century.

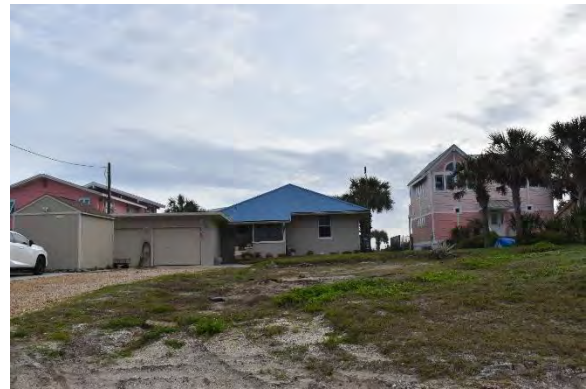
Photograph 74. SJ03909, 3024 Coastal Highway.

The resource consists of a one-story, 1950 hipped-roof, masonry vernacular residence with a flat-roofed, two-car garage addition to the west elevation (Photograph 74). The resource is clad with concrete blocks. The primary entrance door is offset on the west elevation beneath a partial-width entry porch which is partially enclosed with a patterned screen. Exterior concrete block walls are painted, while the roof is sheathed in standing seam metal. Fenestration consists of vinyl one-over-one double-hung windows. A front-gabled storage shed is located immediately west of the resource.

The resource is recommended as a contributing resource to a potential historic district under Criterion A for the development of Vilano Beach from the early twentieth century through the mid-twentieth century.

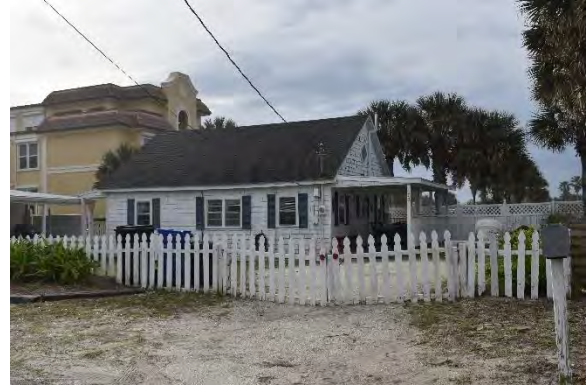
Photograph 75. SJ03911, 103 Palmetto Avenue.

The resource consists of a one-story, 1947 side-gabled frame vernacular residence with shed-roofed open porches spanning the east and west elevations (Photograph 75). The primary entrance door is situated on the west elevation beneath the full-width shed-roofed porch. Exterior walls are clad in painted wood shingles, while the roof is sheathed in asphalt shingles. Fenestration consists of wood two-over-two double-hung windows flanked with decorative shutters.

The resource is recommended as a contributing resource to a potential historic district under Criterion A for the development of Vilano Beach from the early twentieth century through the mid-twentieth century.

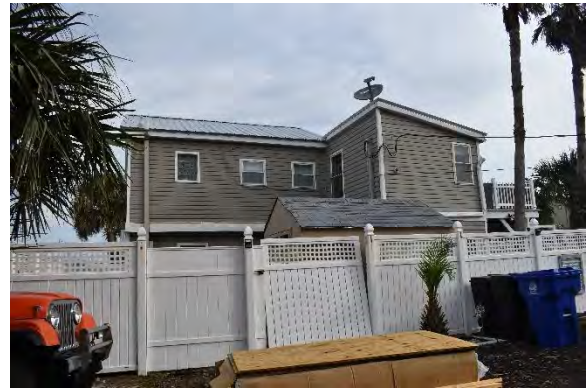
Photograph 76. SJ03912, 2930 Coastal Highway.

The resource consists of a two-story, 1935 frame vernacular residence with a combination front-gabled and shed roof (Photograph 76). The primary entrance door is situated on the second story of the north elevation beneath a shed-roofed, partial-width porch. Exterior walls are clad in horizontal vinyl siding, while the roof is sheathed in asphalt shingles. Fenestration consists of glass block and vinyl one-over-one double-hung windows. A one-story, front-gabled circa-2000 secondary residence with vinyl one-over-one double-hung windows is situated just north of the resource.

The resource is recommended as a contributing resource to a potential historic district under Criterion A for the development of Vilano Beach from the early twentieth century through the mid-twentieth century.

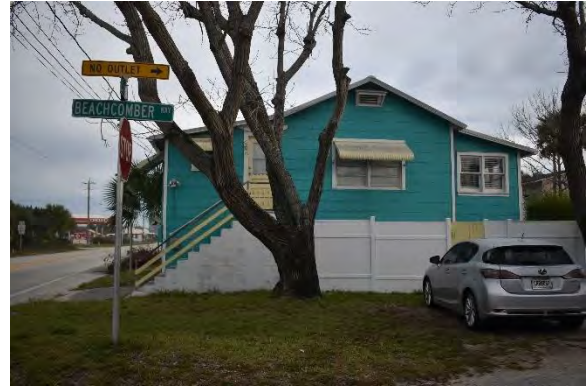
Photograph 77. SJ03914, 50 Beachcomber Way.

The resource consists of a two-story, 1946 front-gabled frame vernacular residence with low-sloped, shed-roofed additions to the east and west (Photograph 77). The primary entrance door is offset on an uncovered porch on the second level of the south elevation and accessed from a wide set of concrete block steps. Exterior walls are clad in asbestos shingle siding with corner boards, while the roof is sheathed in asphalt shingles. Fenestration consists of wood two-over-two and vinyl one-over-one double-hung windows, most of which are set beneath scalloped metal awnings.

The resource is recommended as a contributing resource to a potential historic district under Criterion A for the development of Vilano Beach from the early twentieth century through the mid-twentieth century.

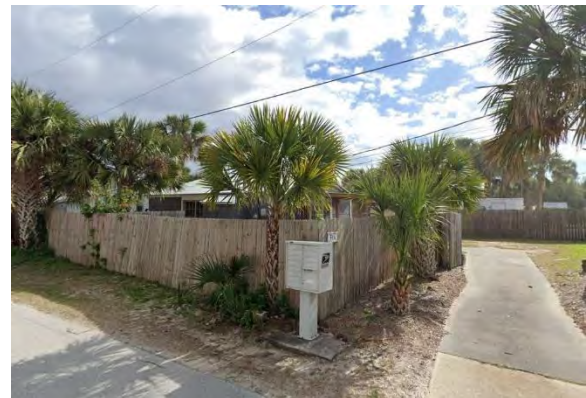
Photograph 78. SJ03915A, 51A Beachcomber Way.

The resource consists of a one-story, 1970 frame vernacular dwelling with a shed-roofed bay extending on the north elevation (Photograph 78). The dwelling is clad with asbestos siding and capped with a gable roof covered with standing seam metal. The primary entrance is located on the west elevation beneath a shed roof. Fenestration consists of six-over-six, double-hung, vinyl-sash windows. A gable-roof shed is located south of the dwelling.

The resource is recommended as a contributing resource to a potential historic district under Criterion A for the development of Vilano Beach from the early twentieth century through the mid-twentieth century.

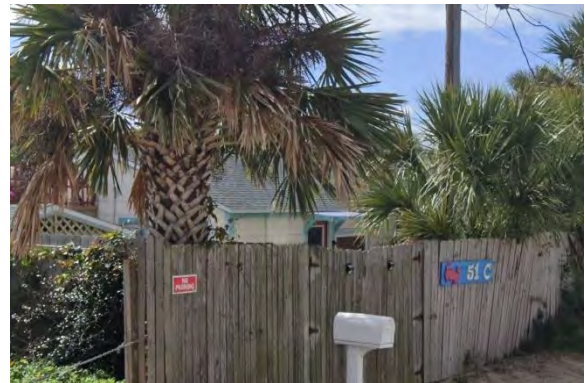
**Photograph 80. SJ03915C, 51C Beachcomber Way.**

The resource consists of a one-story, 1971 frame vernacular dwelling (Photograph 80). The dwelling is clad with asbestos siding and capped with a side-gable roof covered with asphalt shingles. The primary entrance is located on the north elevation beneath a shed-roof hood. Fenestration is not visible from the public right of way.

The resource is recommended as a contributing resource to a potential historic district under Criterion A for the development of Vilano Beach from the early twentieth century through the mid-twentieth century.

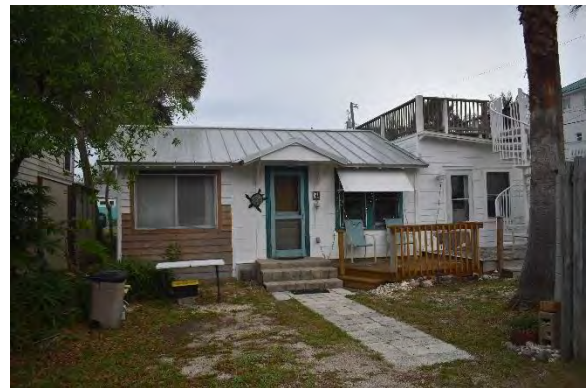
**Photograph 82. SJ03916, 2854 #4 Coastal Highway.**

The resource consists of a one-story, 1970 side-gabled frame vernacular residence with a shed-roofed addition to the east situated beneath an uncovered rooftop deck (Photograph 82). The primary entrance door is situated on the south elevation beneath a front-gabled roof overhang. Exterior walls are clad in horizontal weatherboard siding, while the roof is sheathed in standing seam metal. Fenestration consists of aluminum sliding and one-over-one double-hung, along with vinyl one-over-one double-hung windows.

The resource is recommended as a contributing resource to a potential historic district under Criterion A for the development of Vilano Beach from the early twentieth century through the mid-twentieth century.

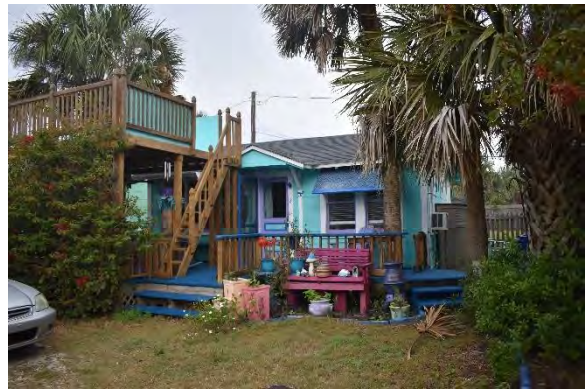
**Photograph 84. SJ03918, 2854 #2 Coastal Highway.**

The resource consists of a one-story, 1970 side-gabled frame vernacular residence with an uncovered, full-width entry porch situated beneath a second-story uncovered deck (Photograph 84). The primary entrance door is centered on the south elevation and situated beneath a front-gabled bracketed overhang. Exterior walls are clad in horizontal asbestos siding with corner boards, while the roof is sheathed in asphalt shingles. Fenestration consists of wood one-over-one double-hung windows, some of which appear beneath bracketed awnings.

The resource is recommended as a contributing resource to a potential historic district under Criterion A for the development of Vilano Beach from the early twentieth century through the mid-twentieth century.

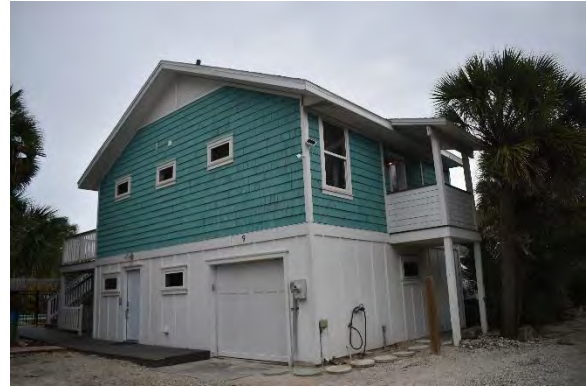
**Photograph 85. SJ03920, 2854 #9 Coastal Highway.**

The resource consists of a two-story, 1977, gabled frame vernacular residence with a built-in, one-car garage at the first level (Photograph 85). The primary entrance door is offset on the first story of the west elevation and accessed from an uncovered, partial-width entry porch. Exterior walls are clad in wood board and batten siding at the first story and painted shingles at the second story, while the roof is sheathed in asphalt shingles. An uncovered, two-story deck is situated on the north elevation and a two-story, shed-roofed porch is centered on the south elevation. Fenestration consists of vinyl awning and one-over-one double-hung windows.

The resource is recommended as a contributing resource to a potential historic district under Criterion A for the development of Vilano Beach from the early twentieth century through the mid-twentieth century.

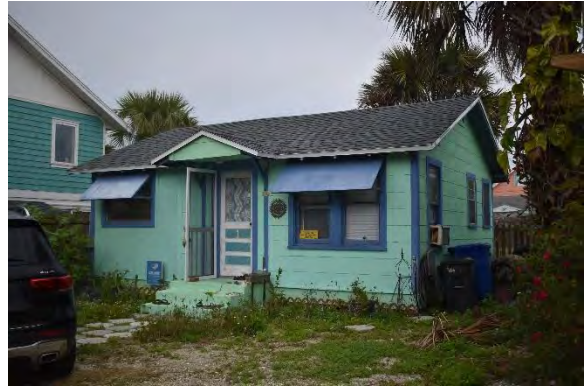
**Photograph 133. SJ08073, 2854 #1 Coastal Highway.**

The resource consists of a one-story, 1970 side-gabled frame vernacular residence with a bracketed, front-gabled entry roof overhang (Photograph 133). The primary entrance door is centered on the south elevation and accessed from a partial-width poured concrete entry porch. Exterior walls are clad in horizontal asbestos siding and vertical wood siding with corner boards, while the roof, which has exposed rafter tails, is sheathed in asphalt shingles. Fenestration consists of wood and aluminum one-over-one double-hung windows, some of which are situated beneath bracketed awnings.

The resource is recommended as a contributing resource to a potential historic district under Criterion A for the development of Vilano Beach from the early twentieth century through the mid-twentieth century.

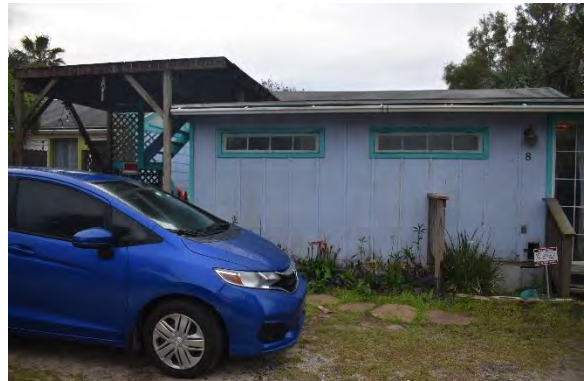
**Photograph 134. SJ08074, 2854 #8 Coastal Highway.**

The resource consists of a one-story, 1970 side-gabled frame vernacular residence with a shed-roofed addition to the north elevation and a second-story, uncovered deck (Photograph 134). The primary entrance door is offset on the north elevation and accessed from an uncovered, partial-width entry porch. Exterior walls are clad in wood board and batten siding, while the roof is sheathed in asphalt shingles. Fenestration consists of wood four-pane awning windows.

The resource is recommended as a contributing resource to a potential historic district under Criterion A for the development of Vilano Beach from the early twentieth century through the mid-twentieth century.
