# St. Johns County State Route A1A

## Historic Resources Survey Report St. Johns County, Florida

GAI Project Number: R210889.00

July 2022

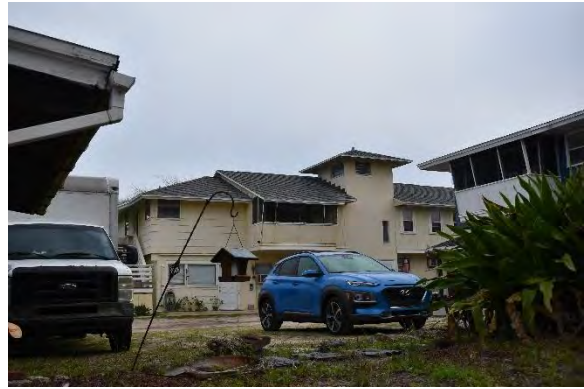
Photograph 135. SJ08075, 2912 Coastal Highway.

The resource consists of a two-story, 1973 combination side-gabled and hipped-roof multi-family residence with a two-and-a-half-story tower centered on the south elevation (Photograph 135). Two primary entrance doors are offset on the first story of the south elevation and recessed beneath a cantilevered second story. Upper-story primary entrance doors are situated on the west and south elevations, respectively, beneath partial-width, shed-roofed entrance porches. A full-width, enclosed porch spans the east elevation at the second story, while a partial-width, shed-roofed enclosed porch is situated on the south elevation at the second story. Exterior concrete block walls at the first story are painted, while second-story walls are clad in wide horizontal and vertical wood siding. The roof is sheathed in asphalt shingles. Fenestration consists of aluminum and vinyl one-over-one double-hung and awning windows.

The resource is recommended as a contributing resource to a potential historic district under Criterion A for the development of Vilano Beach from the early twentieth century through the mid-twentieth century.

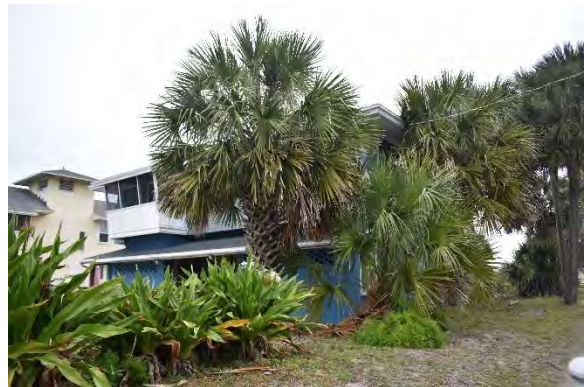
Photograph 136. SJ08076, 2912 Coastal Highway.

The resource consists of a two-story, 1975 hipped-roof vernacular residence with a partial-width, enclosed screen porch at the second story of the west elevation (Photograph 136). The offset primary entrance door is situated beneath a full-width, shed-roofed entry porch spanning the west elevation topped by a cantilevered second story. Exterior concrete block walls at the first story are painted, while second-story walls are clad in wide horizontal wood siding. The roof is sheathed in asphalt shingles. Fenestration consists of vinyl one-over-one double-hung and aluminum awning windows. A rectangular, concrete block three-car garage building with a gable-on-hip roof is situated at the western extent of the property.

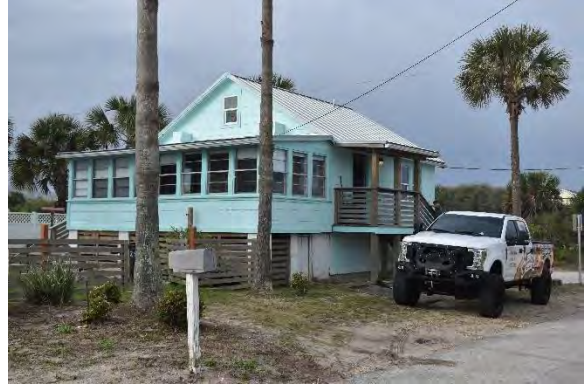
**Photograph 137. SJ08077, 2984 Coastal Highway.**

The resource consists of a two-story, 1947 side-gabled frame vernacular residence with a built-in two-car garage at the first level (Photograph 137). The primary entrance door is offset on the north elevation beneath a partial-width shed-roofed entry porch. A shed-roofed addition on concrete block piers spans the east elevation. Concrete block foundation walls are painted, exterior walls at the second level are clad in horizontal asbestos and vinyl siding, and the roof is sheathed in standing seam metal. Fenestration consists of wood two-over-two double-hung windows.

The resource is recommended as a contributing resource to a potential historic district under Criterion A for the development of Vilano Beach from the early twentieth century through the mid-twentieth century.

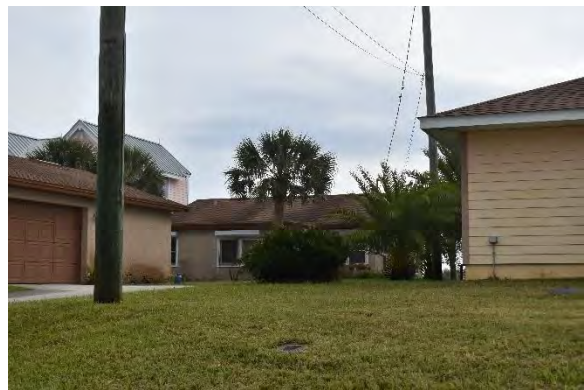
**Photograph 138. SJ08078, 3008 Coastal Highway.**

The resource consists of a one-story, 1972 side-gabled frame vernacular residence with a flat-roofed, partial-width addition to the west elevation (Photograph 138). The primary entrance door is set within the south elevation of the addition. Exterior walls are clad in stucco, while the roof is sheathed in asphalt shingles. Fenestration consists of vinyl one-over-one double-hung windows.

The resource is recommended as a contributing resource to a potential historic district under Criterion A for the development of Vilano Beach from the early twentieth century through the mid-twentieth century.

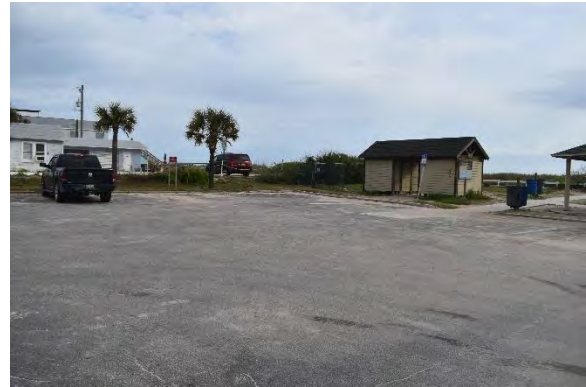
Photograph 139. SJ08079, Surfside Avenue.

The resource consists of a circa-1975, half-acre open park lot largely comprised of a crushed gravel parking lot measuring approximately 0.3 acres surrounded by fencing and accessed from Surfside Avenue (Photograph 139). A hexagonal, open gazebo with a roof sheathed in asphalt shingles over a poured concrete pad is situated at the southeast corner of the lot. A small side-gabled frame restroom building is situated north of the gazebo.

The resource is recommended as a contributing resource to a potential historic district under Criterion A for the development of Vilano Beach from the early twentieth century through the mid-twentieth century.

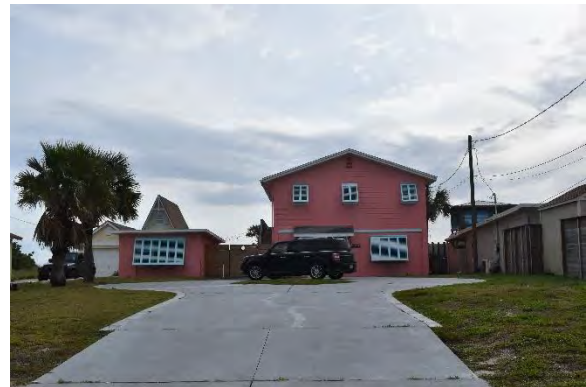
Photograph 140. SJ08080, 3032 Coastal Highway.

The resource consists of a two-story, 1977 residence with a front-gabled, low-pitch roof sheathed in asphalt shingles (Photograph 140). The offset primary entrance door is situated beneath a partial-width, bracketed shed-roofed overhang. Exterior walls at the first level are clad in stucco, while walls on the upper level are clad in wide horizontal aluminum siding. Fenestration consists of vinyl one-over-one double-hung windows set beneath louvered awnings. A shed-roofed former garage clad in stucco, also with double-hung windows beneath louvered awnings, is situated northwest of the resource.

The resource is recommended as a contributing resource to a potential historic district under Criterion A for the development of Vilano Beach from the early twentieth century through the mid-twentieth century.

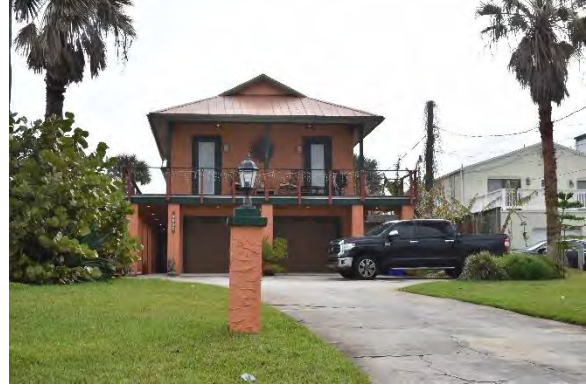
**Photograph 141. SJ08081, 3108 Coastal Highway.**

The resource consists of a two-story, 1971 residence with a gable-on-hip roof and built-in two-car garage at the first level (Photograph 141). The primary entrance door is not visible from the right-of-way. An uncovered deck wraps around the second level. Exterior walls are clad in stucco, while the roof is sheathed in standing seam metal. Fenestration consists of single-leaf, full-glazed doors and aluminum sliding and over-one double-hung windows.

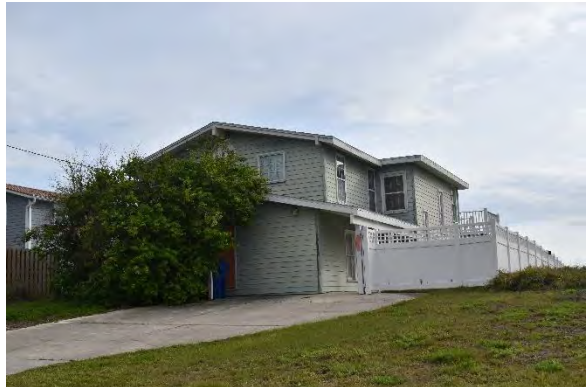
**Photograph 142. SJ08082, 3116 Coastal Highway.**

The resource consists of a two-story, 1968 residence with a low-sloped, front-gabled roof (Photograph 142). The primary entrance door is recessed beneath a partial-width, inset entry porch on the south elevation. Exterior walls are clad in horizontal weatherboard siding, while the roof is sheathed in asphalt shingles. Fenestration consists of vinyl fixed, six-over-six, and one-over-one double-hung windows.

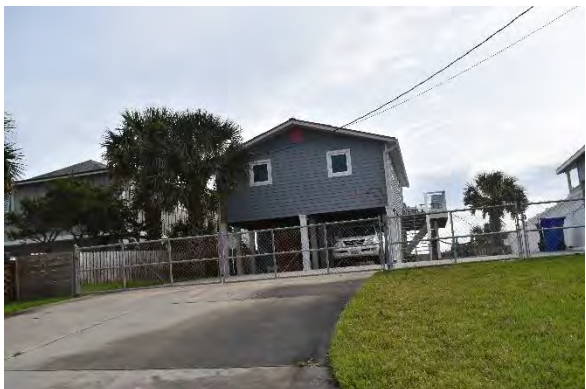
**Photograph 143. SJ08083, 3120 Coastal Highway.**

The resource consists of a two-story, 1971 front-gabled residence with a partially-enclosed first level consisting of a multi-space carport (Photograph 143). The primary entrance door is situated on the second level of the south elevation and accessed from an uncovered wooden deck. Exterior

walls are clad in horizontal weatherboard siding, while the roof is sheathed in standing seam metal. Fenestration consists of vinyl fixed and sliding windows.

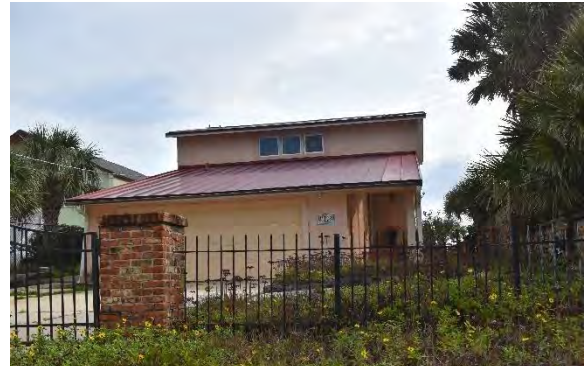
**Photograph 144. SJ08084, 3128 Coastal Highway.**

The resource consists of a two-story, 1973 side-gabled residence with a shed-roofed, two-car garage spanning the first level of the west elevation (Photograph 144). The primary entrance door is recessed beneath an inset entry corridor situated along the south elevation. Exterior walls are clad in stucco, while the roof is sheathed in standing seam metal. Fenestration consists of vinyl sliding and fixed windows.

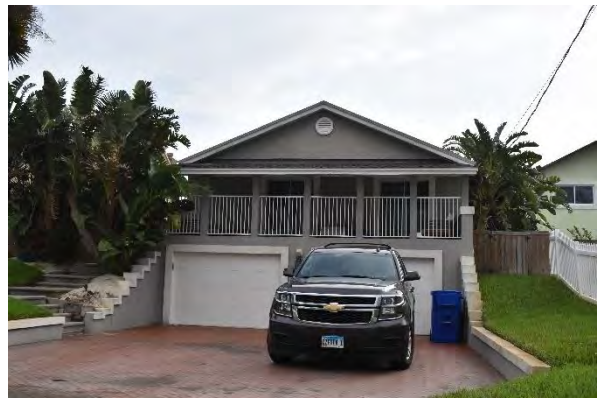
**Photograph 145. SJ08085, 3136 Coastal Highway.**

The resource consists of a two-story, 1950 cross-gabled residence with a two-car garage situated on the first level of the west elevation (Photograph 145). The primary entrance door is not visible from the right-of-way. Exterior walls are clad in stucco, while the cross-gabled main roof is sheathed in standing seam metal and the full-width, shed-roofed porch on the west elevation is sheathed in asphalt shingles. Fenestration consists of double leaf sliding glass doors.

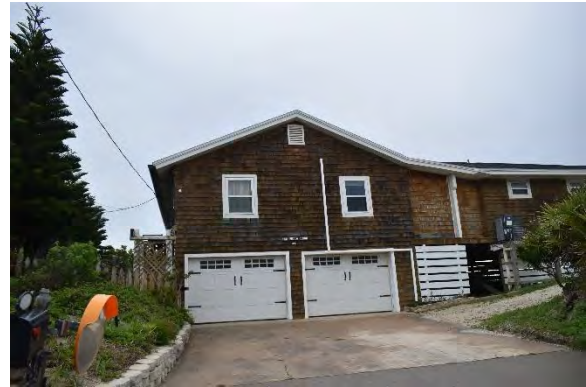
**Photograph 146. SJ08086, 3490 Coastal Highway.**

The resource is a two-story, 1971 frame-vernacular dwelling (Photograph 146). The foundation material is not visible from the public right of way. The dwelling is clad in wood shingle and capped with a front-gable roof covered in asphalt shingles. A lateral addition is appended to the south elevation atop an elevated wood pier foundation, and capped by a side-gable roof. Two, single-car basement garages are located on the west elevation. The primary entrance is not visible from the public right of way. Fenestration includes one-over-one, double-hung, vinyl-sash windows.

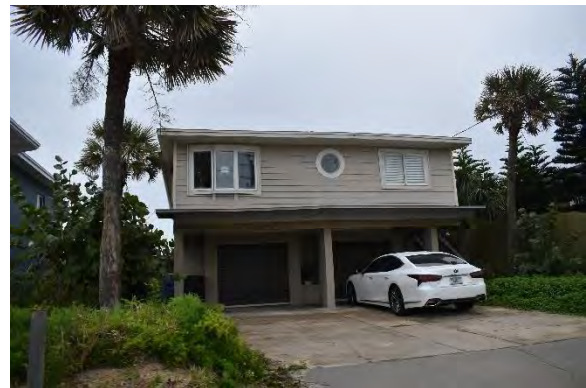
**Photograph 147. SJ08087, 3494 Coastal Highway.**

The resource is a two-story, 1955 frame-vernacular dwelling (Photograph 147). The foundation material is not visible from the public right of way. The dwelling is clad in weatherboard and capped with a flat roof. Two, single-car basement garages are located on the west elevation. The primary entrance is not visible from the public right of way. Fenestration includes vinyl horizontal sliders, porthole, and bow windows.

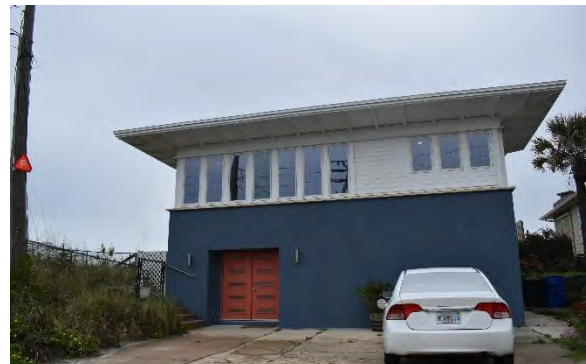
**Photograph 148. SJ08088, 3498 Coastal Highway.**

The resource is a two-story, 1956 frame-vernacular dwelling (Photograph 148). The foundation material is not visible from the public right of way. The dwelling is clad in weatherboard and stucco siding and capped with a hipped roof. The primary double

entrance is located on the west elevation of the dwelling. Fenestration includes vinyl fixed frame windows.

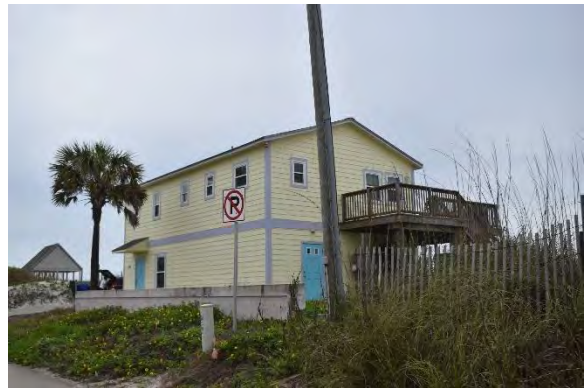
**Photograph 149. SJ08089, 3580 Coastal Highway.**

The resource is a two-story, 1971 frame-vernacular dwelling (Photograph 149). The foundation material is not visible from the public right of way. The dwelling is clad in weatherboard siding and capped with a side-gable roof covered in asphalt shingle. The primary single entrance is located on the west elevation of the dwelling and sheltered beneath a shed roof wood awning. A secondary single entry is located on the second story of the south elevation, atop a wood deck and stairs. Fenestration includes one-over-one, double-hung, vinyl-sash windows.

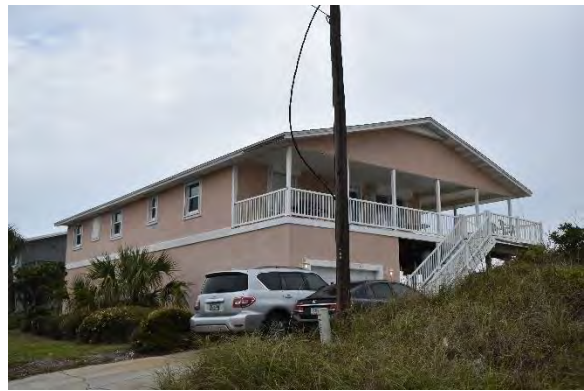
**Photograph 150. SJ08090, 3810 Coastal Highway.**

The resource is a two-story, 1976 frame-vernacular dwelling (Photograph 150). The foundation material is not visible from the public right of way. The dwelling is clad in stucco siding and capped with a side-gable roof. The primary single entrance is located on the second story of the south elevation, atop a three-bay porch and sheltered beneath a gable roof supported by wood posts. Two single-car basement garages are located on the south and west elevations. Fenestration includes one-over-one, double-hung, vinyl-sash windows.

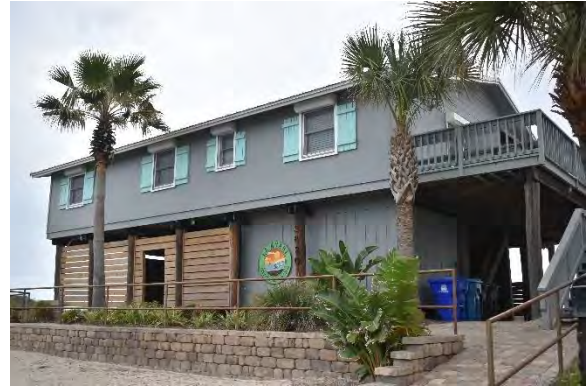
Photograph 151. SJ08091, 3820 Coastal Highway.

The resource is a two-story, 1976 frame-vernacular dwelling (Photograph 151). The dwelling rests on wooden piers, is clad in vertical board and batten siding, and capped with a side-gable roof covered in standing-seam metal. The primary single entrance is located on the second story of the south elevation, atop a two-bay porch. Fenestration includes one-over-one, double-hung, wood-sash windows with lintels.

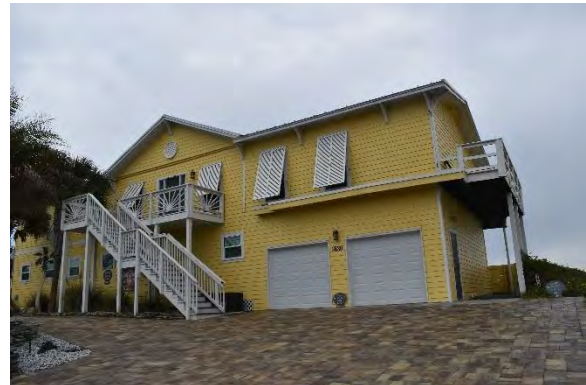
Photograph 152. SJ08092, 3830 Coastal Highway.

The resource is a two-story, 1976 frame-vernacular dwelling (Photograph 152). The foundation material is not visible from the public right of way. The dwelling is clad in weatherboard siding, and capped with a side-gable roof with a central intersecting gable and wooden brackets covered in standing-seam metal. The primary single entrance is located on the second story of the west elevation, atop a three-bay porch. A secondary single-entry is located on the south elevation, atop a wraparound porch. Two basement single-car garages are located on the west elevation. Fenestration includes one-over-one, double-hung, vinyl-sash windows.

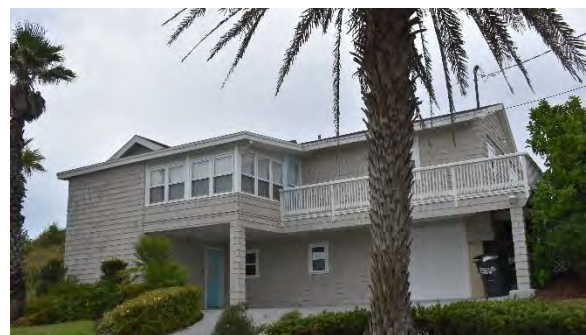
Photograph 153. SJ08093, 3840 Coastal Highway.

The resource is a two-story, 1972 frame-vernacular dwelling (Photograph 153). The foundation material is not visible from the public right of way. The dwelling is clad in wood shingle siding, and capped with a side-

gable roof covered in asphalt shingle. A two-story addition is located on the west elevation, capped by a shed roof with a gablet. A one-car garage is located on the west elevation. A flush, brick chimney is located on the north elevation. The primary single entrance is located on the west elevation, beneath a second-story overhang. A secondary single entrance is located on a second-story wraparound porch on the west and south elevations. Fenestration includes one-over-one, double-hung, vinyl-sash windows.

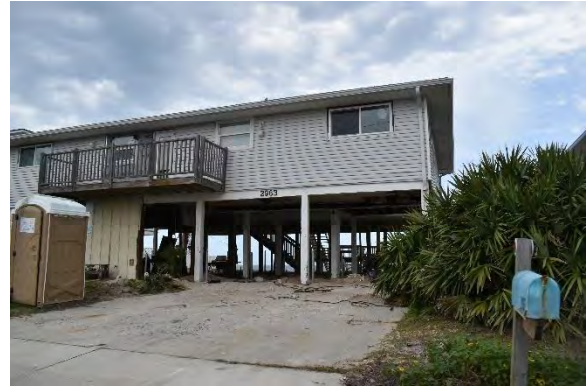
**Photograph 173. SJ08113, 2963 South Ponte Vedra Boulevard.**

The resource is a two-story, 1976 frame vernacular dwelling (Photograph 173). The dwelling sits atop wood piers, is clad in vinyl siding, and capped with a hipped roof with gablets, covered in asphalt shingle. The primary entrance is not visible from the public right of way. A two-bay balcony is located on the second-story of the west elevation. An obscured deck is located on the east elevation. Fenestration includes one-over-one, double-hung, vinyl sash and horizontal slider windows. The dwelling is in the process of renovation. Siding is being removed and the first story is being opened to the elements.

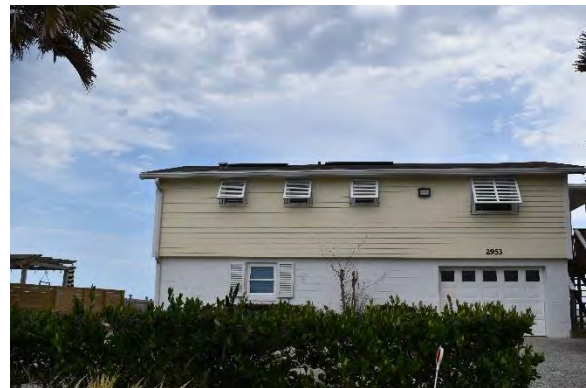
**Photograph 174. SJ08114, 2953 Ponte Vedra Boulevard.**

The resource is a two-story, 1971 frame vernacular dwelling (Photograph 174). The dwelling rests on a concrete block foundation, is clad in vinyl siding and capped with a side-gable roof covered in asphalt shingle. A one-car garage is located on the west elevation. The primary entrance is not visible from the public right of way. A mostly obscured wraparound porch is located on the second-story of the south elevation, sheltered beneath a hipped roof. Fenestration includes one-over-one, double-hung, wood-sash windows.

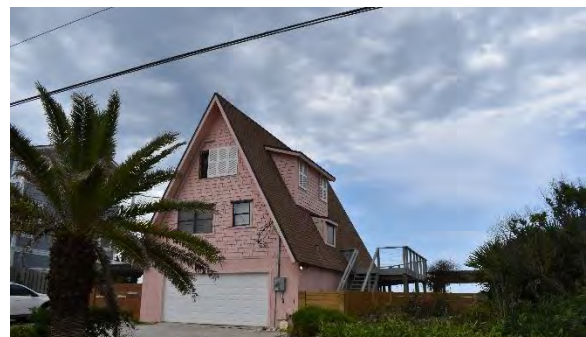
**Photograph 175. SJ08115, 2951 Ponte Vedra Boulevard.**

The resource is a two-and-a-half-story, 1970 frame vernacular dwelling (Photograph 175). The foundation material is not visible from the public right of way. The dwelling is clad in stucco and cement mineral-fiber shingle, and capped with a front-gable roof covered

in asphalt shingle. The roofline reaches to the top of the first-story. A two-car garage is located on the west elevation. Two shed roof dormers are located on the south elevation. The primary entrance is not visible from the public right of way. A second-story wraparound porch is located on the south elevation. Fenestration includes one-over-one, double-hung, vinyl-sash and fixed frame windows.

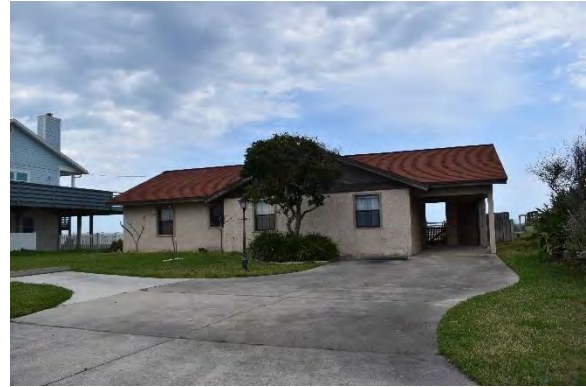
**Photograph 176. SJ08116, 2933 Ponte Vedra Boulevard.**

The resource is a one-story, 1960 Ranch dwelling (Photograph 176). The foundation material is not visible from the public right of way. The dwelling is clad in stucco, and capped with a side-gable roof covered in asphalt shingle. An intersecting gable addition is located on the west elevation. The primary entrance is located on the south elevation, sheltered beneath an extended roof supported by stucco-clad posts. Fenestration includes one-over-one, double-hung, vinyl-sash windows.

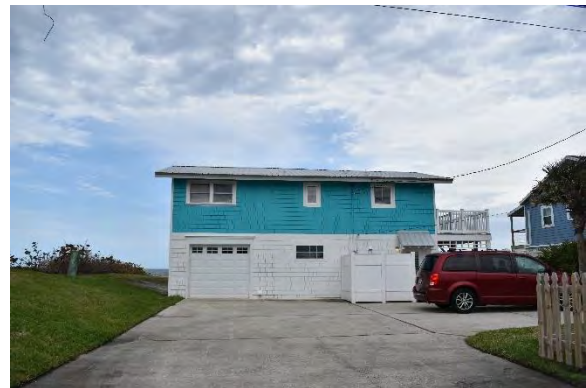
**Photograph 177. SJ08117, 2927 Ponte Vedra Boulevard.**

The resource is a two-story, 1975 frame vernacular dwelling (Photograph 177). The foundation material is not visible from the public right of way. The dwelling is clad in cement mineral-fiber shingle and capped with a side-gable roof covered in standing-seam metal. A one-car garage is located on the west elevation. A second-story wraparound porch is located on the south elevation. The primary entrance is located on the west elevation, sheltered beneath a metal awning supported by wood brackets. Fenestration includes one-over-one, double-hung, wood-sash, four-pane casement and eight-pane fixed windows.

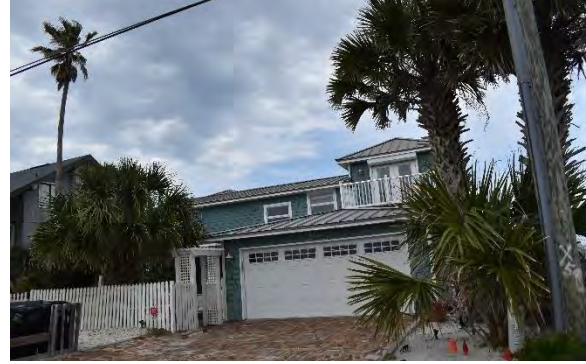
**Photograph 178. SJ08118, 2921 Ponte Vedra Boulevard.**

The resource is a partially obscured two-story, 1947 frame vernacular dwelling (Photograph 178). The foundation material is not visible from the public right of way. The dwelling is clad in wood shingle and capped with a side-gable roof covered in standing-seam metal. A two-car garage is appended to the west elevation. A second-story balcony is located on the west elevation, capped by a hipped roof. An obscured, hipped dormer is located on the east elevation. The primary entrance is located on the west elevation, sheltered beneath a hipped roof supported by wood columns. Visible fenestration includes one-over-one, double-hung, vinyl-sash and an octagon window.

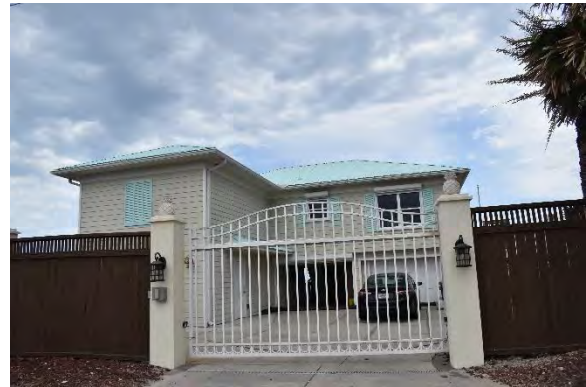
**Photograph 179. SJ08119, 2913 Ponte Vedra Boulevard.**

The resource is a partially obscured two-story, 1973 frame vernacular dwelling (Photograph 179). The foundation material is not visible from the public right of way. The dwelling is clad in vinyl siding and capped with a hipped roof covered in standing-seam metal. A two-story, hipped roof, lateral addition is appended to the west elevation. Two one-car garage are located on the west elevation. The primary entrance is located on the south elevation of the two-story addition, sheltered beneath a hipped roof. An obscured porch is located on the first and second-story of the east elevation. Visible fenestration includes one-over-one, double-hung, wood-sash windows. A wood privacy wall and gate partially obscures the dwelling from view.

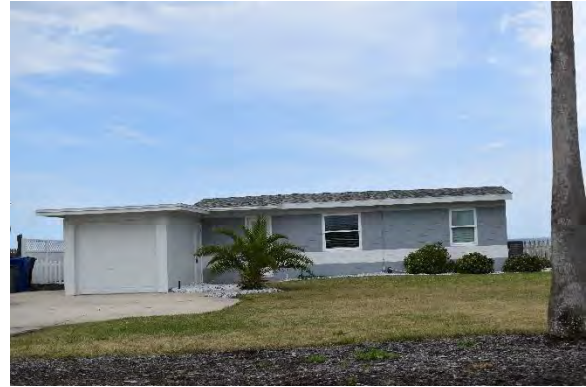
**Photograph 180. SJ08120, 2911 Ponte Vedra Boulevard.**

The resource is a one-story, 1960 Ranch dwelling (Photograph 180). The concrete block dwelling rests on a concrete foundation and is capped with a side-gable roof covered in asphalt shingle. A one-car garage is appended to the west elevation. The primary entrance is located on the west elevation, sheltered beneath an extended roof. An obscured porch is located on the east elevation. Fenestration includes one-over-one, double-hung, vinyl-sash windows.

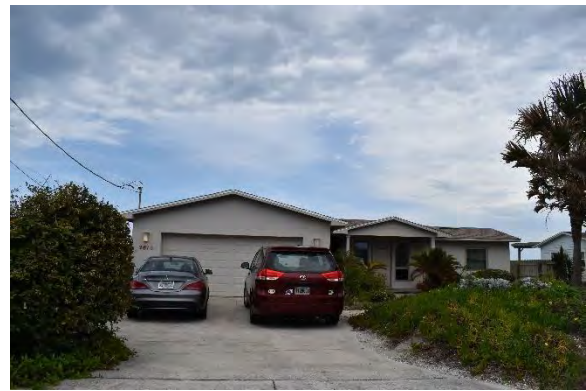
**Photograph 181. SJ08121, 2879 Ponte Vedra Boulevard.**

The resource is a partially obscured one-story, 1957 Ranch dwelling (Photograph 181). The foundation material is not visible from the public right of way. The dwelling is clad in stucco siding and capped with a side-gable roof covered in asphalt shingle. A two-car garage, capped by a gable roof, is appended to the west elevation. An obscured addition is appended to the east elevation, capped by a hipped roof. The primary entrance is located on the west elevation, atop a three-bay porch and sheltered beneath a gable roof supported by wood posts. Fenestration includes one-over-one, double-hung, wood-sash windows.

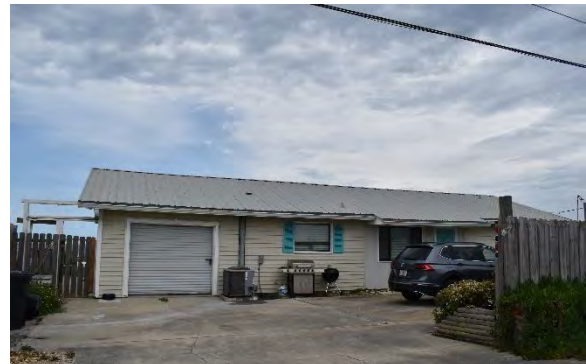
**Photograph 182. SJ08122, 2875 Ponte Vedra Boulevard.**

The resource is a partially obscured one-story, 1956 Ranch dwelling (Photograph 182). The foundation material is not visible from the public right of way. The dwelling is clad in vinyl siding and capped with a side-gable roof covered in standing-seam metal. An obscured shed roof addition is located on

the east elevation. A one-car attached garage is located on the north elevation. The primary entrance is located on the west elevation, sheltered beneath an extended roof. Fenestration includes wood fixed frame windows. A wood privacy fence partially obscures the dwelling.

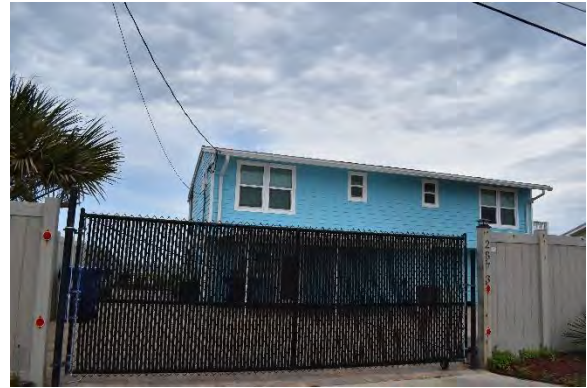
**Photograph 183. SJ08123, 2873 Ponte Vedra Boulevard.**

The resource is a partially obscured two-story, 1970 frame vernacular dwelling (Photograph 183). The foundation material is not visible from the public right of way. The dwelling is clad in vinyl siding and capped with a side-gable roof covered in asphalt shingle. The primary entrance is located on the west elevation, sheltered beneath a shed roof supported by wood posts. A second-story porch is located on the south elevation. Fenestration includes one-over-one, double-hung, wood-sash windows. A wood privacy fence partially obscures the dwelling.

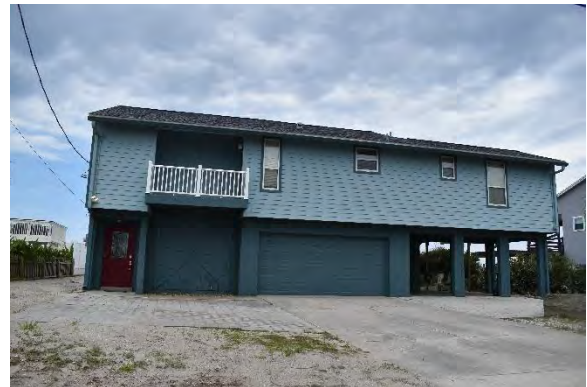
**Photograph 184. SJ08124, 2863 Ponte Vedra Boulevard.**

The resource is a two-story, 1976 frame vernacular dwelling (Photograph 184). The foundation material is not visible from the public right of way. The dwelling is clad in weatherboard siding and capped with a side-gable roof covered in asphalt shingle. A gable roof addition is appended to the south elevation, and rests atop wood piers. The recessed primary entrance is located on the west elevation. A second-story porch is located on the east elevation. A one-bay wood barn door is located on the west elevation. A two-car garage is located on the west elevation. A second-story, one-bay balcony is located on the west elevation. Fenestration includes one-over-one, double-hung, vinyl-sash windows.

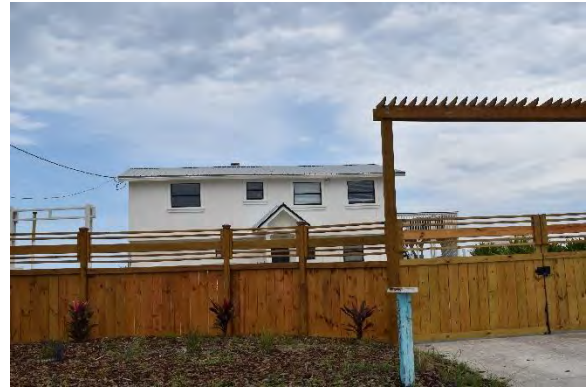
**Photograph 185. SJ08125, 2861 Ponte Vedra Boulevard.**

The resource is a partially obscured two-story, 1971 frame vernacular dwelling (Photograph 185). The foundation material is not visible from the public right of way. The dwelling is clad in stucco siding and capped with a side-gable roof covered in standing-seam metal. An interior brick chimney interrupts the roof surface. The primary entrance is located on the west elevation, atop a one-bay porch and sheltered beneath a gable roof supported by wood posts. A second-story porch is located on the south elevation. Fenestration includes one-over-one, double-hung, vinyl-sash windows.

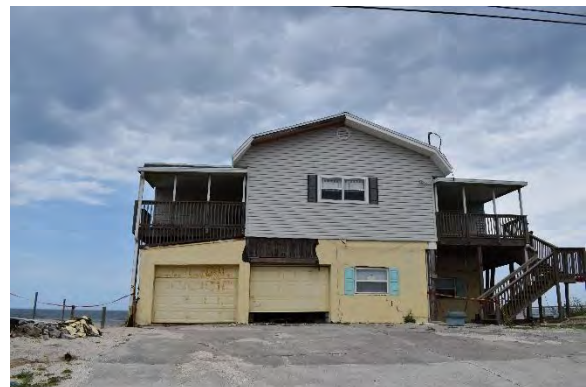
**Photograph 186. SJ08126, 2853 Ponte Vedra Boulevard.**

The resource is a two-story, circa-1972 frame vernacular dwelling (Photograph 186). The foundation material is not visible from the public right of way. The dwelling is clad in stucco and vinyl siding and capped with a side-gambrel roof covered in asphalt shingle. A lateral two-story addition is located on the west elevation. Two one-car garages are located on the west elevation. The primary entrance is located on the west elevation. A second-story porch is located on the south elevation. Two one-bay balconies are located on the second-story of the west elevation. Fenestration includes one-over-one, double-hung, vinyl-sash windows. The dwelling is undergoing renovations.

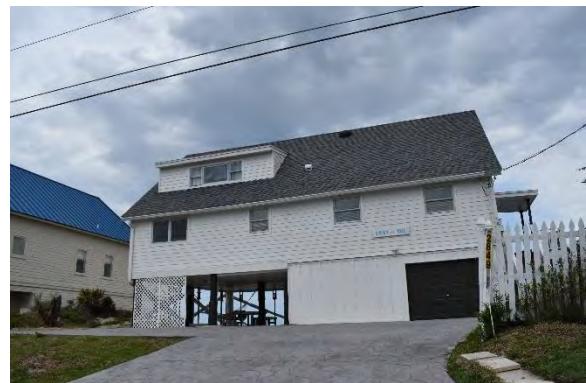
**Photograph 187. SJ08127, 2849 Ponte Vedra Boulevard.**

The resource is a two-story, 1975 frame vernacular dwelling (Photograph 187). The dwelling rests atop wood piers, is clad in stucco and weatherboard and batten siding and capped with a side-gable roof covered in asphalt shingle. Two one-bay shed roof

dormers are located on the east and west elevations. A one-car garage is located on the west elevation. The primary entrance is not visible from the public right of way. A second-story wraparound porch is located on the south and east elevations. Fenestration includes one-over-one, double-hung, wood-sash and picture windows.

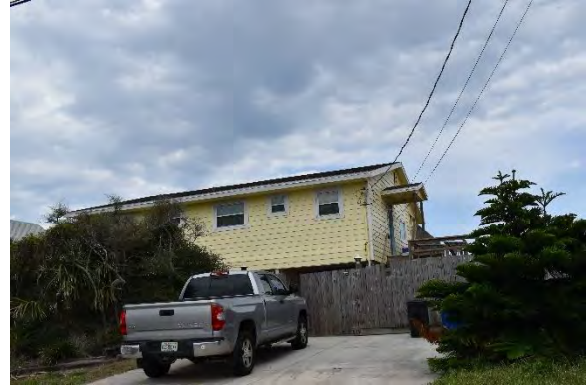
**Photograph 188. SJ08128, 2845 Ponte Vedra Boulevard.**

The resource is a mostly obscured two-story, 1972 frame vernacular dwelling (Photograph 188). The foundation material is not visible from the public right of way. The dwelling is clad in weatherboard siding and capped with a side-gable roof covered in asphalt shingle. The primary entrance is not visible from the public right of way. A secondary single entrance is located atop a second-story porch located on the south elevation, sheltered beneath a gable roof supported by wood posts. Fenestration includes one-over-one, double-hung, vinyl-sash windows.

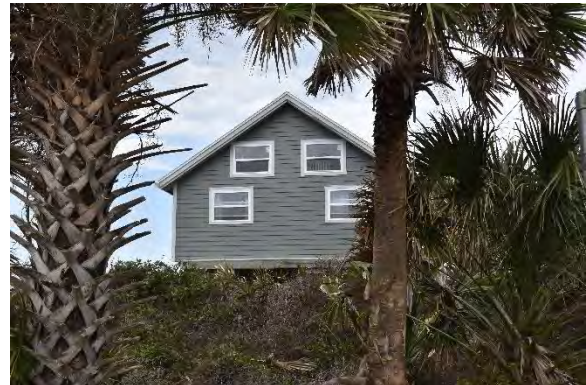
**Photograph 189. SJ08129, 2843 Ponte Vedra Boulevard.**

The resource is a mostly obscured two-story, 1971 frame vernacular dwelling (Photograph 189). The foundation material is not visible from the public right of way. The dwelling is clad in weatherboard siding and capped with a front-gable roof covered in asphalt shingle. The primary entrance is not visible from the public right of way. An obscured second-story wraparound porch is located on the east and south elevations. Fenestration includes one-over-one, double-hung, vinyl-sash windows.

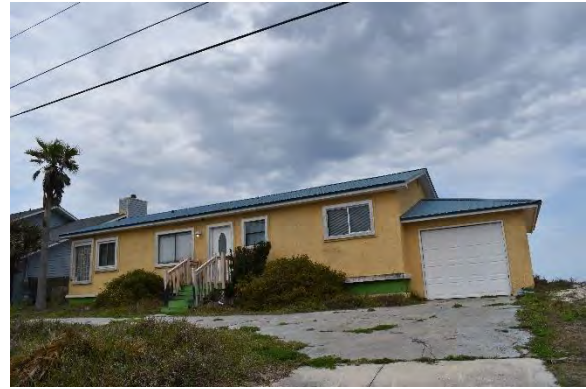
**Photograph 190. SJ08130, 2833 Ponte Vedra Boulevard.**

The resource is a one-story, 1964 Ranch dwelling (Photograph 190). The foundation material is not visible from the public right of way. The dwelling is clad in stucco siding and capped with a side-gable roof covered in standing-seam metal. A one-car garage is appended to the south elevation, capped by a hipped roof. An obstructed interior chimney interrupts the roof surface. The primary entrance is located on the west elevation, atop a stoop. An obstructed porch is located on the east elevation. Fenestration includes one-over-one, double-hung, wood-sash, vinyl horizontal slider, and glass block windows.

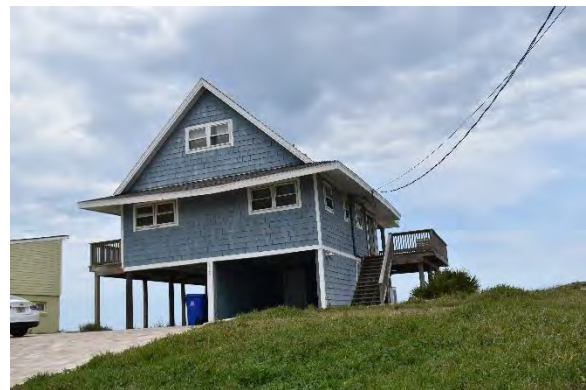
**Photograph 191. SJ08131, 2829 Ponte Vedra Boulevard.**

The resource is a two-and-a-half-story, 1972 frame vernacular dwelling (Photograph 191). The dwelling rests on wood piers, is clad in wood shingle and capped with a front-gable roof with hipped eaves covered in asphalt shingle. The recessed primary entrance is located on the west elevation, within a carport. A secondary double entrance is located on the south elevation, atop a second-story wraparound porch on the south, east, and north elevations. Fenestration includes one-over-one, double-hung, vinyl-sash windows.

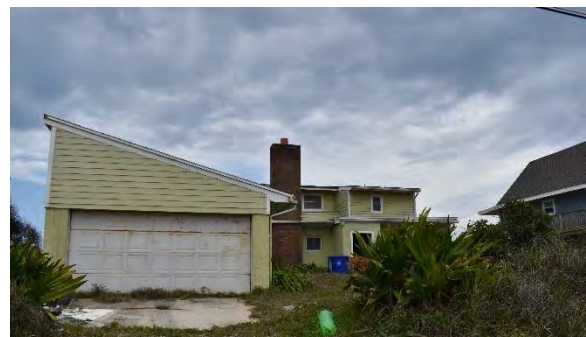
**Photograph 192. SJ08132, 2827 Ponte Vedra Boulevard.**

The resource is a partially obscured two-story, 1955 frame vernacular dwelling (Photograph 192). The foundation material is not visible from the public right of way. The dwelling is clad in stucco and weatherboard

siding and capped with an irregular roof covered in asphalt shingle. A two-car garage is appended to the west elevation, capped by a front-gable roof. A brick exterior chimney is located on the west elevation. The recessed primary entrance is set within a one-bay projection on the west elevation. Fenestration includes one-over-one, double-hung, wood-sash, and vinyl horizontal slider windows. Dense vegetation partially obscures the dwelling.

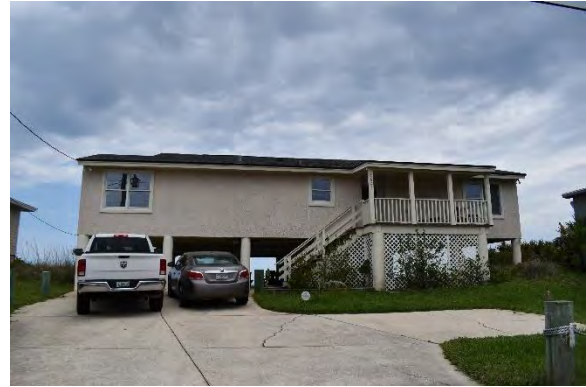
**Photograph 193. SJ08133, 2823 Ponte Vedra Boulevard.**

The resource is a two-story, 1973 frame vernacular dwelling (Photograph 193). The dwelling rests atop wood piers, is clad in stucco siding and capped with a side-gable roof covered in asphalt shingle. Two second-story, one-bay additions are located on the north and south elevations. The primary entrance is located on the west elevation, atop a second-story one-bay porch and sheltered beneath a shed roof supported by wood posts. Fenestration includes one-over-one, double-hung, vinyl-sash windows.

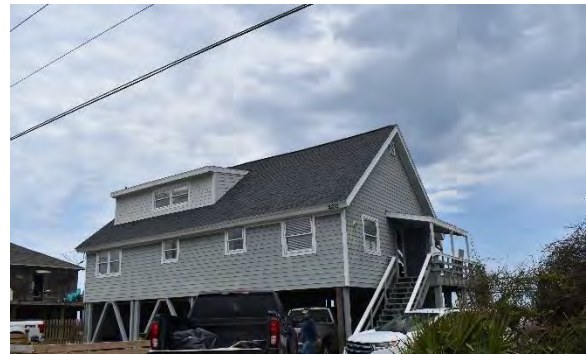
**Photograph 194. SJ08134, 2815 Ponte Vedra Boulevard.**

The resource is a two-and-a-half-story, 1975 frame vernacular dwelling (Photograph 194). The dwelling rests atop wood piers, is clad in cement-mineral fiber shingle and weatherboard siding and capped with a side-gable roof covered in asphalt shingle. Two shed roof dormers are located on the east and west elevations. The primary entrance is located on the south elevation, atop a second-story wraparound porch and sheltered beneath a shed roof supported by wood posts. Fenestration includes one-over-one, double-hung, vinyl-sash windows.

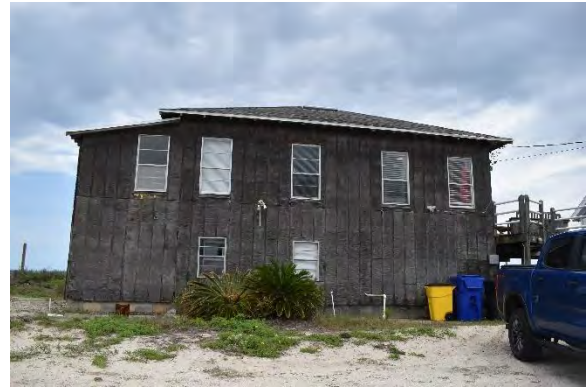
**Photograph 195. SJ08135, 2813 Ponte Vedra Boulevard.**

The resource is a two-story, 1973 frame vernacular dwelling (Photograph 195). The dwelling rests atop a concrete block foundation, is clad in wood vertical board siding, and capped with a hipped roof covered in asphalt shingle. A two story addition is appended to the north elevation, capped by a shed roof. The primary entrance is located on the south elevation, atop a second-story wraparound porch and sheltered beneath the eaves. Fenestration includes two-over-two, double-hung, aluminum-sash windows.

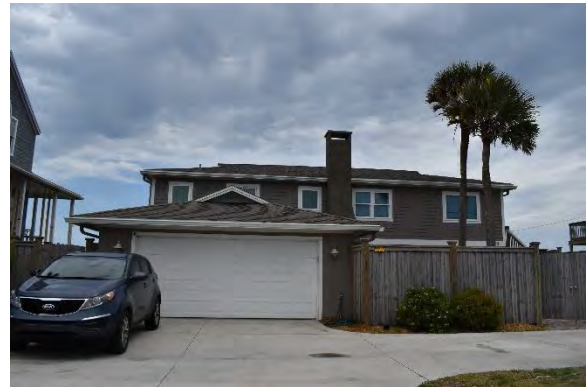
**Photograph 196. SJ08136, 2809 Ponte Vedra Boulevard.**

The resource is a partially obscured two-story, 1975 frame vernacular dwelling (Photograph 196). The foundation material is not visible from the public right of way. The dwelling is clad in cement-mineral fiber shingle and capped with a hipped roof with gablets covered in asphalt shingle. A brick exterior chimney interrupts the roof surface on the west elevation. A two-car garage is appended to the west elevation, capped by a hipped roof with gablets. The primary entrance is not visible from the public right of way. A second-story wraparound porch is located on the east and south elevations. Fenestration includes one-over-one, double-hung, vinyl-sash and pictures windows. A wood privacy fence partially obscures the dwelling.

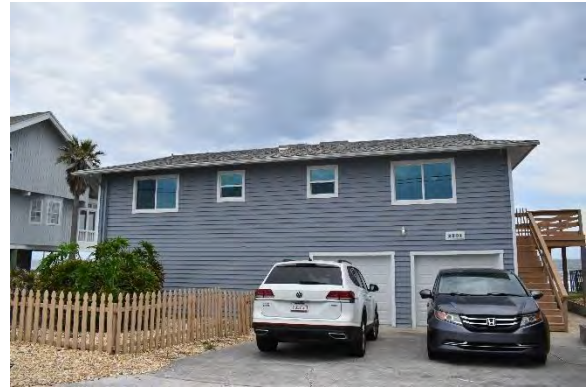
Photograph 197. SJ08137, 2801 Ponte Vedra Boulevard.

The resource is a two-story, 1977 frame vernacular dwelling (Photograph 197). The foundation material is not visible from the public right of way. The dwelling is clad in weatherboard and capped with a hipped roof with gablets covered in asphalt shingle. A two-car garage is located on the west elevation. The primary entrance, atop a second-story wraparound porch, is located on the east and south elevations. Fenestration includes one-over-one, double-hung, vinyl-sash and horizontal slider windows.

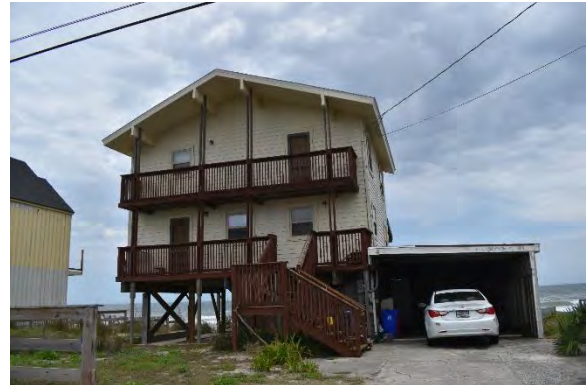
Photograph 198. SJ08138, 2789 Ponte Vedra Boulevard.

The resource is a three-story, 1975 frame vernacular dwelling (Photograph 198). The dwelling rests atop wood piers, is clad in weatherboard and capped with a front-gable roof with large eaves and brackets, covered in asphalt shingle. A one-car garage is appended to the south elevation. The primary entrance, atop a second-story full-width porch and supported by wood posts, is located on the west elevation. A two-bay balcony is located on the third-story of the west elevation, supported by wood posts. An obscured full-width porch is located on the east elevation, sheltered beneath a shed roof. Fenestration includes one-over-one, double-hung, vinyl-sash windows.

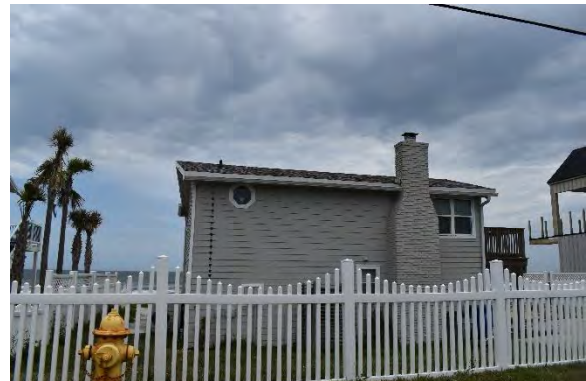
Photograph 199. SJ08139, 2785 Ponte Vedra Boulevard.

The resource is a two-story, 1970 frame vernacular dwelling (Photograph 199). The foundation material is not visible from the public right of way. The dwelling is clad in vinyl and capped with a side-gable roof

covered in asphalt shingle. An obscured two-story gable addition is located on the east elevation. A brick external chimney interrupts the roof surface on the west elevation. The primary entrance is not visible from the public right of way. A second-story wraparound porch is located on the south and east elevations. Fenestration includes one-over-one, double-hung, vinyl-sash and an octagon window.

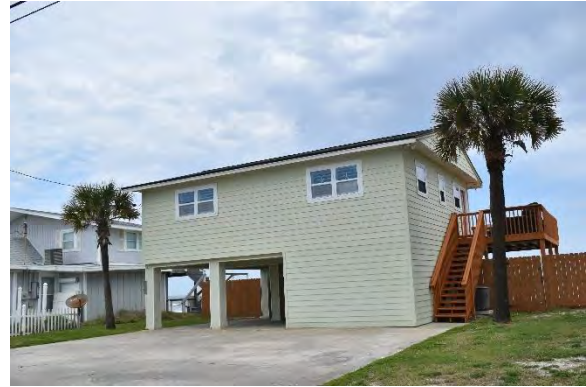
**Photograph 200. SJ08140, 2767 Ponte Vedra Boulevard.**

The resource is a two-story, 1970 frame vernacular dwelling (Photograph 200). The foundation material is not visible from the public right of way. The dwelling is clad in weatherboard and capped with a side-gable roof covered in asphalt shingle. Two one-car carports are located on the west elevation. The primary entrance is located on a second-story wraparound porch is located on the south and east elevations. Fenestration includes one-over-one, double-hung, vinyl-sash windows.

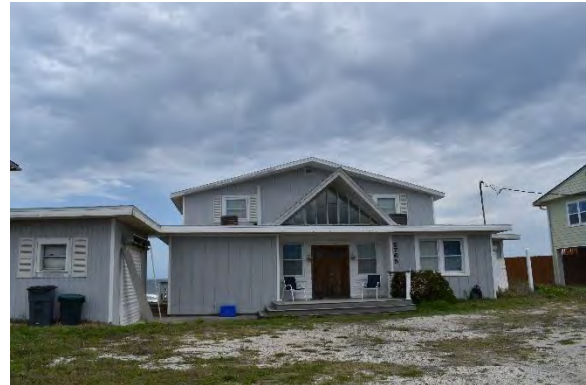
**Photograph 201. SJ08141, 2765 Ponte Vedra Boulevard.**

The resource is a two-story, 1965 frame vernacular dwelling (Photograph 201). The foundation material is not visible from the public right of way. The dwelling is clad in vertical wood board, batten, and brick and capped with a side-gable roof covered in asphalt shingle. A one-story addition is located on the west elevation, capped by a flat roof. An intersecting one-bay gable is located atop the addition. A one-story addition is appended to the south elevation, capped by a shed roof. An obscured interior chimney interrupts the roof surface. The primary recessed double entrance, atop a three-bay porch, is located on the west elevation. An obscured full-width porch is located on the east elevation. Fenestration includes one-over-one, double-hung, wood-sash and fixed frame windows. Outbuildings on this property include a one-car garage capped by a flat roof.

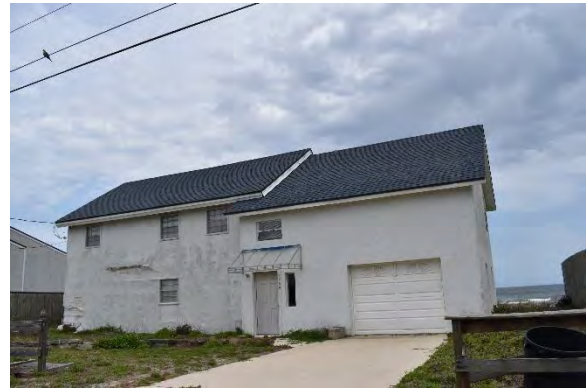
Photograph 202. SJ08142, 2759 Ponte Vedra Boulevard.

The resource is a two-story, 1968 frame vernacular dwelling (Photograph 202). The foundation material is not visible from the public right of way. The dwelling is clad in stucco and capped with a side-gable roof covered in asphalt shingle. A one-car garage is located on the west elevation. The primary entrance is located on the west elevation and sheltered beneath a metal awning. An obscured porch is located on the east elevation. Fenestration includes one-over-one and six-over-six, double-hung, vinyl-sash and fixed frame windows. The dwelling is in a state of disrepair.

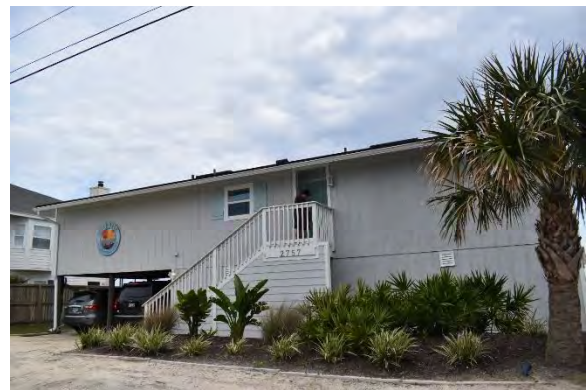
Photograph 203. SJ08143, 2757 Ponte Vedra Boulevard.

The resource is a two-story, 1973 frame vernacular dwelling (Photograph 203). The dwelling rests atop wood piers, is clad in batten siding, and capped with a side-gable roof covered in asphalt shingle. Two one-car carports are located on the west elevation. The recessed primary entrance, atop a second-story one-bay stoop, is located on the west elevation. An obstructed porch is located on the east elevation. Fenestration includes one-over-one, double-hung, vinyl-sash windows.

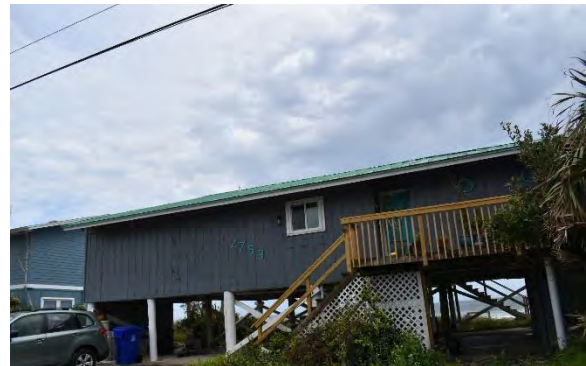
Photograph 204. SJ08144, 2753 Ponte Vedra Boulevard.

The resource is a two-story, 1973 frame vernacular dwelling (Photograph 204). The dwelling rests atop wood piers, is clad in batten siding, and capped with a side-gable roof covered in standing-seam metal. Two one-car carports are located on the west

elevation. The recessed primary entrance, atop a second-story one-bay porch, is located on the west elevation. An obstructed porch is located on the east elevation. Fenestration includes vinyl horizontal slider windows.

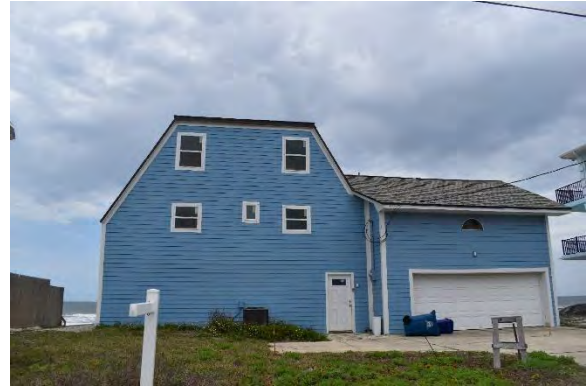
**Photograph 205. SJ08145, 2745 Ponte Vedra Boulevard.**

The resource is a two-and-a-half-story, 1971 frame vernacular dwelling (Photograph 205). The foundation material is not visible from the public right of way. The dwelling is clad in weatherboard and capped with a gambrel roof covered in asphalt shingle. An obstructed two-story addition is appended to the east elevation, capped by a flat roof. A lateral two-story gambrel roof addition is appended to the south elevation. A two-car garage is located on the west elevation of the gambrel addition. The primary entrance is located on the west elevation. Fenestration includes one-over-one, double-hung, vinyl-sash, a fanlight, and fixed frame windows.

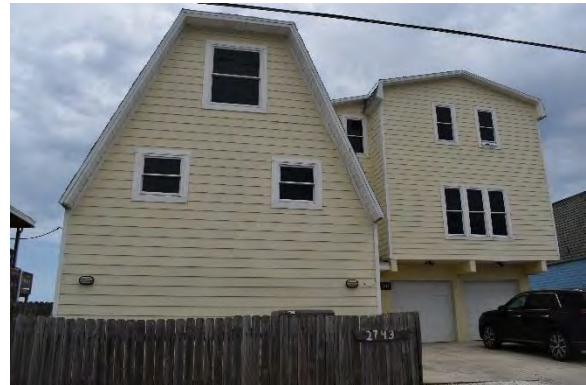
**Photograph 206. SJ08146, 2743 Ponte Vedra Boulevard.**

The resource is a two-and-a-half-story, 1975 frame vernacular dwelling (Photograph 206). The foundation material is not visible from the public right of way. The dwelling is clad in weatherboard and capped with an irregular roof covered in asphalt shingle. A lateral one-and-a-half-story gambrel roof addition is appended to the west elevation. A gable roof wall dormer is located on the south elevation of the gambrel addition. Two one-car garages are located on the west elevation. The primary double entrance is located on the west elevation, sheltered beneath a shed roof. An obstructed porch is located on the east elevation. Fenestration includes one-over-one, double-hung, wood-sash windows.
