MISC 1794: REEF MONITORING FOR MOODY, TAYLOR, AND INTRUDER REEF SITES

Subject: Please find the following report dated Feb 7, 2025, which completes the contract. Invoice to be submitted separately.

Project Overview

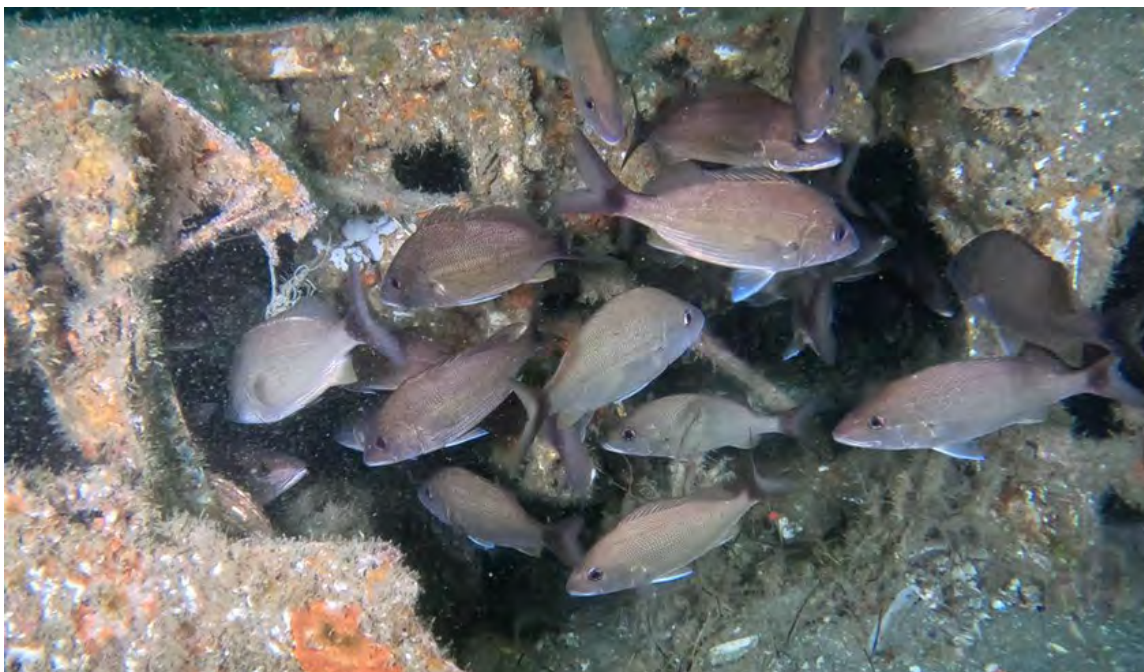
Figure 31 - Fishing line and Tomtate Grunt

Following the fish count operations, the divers returned to the site for Debris Removal Operations. All fishing lines and boat anchor ropes that created a hazard for marine life and scuba divers as well as snagged fishing line from above fishermen were removed.

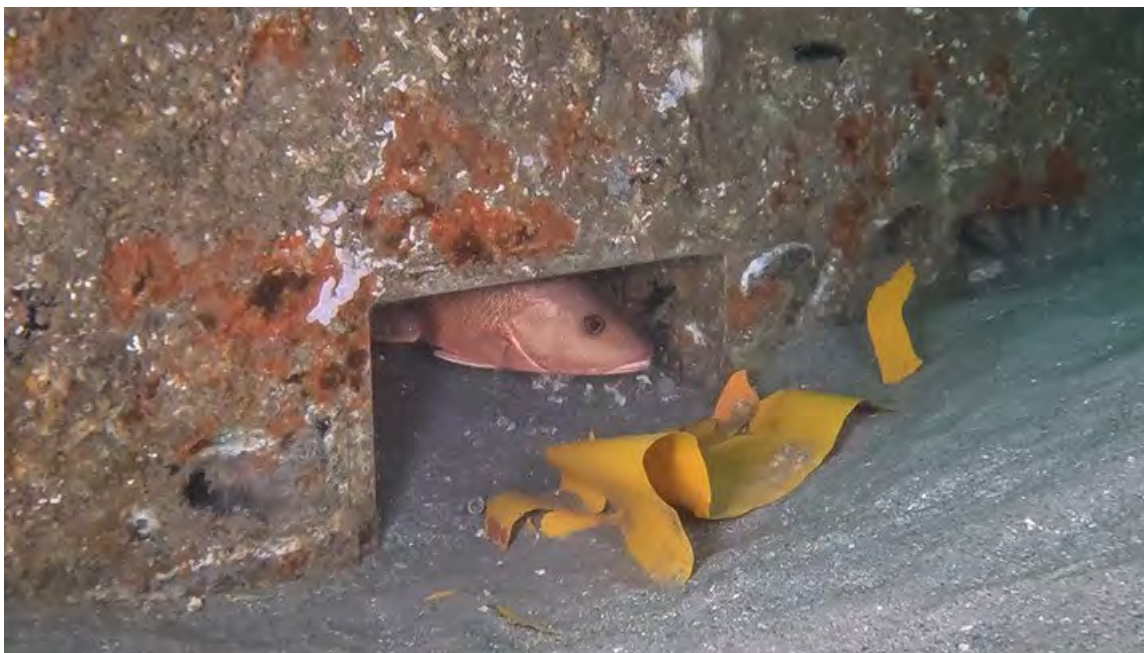
Figure 33 - Mangrove Snapper and yellow plastic trash

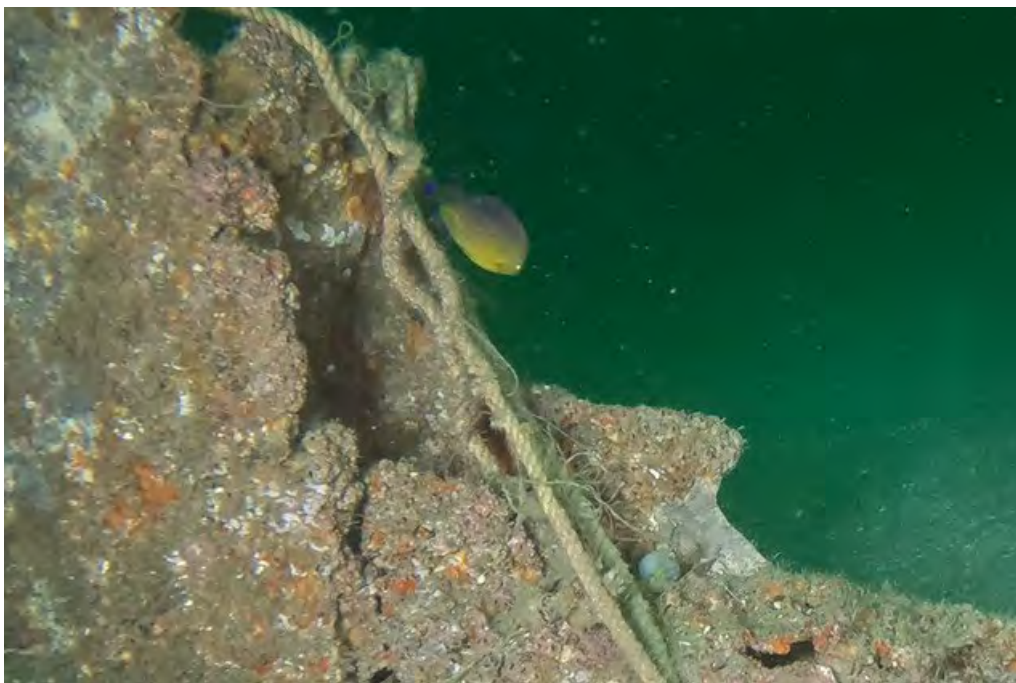
Figure 37 - Cocoa Damselfish and anchor rope

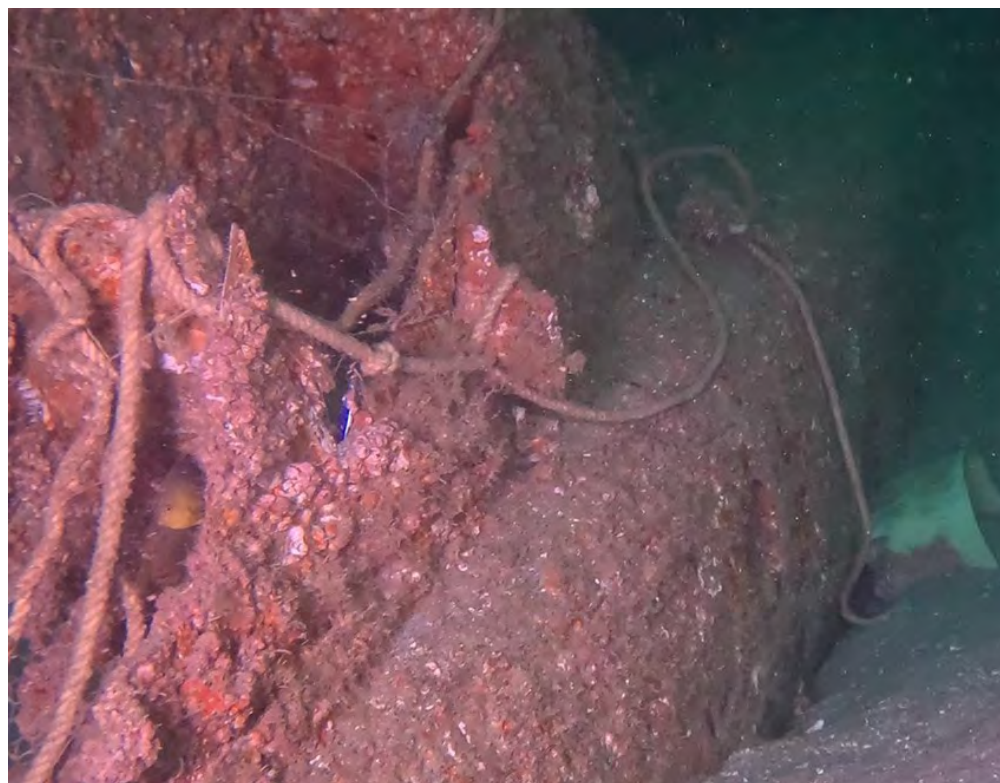
Figure 38 - Fishing line and anchor rope on Tail-section

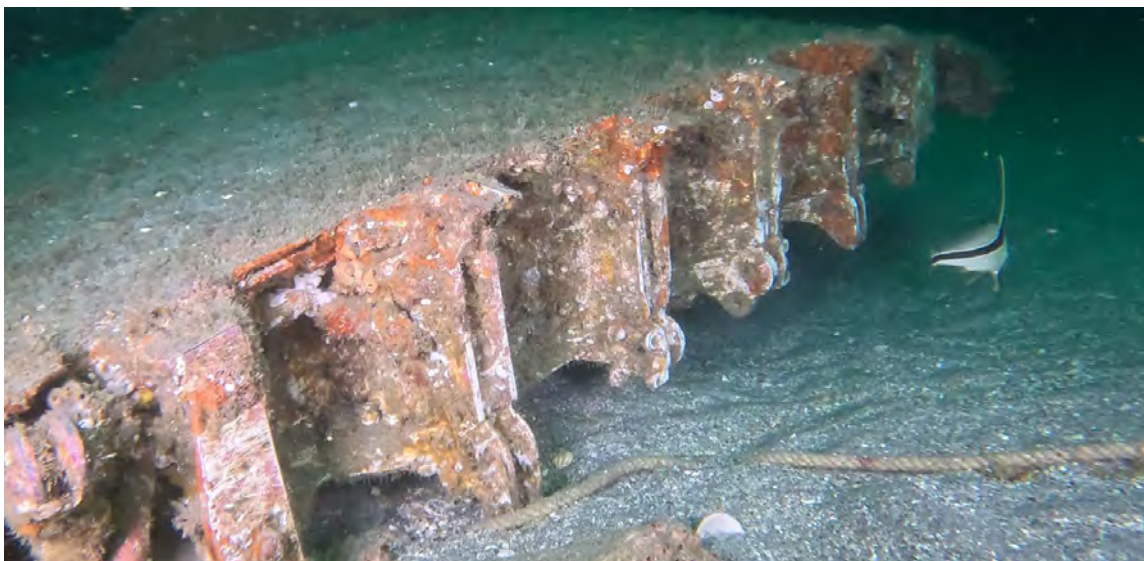
Figure 41 - Airplane wing section with anchor rope

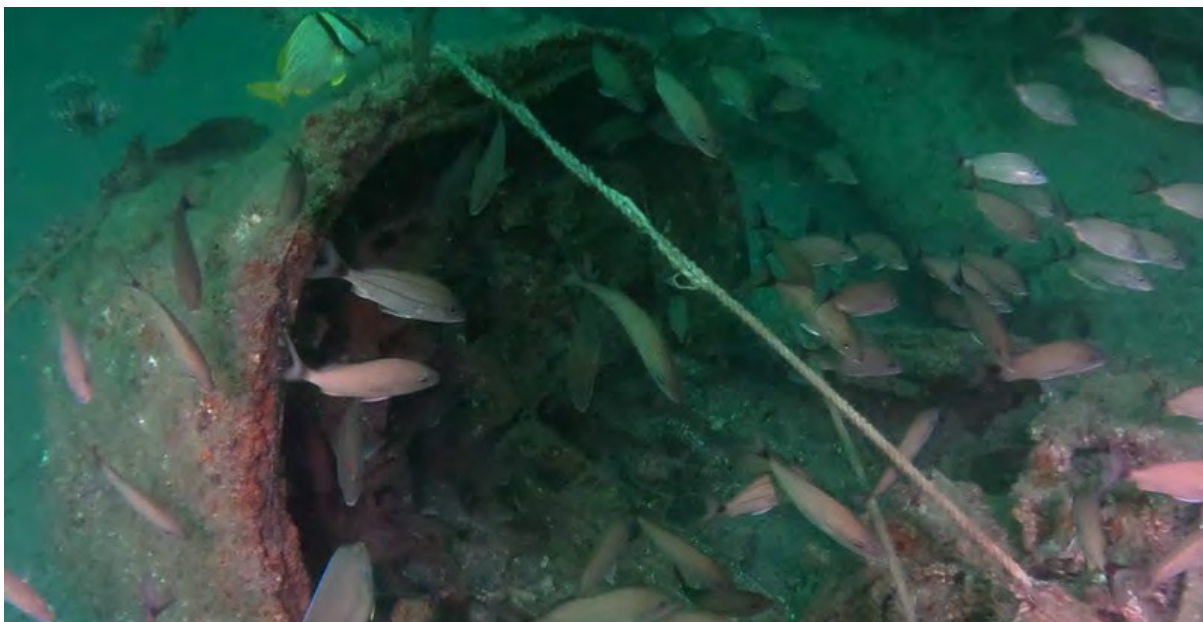
Figure 54 - Anchor stuck in hole in airplane wing

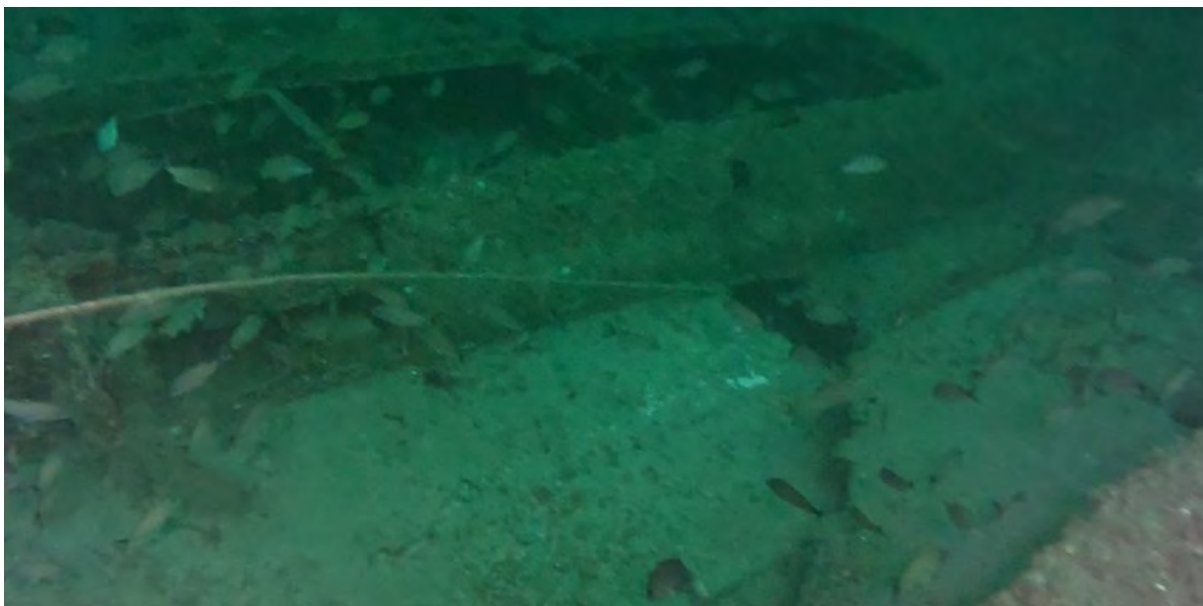
Figure 55 - Anchor ropes on engine bay

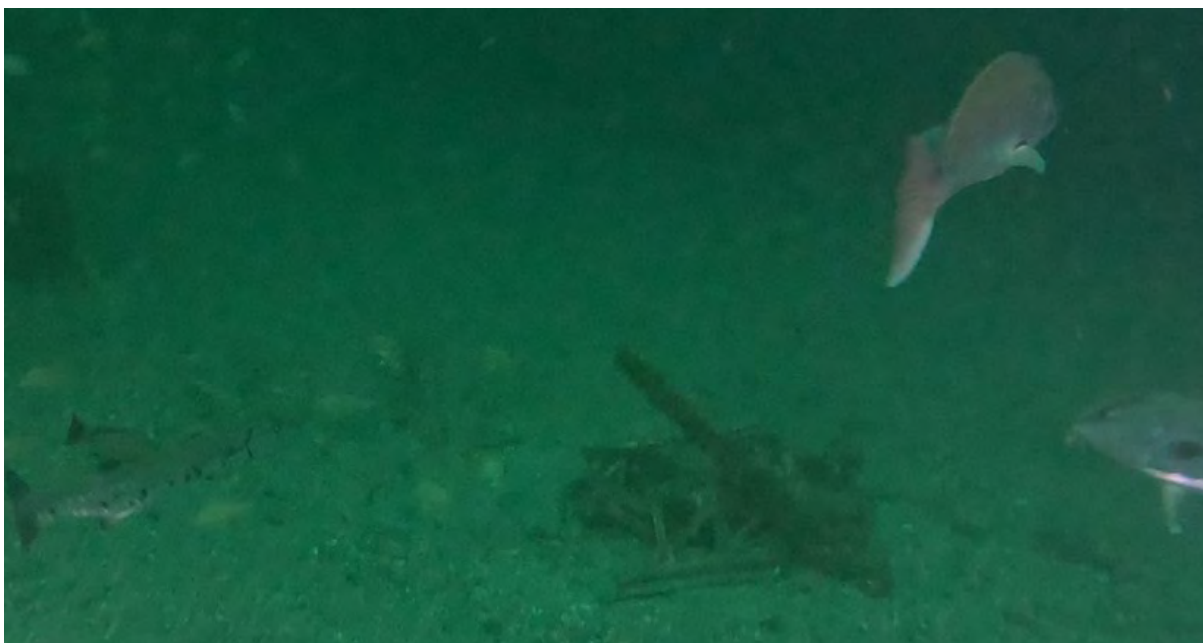
Figure 56 - Anchor stuck in hole in airplane wing

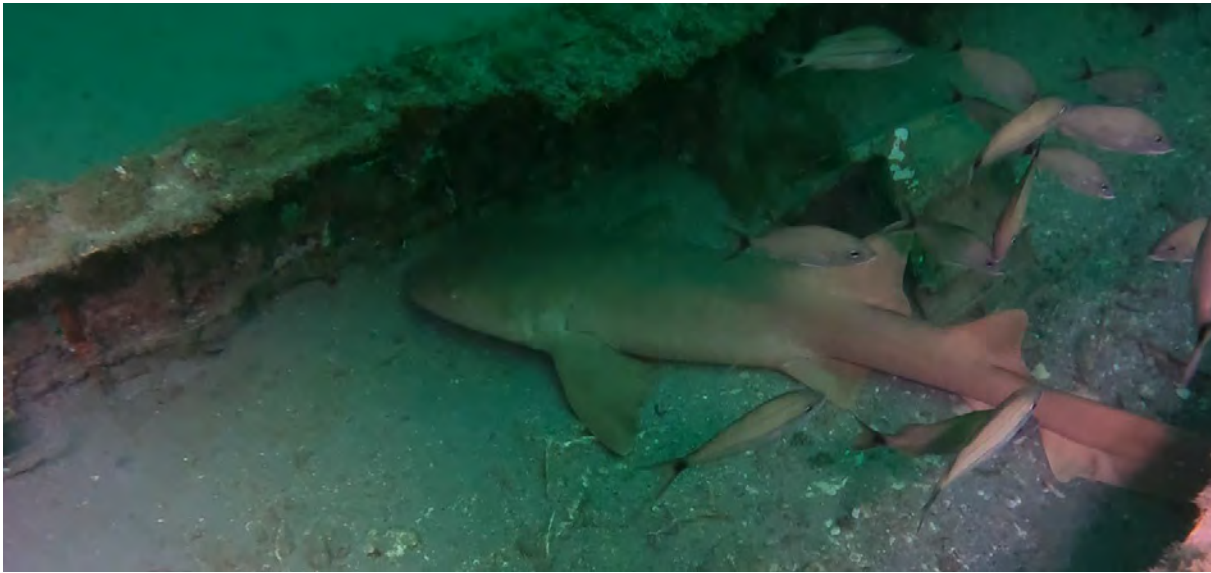
Figure 64 - Partial Wing & fuselage and anchor rope

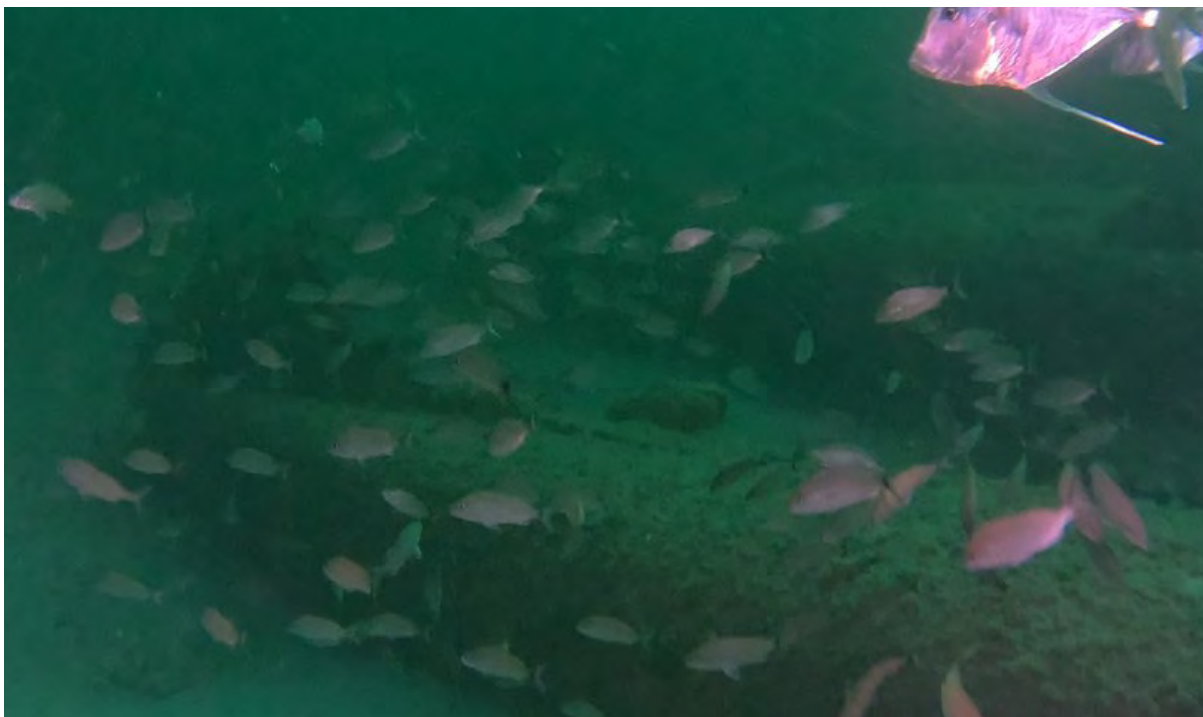
Figure 74 - More Anchor Rope on Cockpit

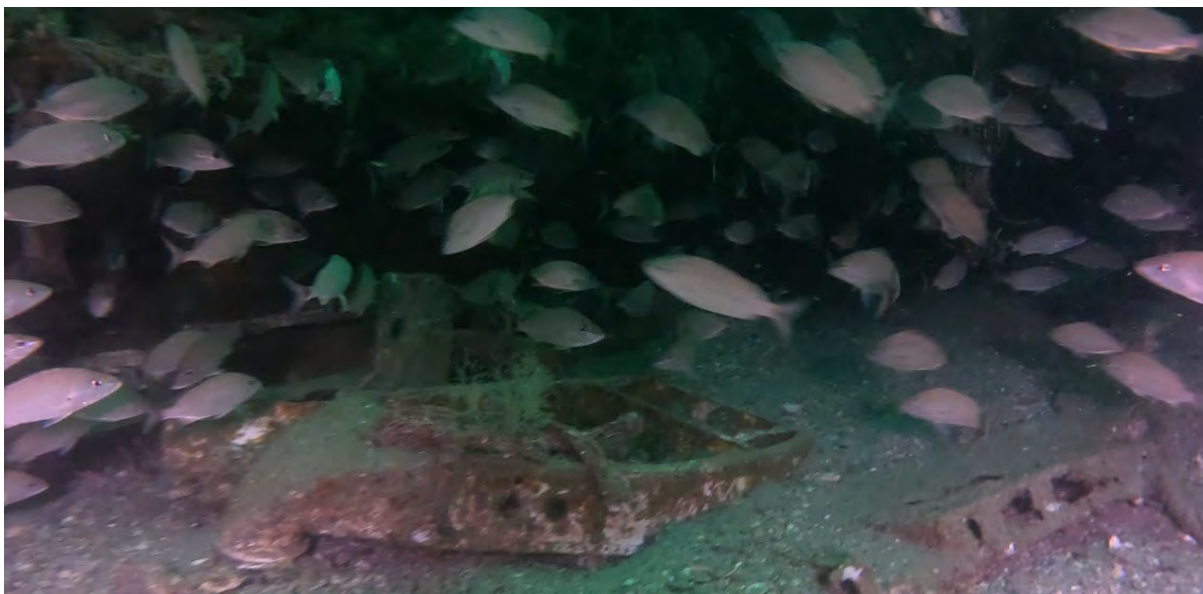
Figure 76 - Fishing line and rope

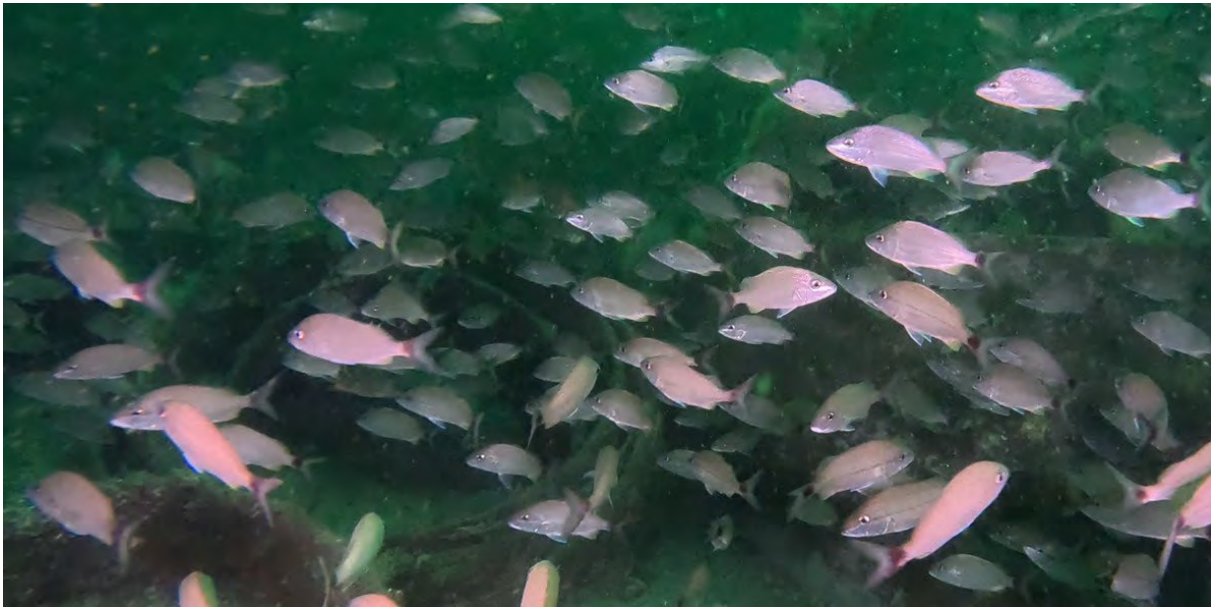
Figure 89 - Mangrove Snapper and Tomato Grunts

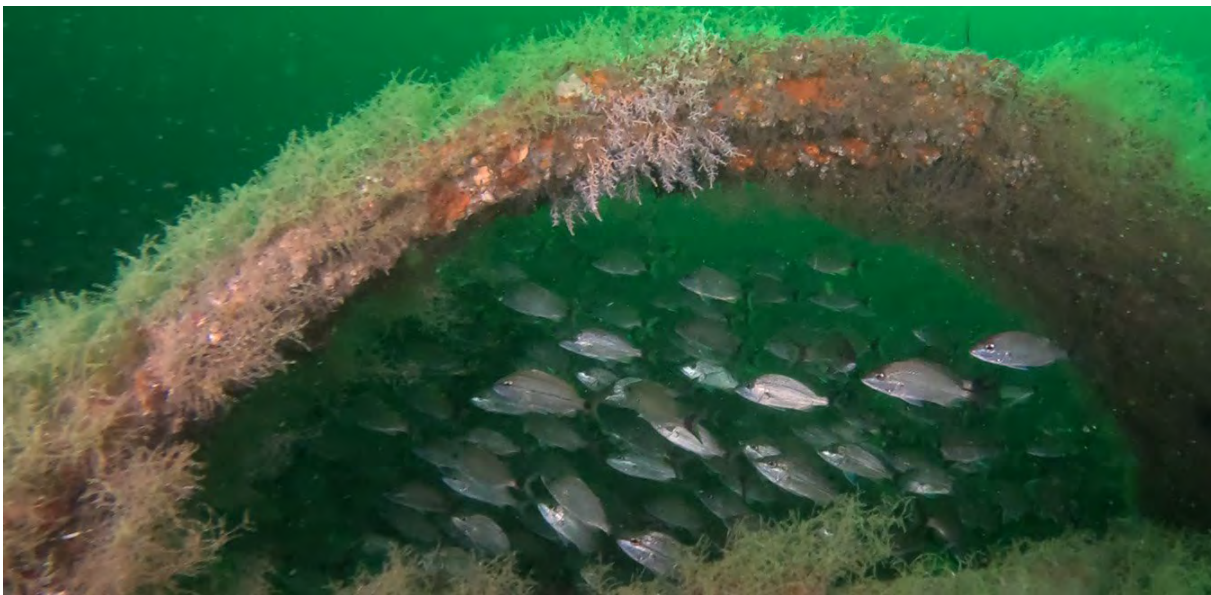
Figure 92 - Coral growth / Marine Growth

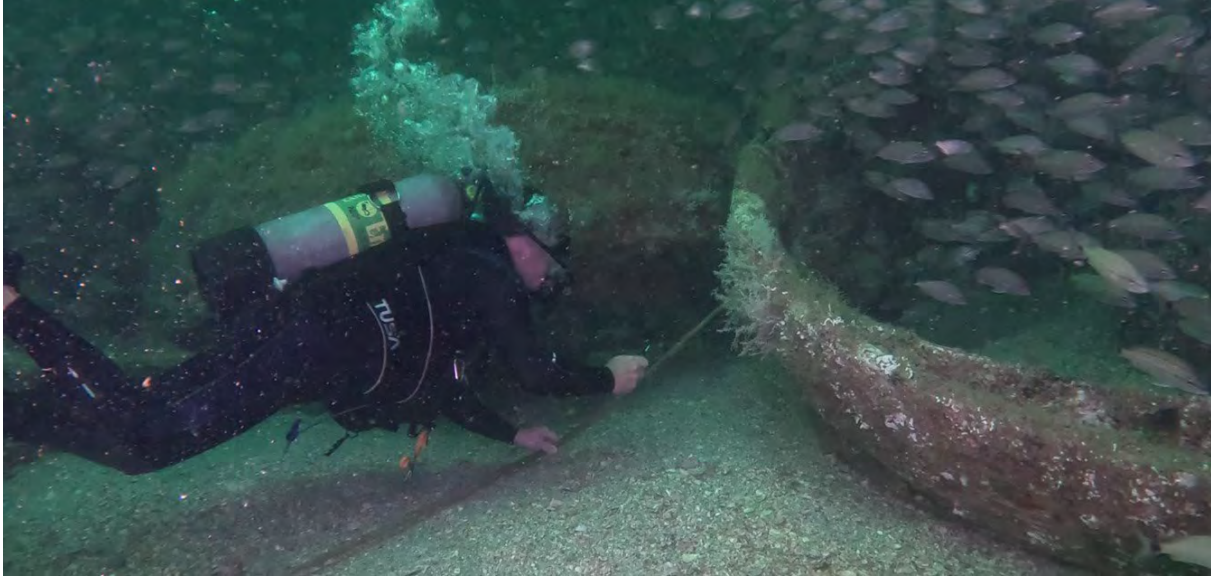
Figure 95 - Reef Cleanup Efforts, removal of anchors, anchor ropes, and fishing line

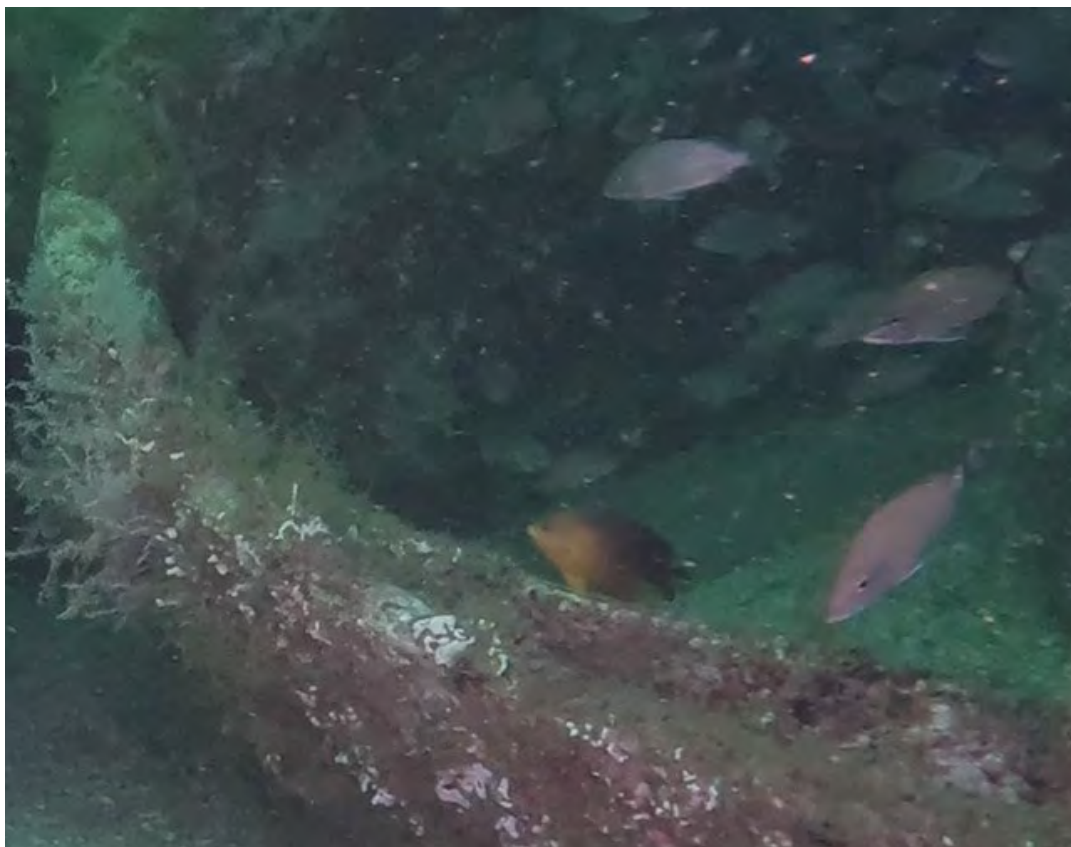
Figure 96 - Reef Cleanup Efforts, removal of anchors, anchor ropes, and fishing line

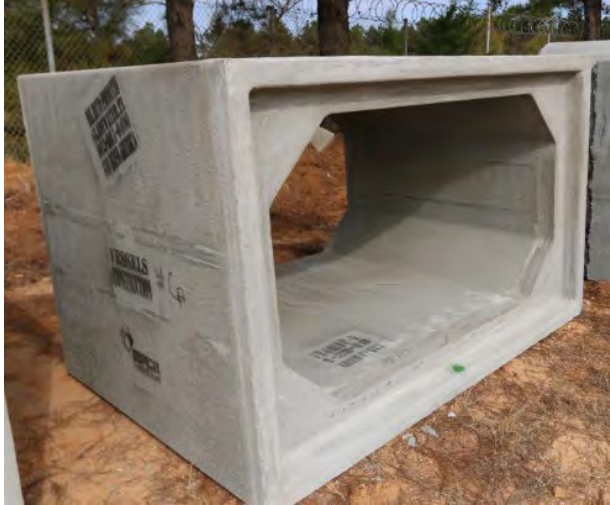
Figure 106 - Typical Concrete Culverts on Moody

Current Condition of the Reef: Reef is very healthy. Concrete Culverts appear to have almost 100% marine growth coverage. Good healthy coral growth. Fish species is predominantly Greater Amberjack

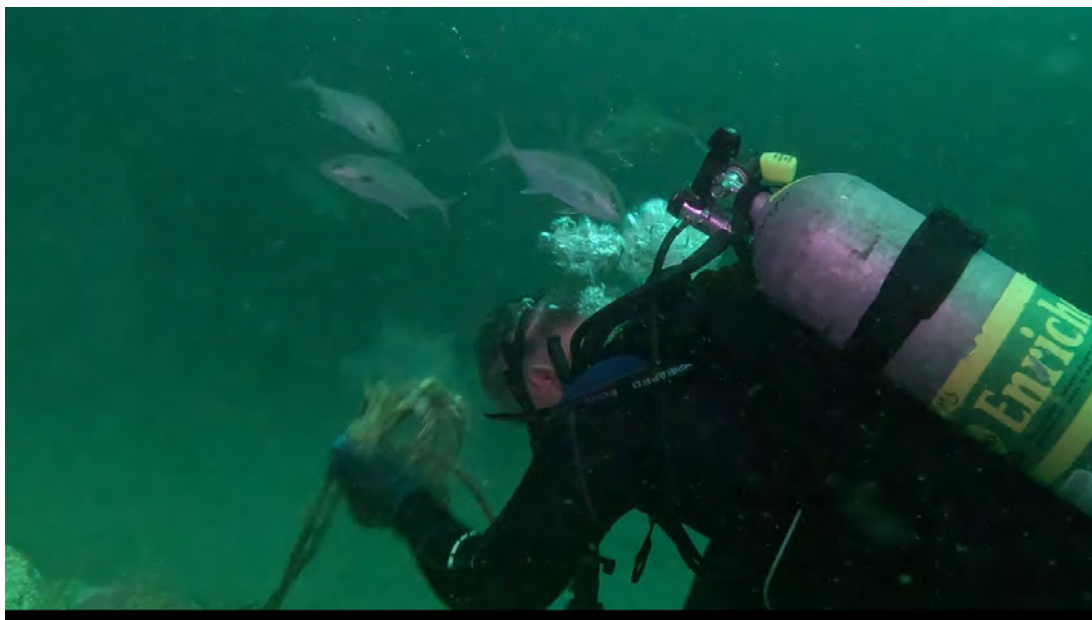
Clean up efforts: Lots of Anchor rope and fishing line. Reef appears to be very well utilized. There

Figure 117 - Clean up efforts, remove rope

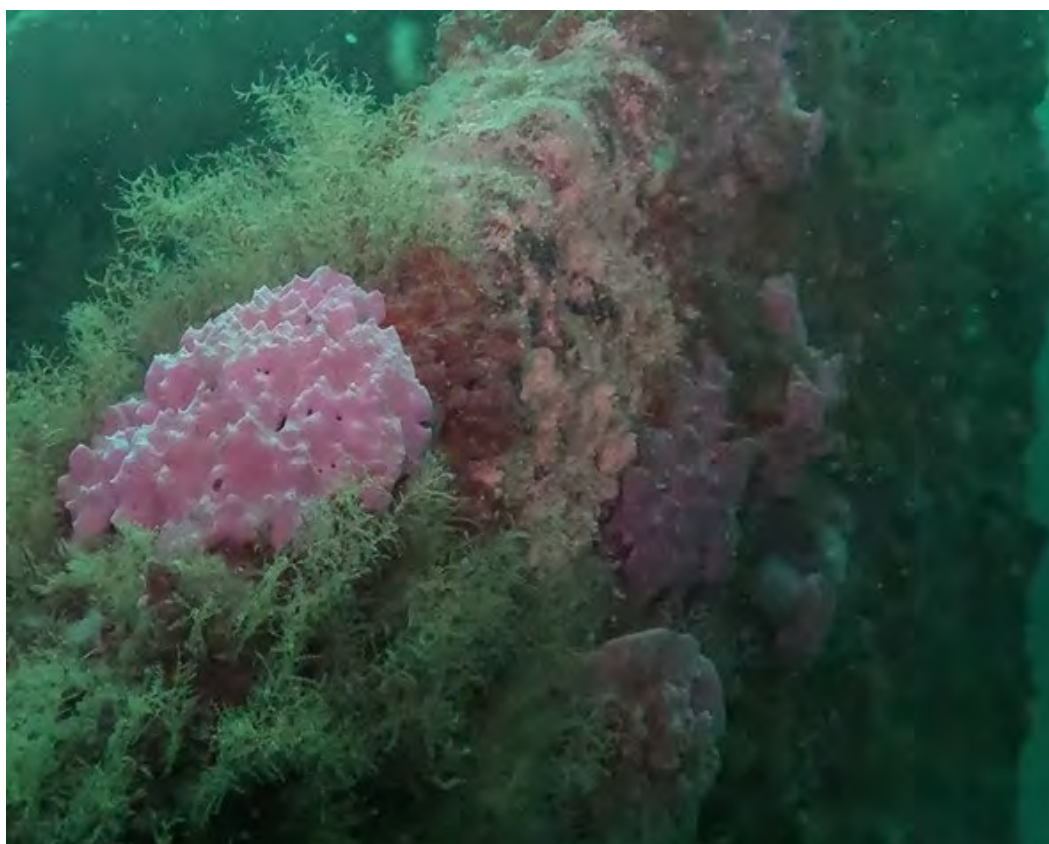
Figure 118 - Lots of coral growth

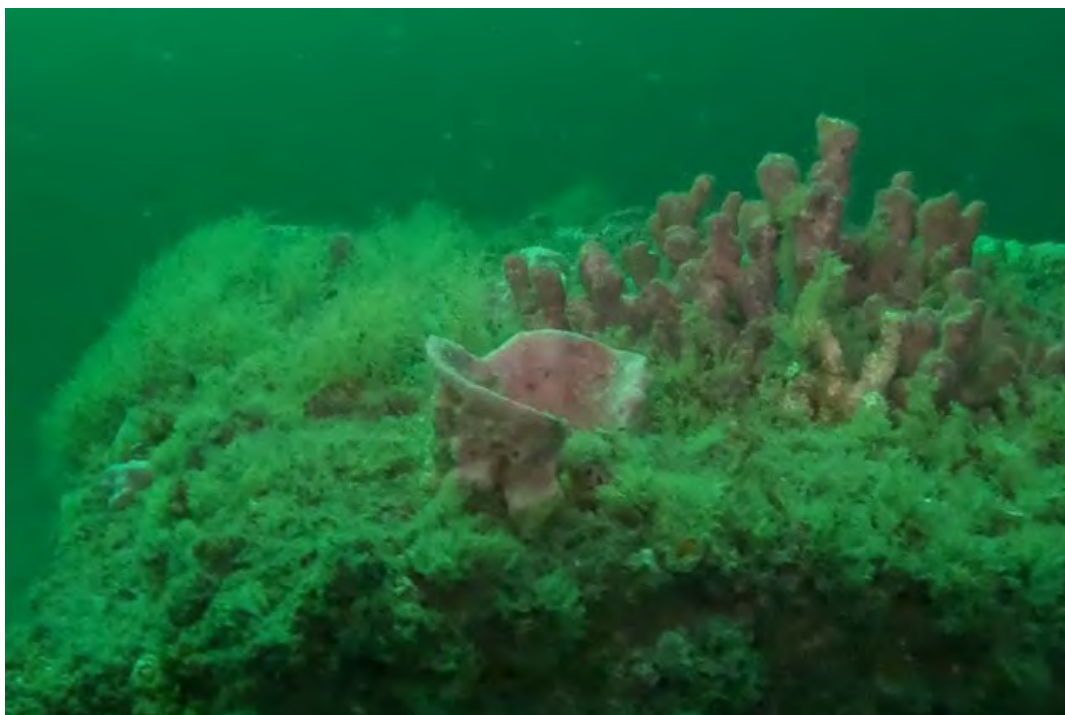
Figure 119 - Lots of coral growth

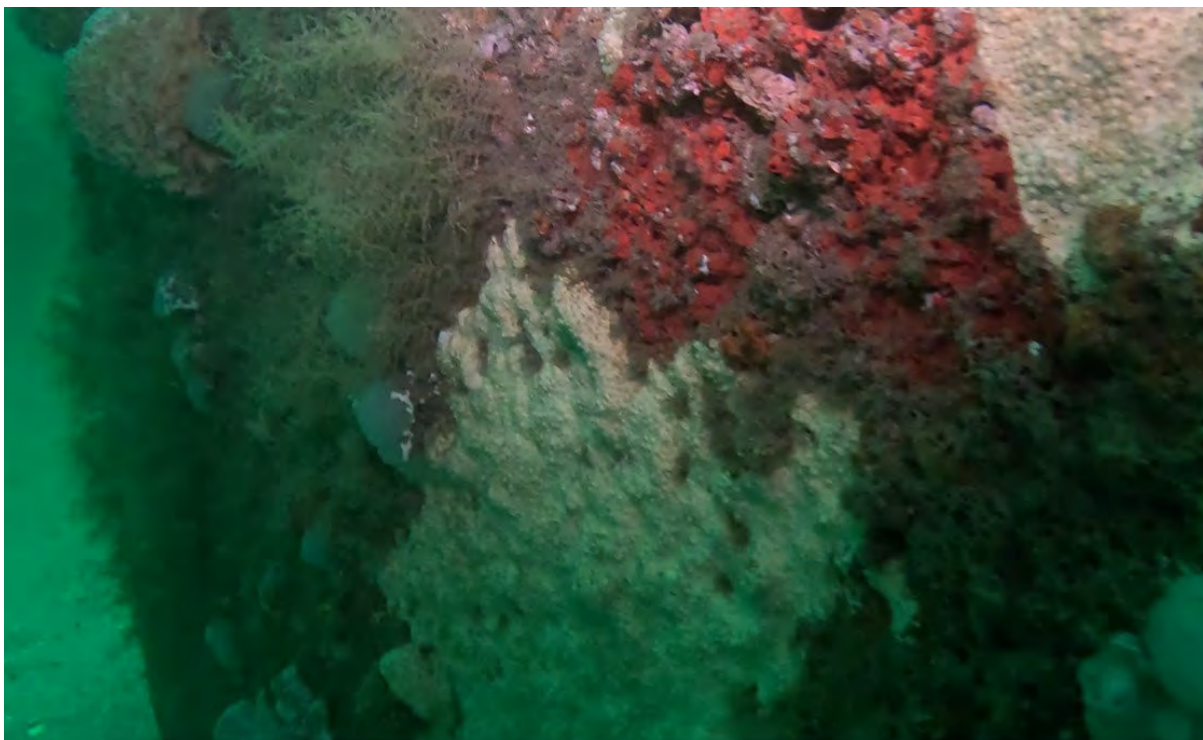
Figure 121 - Lots of coral growth

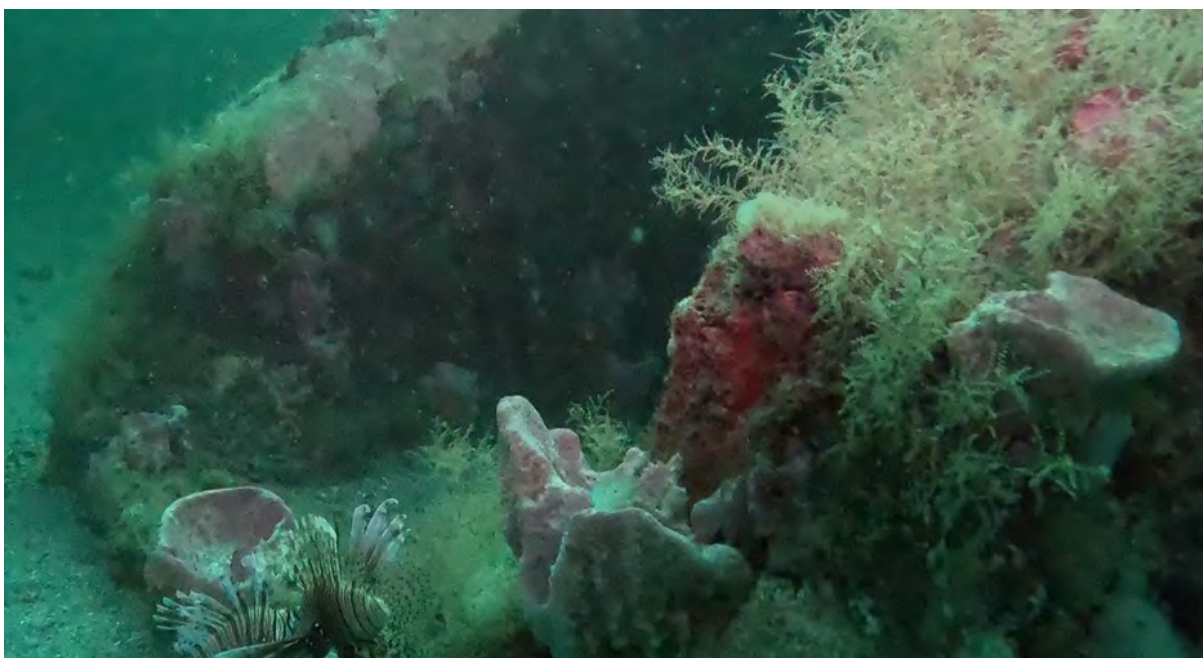
Figure 122 - Lots of coral growth and Lionfish

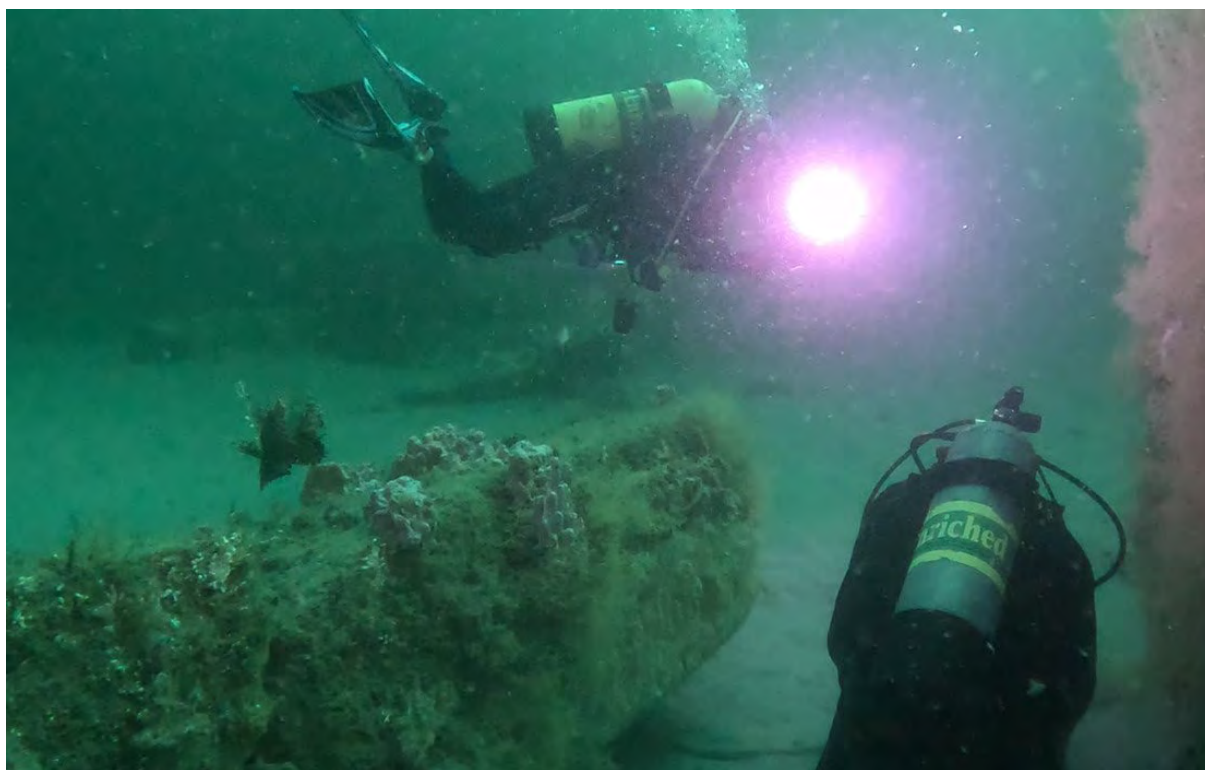
Figure 123 - Cleanup efforts

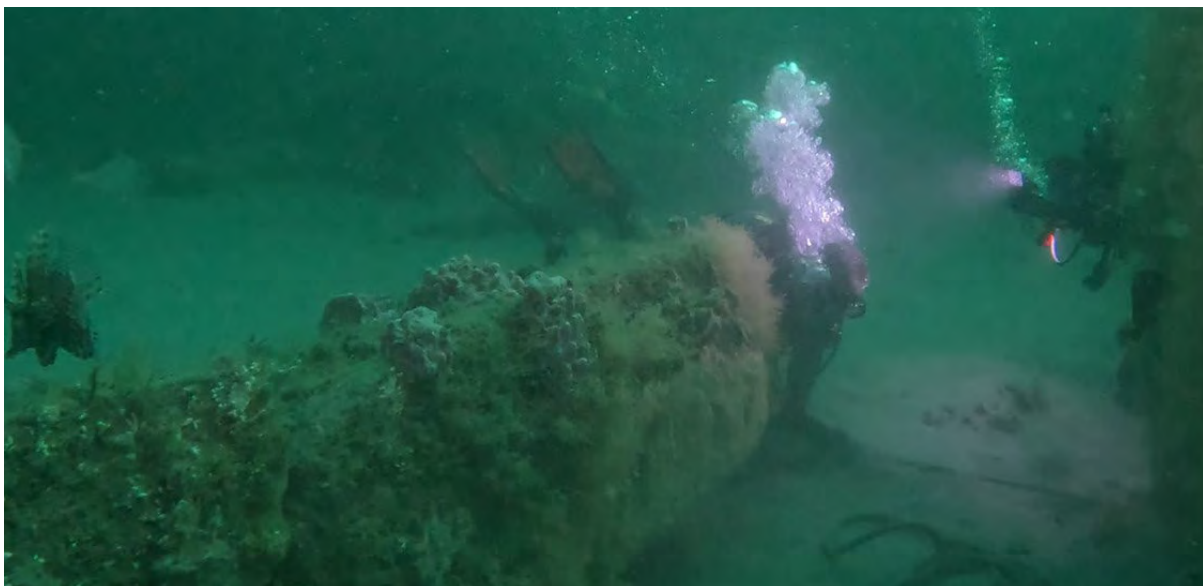
Figure 125 - Cleanup efforts

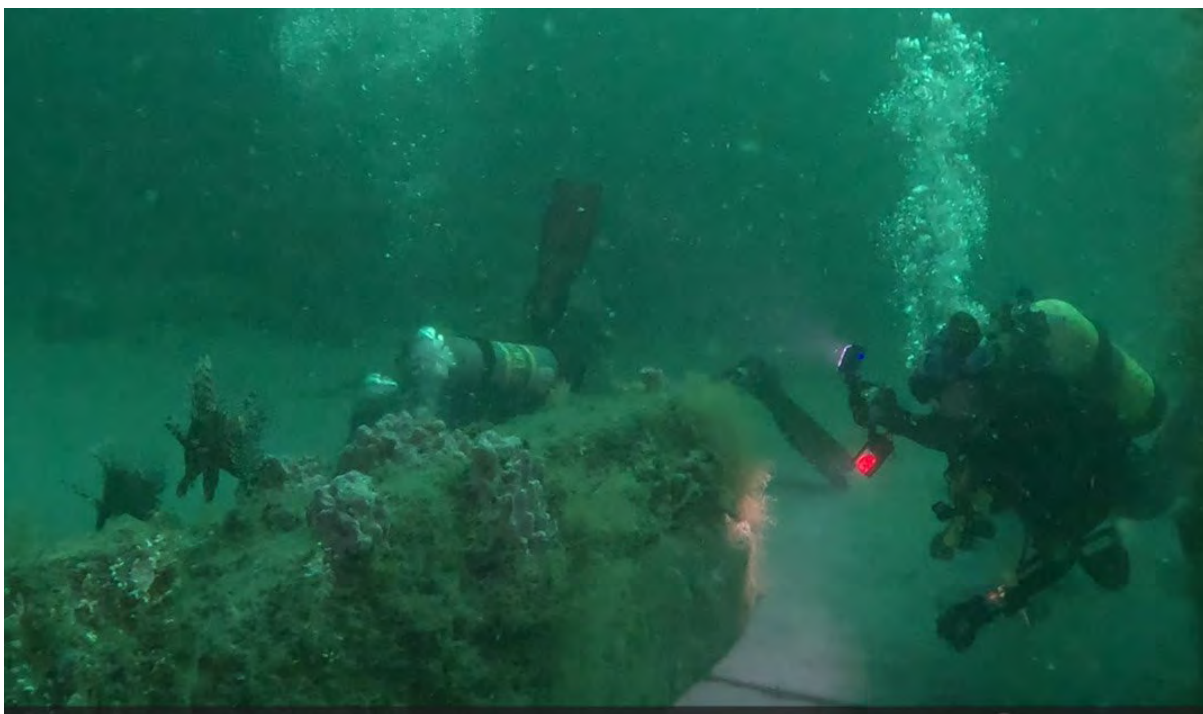
Figure 126 - Cleanup efforts

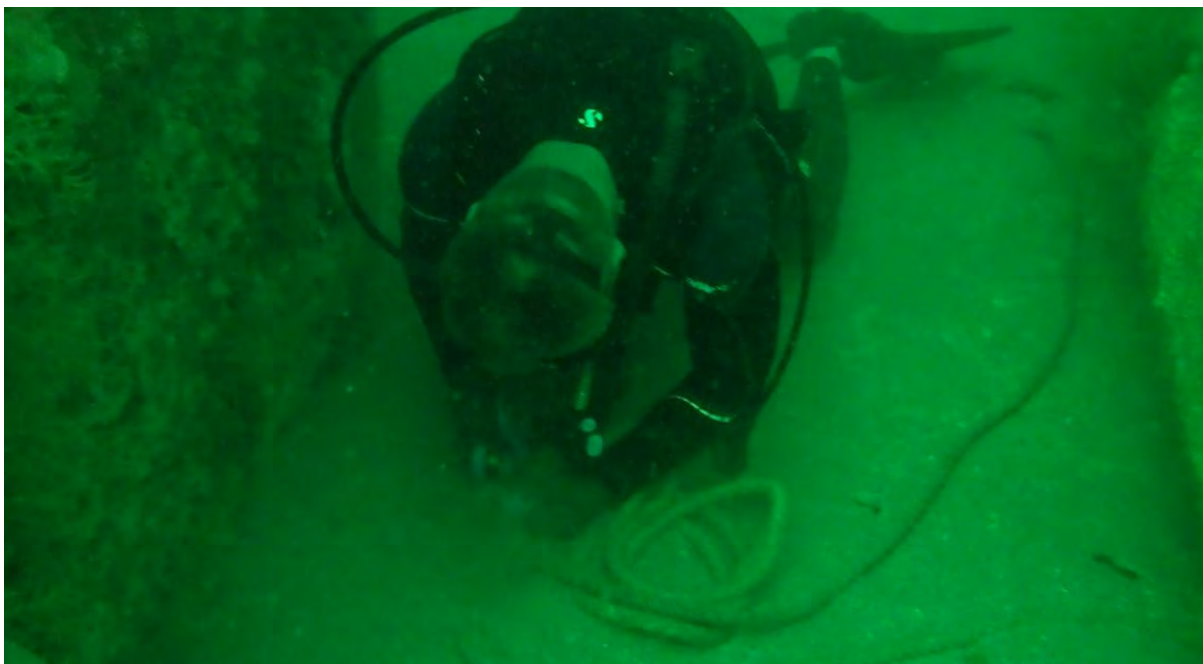
Figure 127 - Cleanup efforts

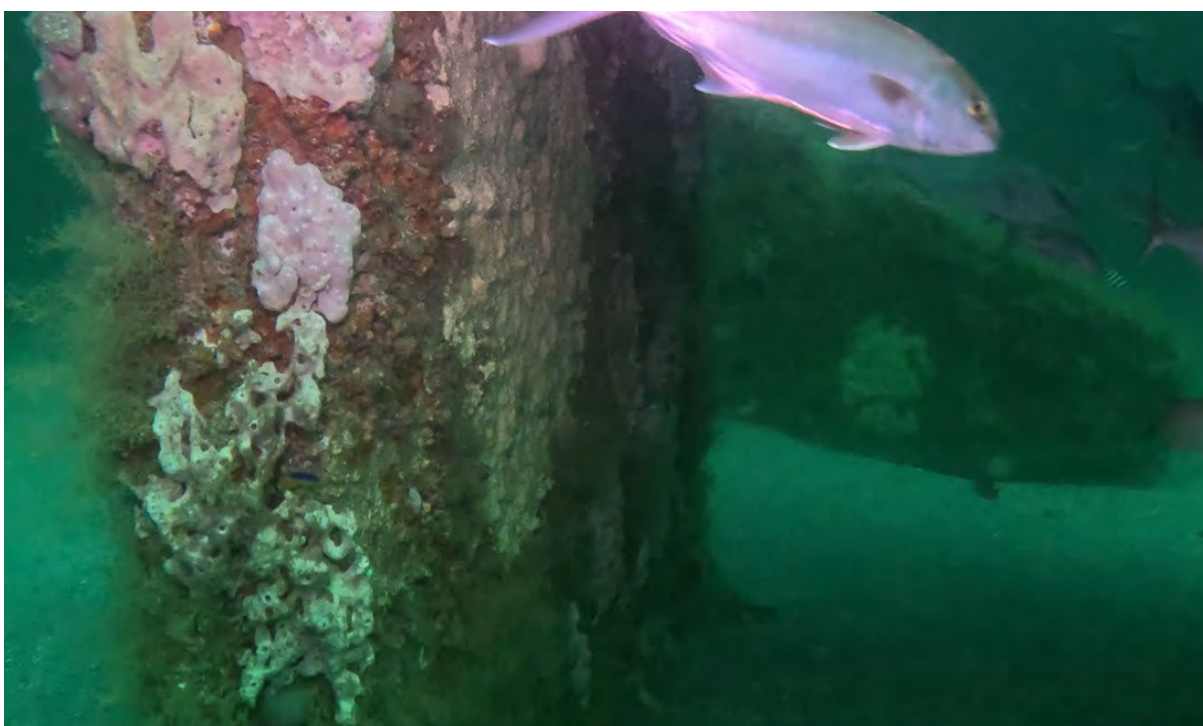
Figure 128 - Coral Growth and Greater Amberjack

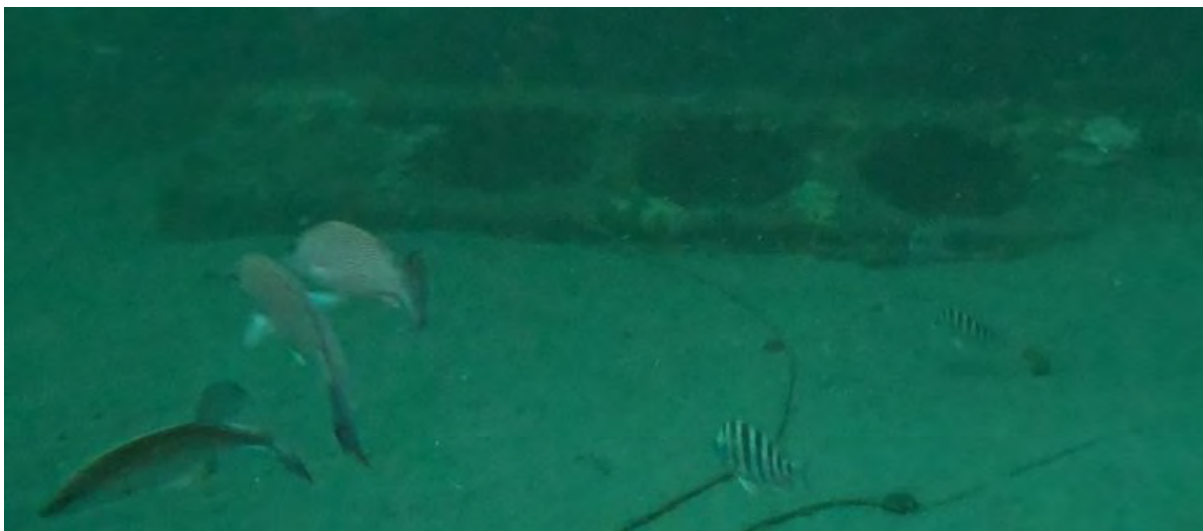
Figure 131 - Abandoned anchor rope

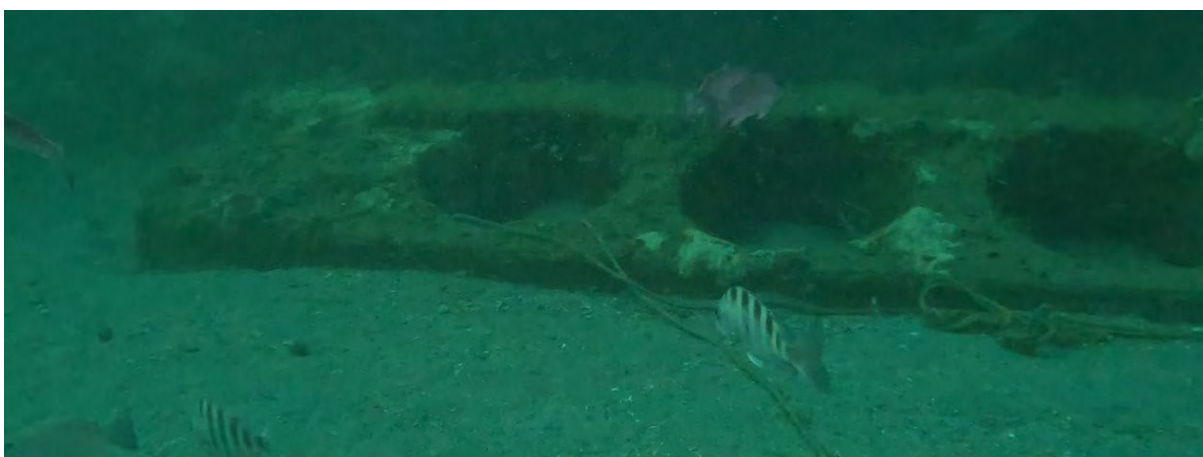
Figure 132 - Abandoned anchor rope

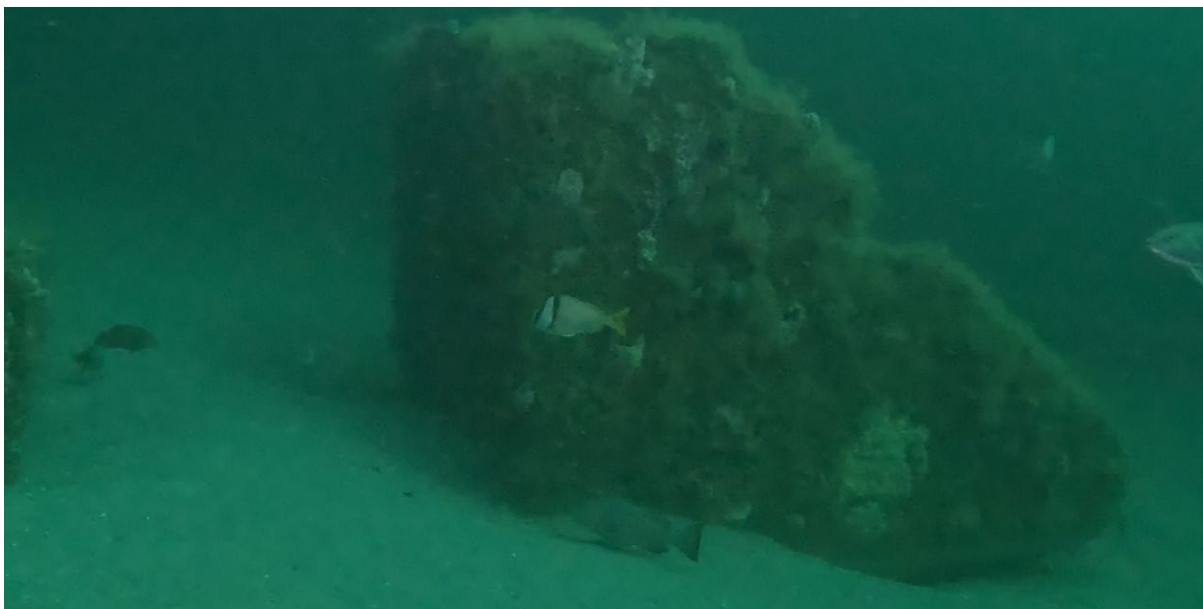
Figure 135 - Grouper and Porkfish

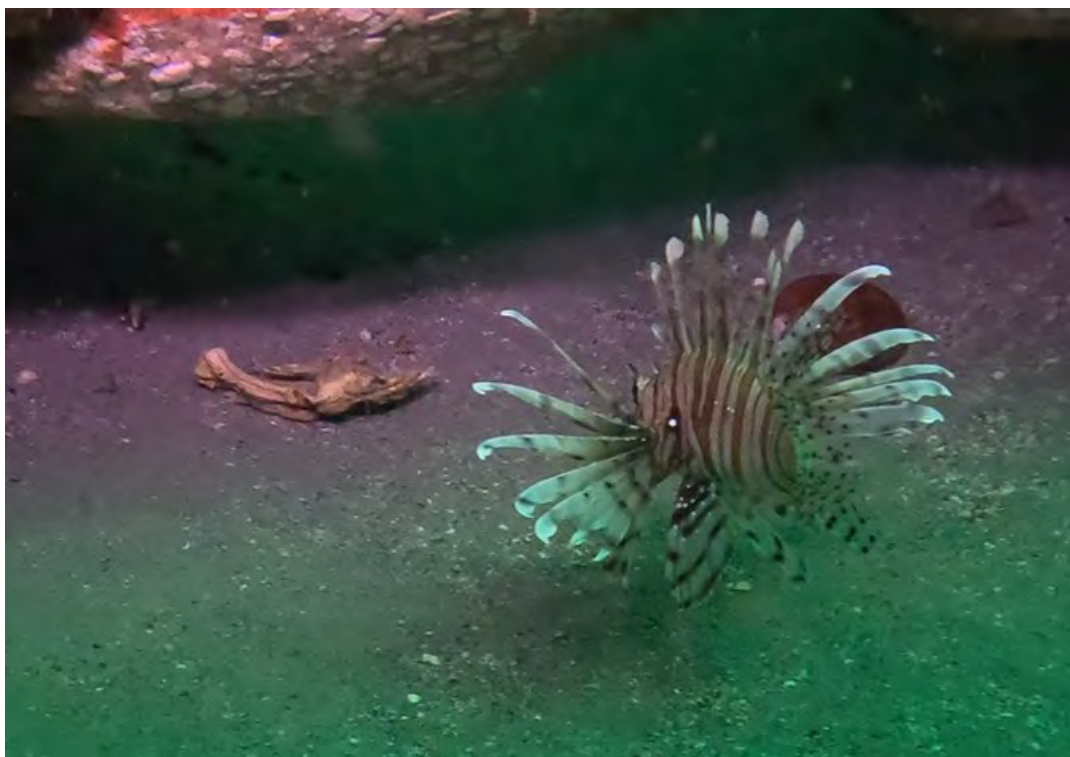
Figure 137 - Lionfish
