MISC 1794: REEF MONITORING FOR MOODY, TAYLOR, AND INTRUDER REEF SITES

Subject: Please find the following report dated Feb 7, 2025, which completes the contract. Invoice to be submitted separately.

Project Overview

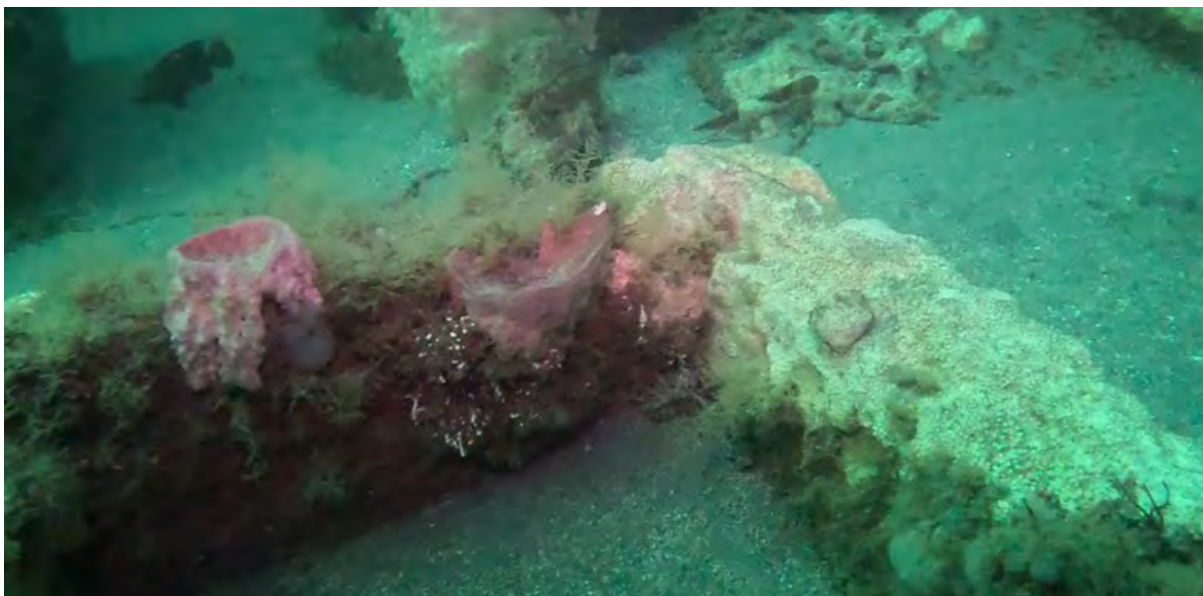
Figure 141 - Coral Growth

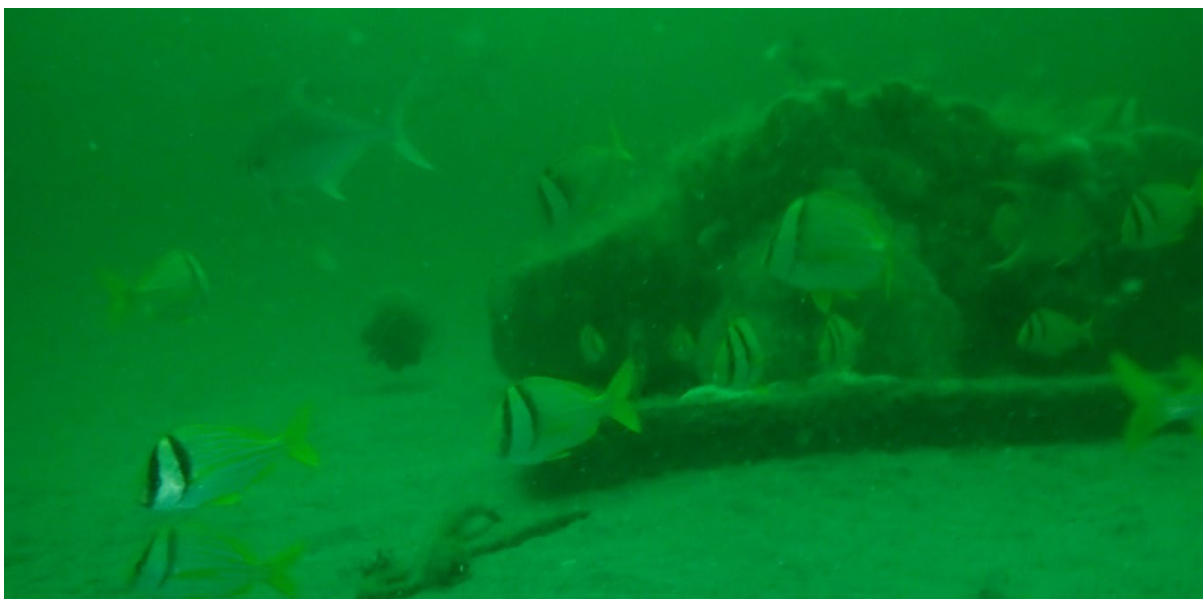
Figure 142 - Porkfish & anchor rope

Following the fish count operations, the divers returned to the site for Debris Removal Operations. All fishing lines and boat anchor ropes that created a hazard for marine life and scuba divers as well as snagged fishing line from above fishermen were removed.
